# Utility Infrastructure Master Plan

## San Bernardino Valley College

P2S Project #0191

Issued September 2, 2020

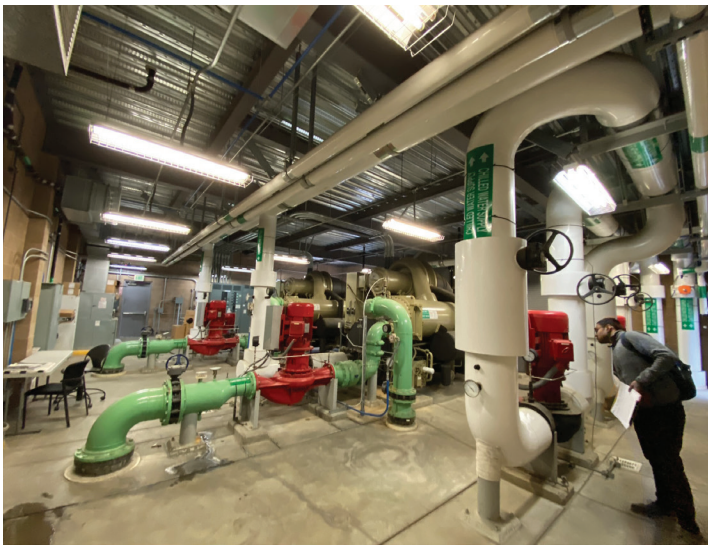
HHW Pumps at Central Plant

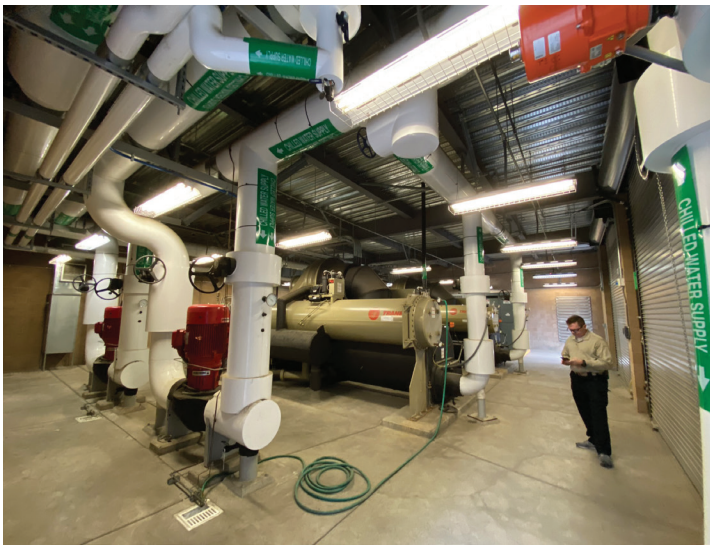
The central cooling plant was constructed in 2013. There are two (2) Trane centrifugal chillers rated at 600 tons each, utilizing R-123 refrigerant. Associated with the chillers are two (2) Evapco induced draft counter flow cooling towers. The cooling towers are elevated with piped Condenser Water Supply and Return (CWS&R) connections to each cell. There is a piped equalizer line between the two cells. A side stream sand filter serves the condenser water system and is located within the cooling tower yard. To offset peak electrical demand, and to provide additional capacity during peak periods, there is also a large Thermal Energy Storage (TES) tank in the central plant. The TES tank has a rated capacity of 8,000 ton-hours, and a rated discharge rate of 1,500 tons/hour. It is sized to handle the campus load during the peak electrical charge period of 12pm-6pm. Tank diameter is 45ft and is it 65ft tall.The chilled water system is pumped primary variable secondary variable.

HHW Pumps and Chillers at Central Plant

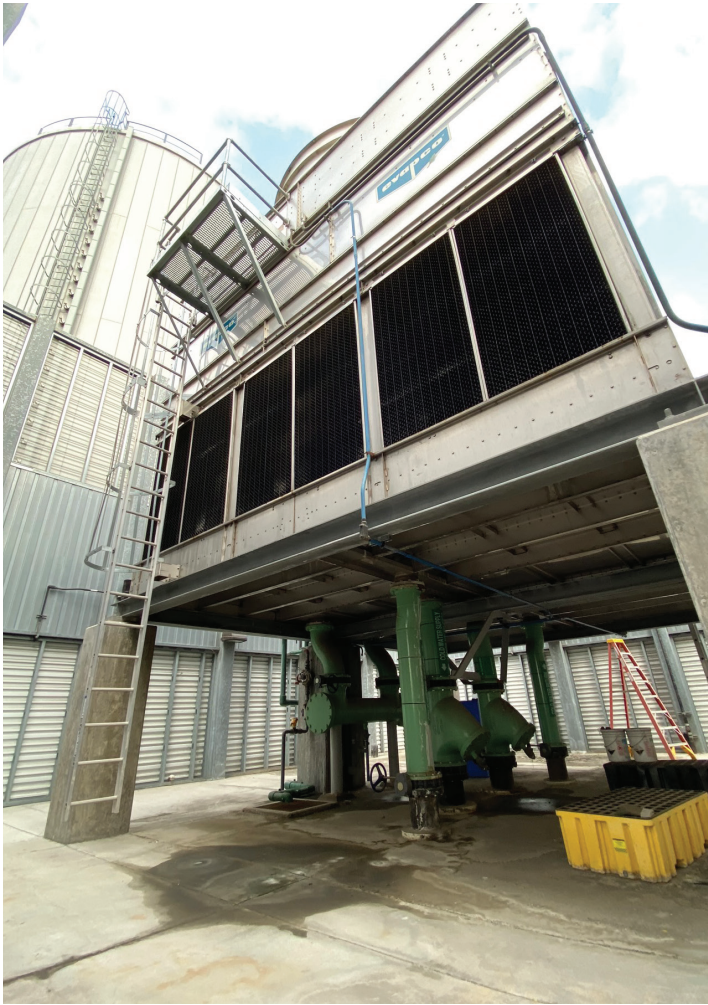
Cooling Tower at Central Plant

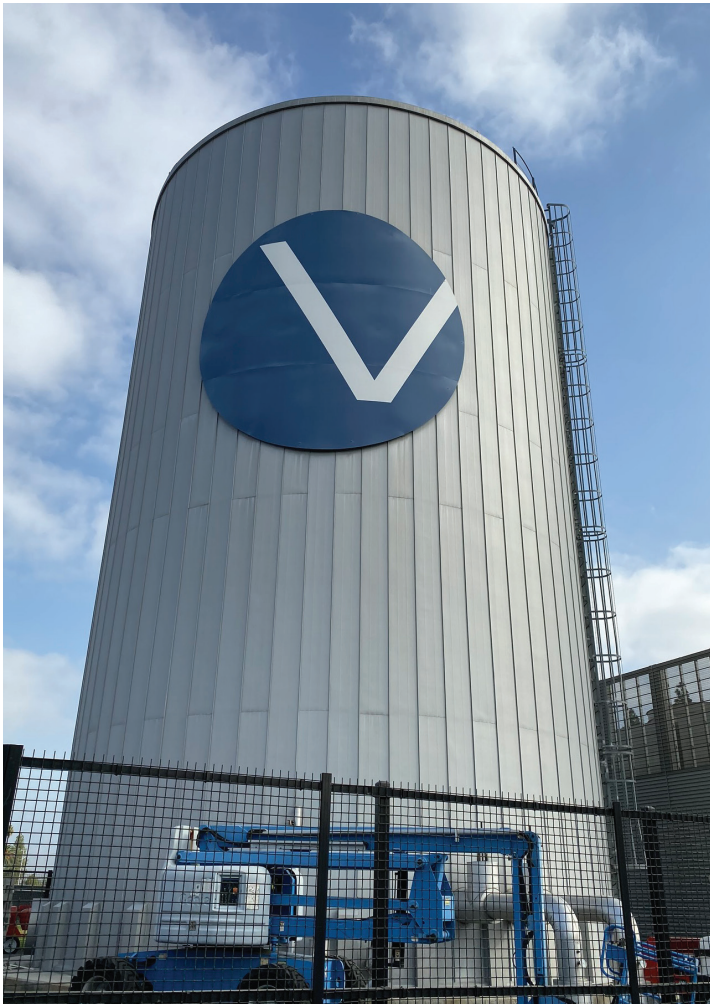
Thermal Energy Storage Tank

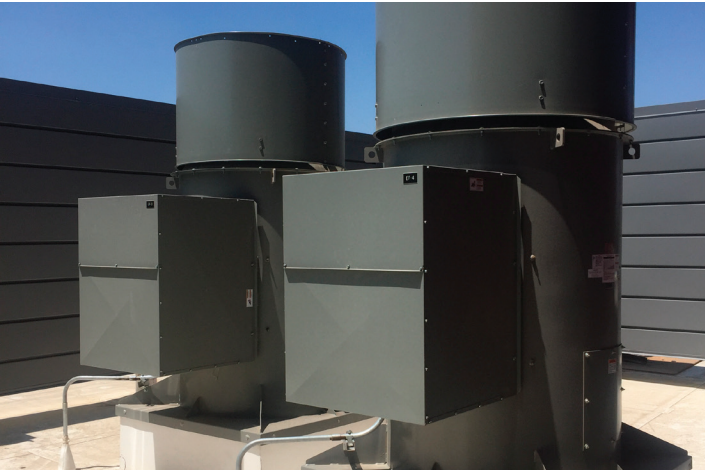
The Gymnasium was constructed in 2016 and houses one (1) mechanical room for the local heating hot water (HHW) plant. Domestic hot water is created from a heat exchanger connected to the HHW system. There are seven (7) Western Aire variable speed air handlers – located on the roof and split between the north, south, and center of the building. The air handling units have CHW & HHW coils. The building uses VAV boxes with reheat coils for zone temperature control. The air handlers are approximately 4 years old and are in good condition.

Exhaust Fans at Gym

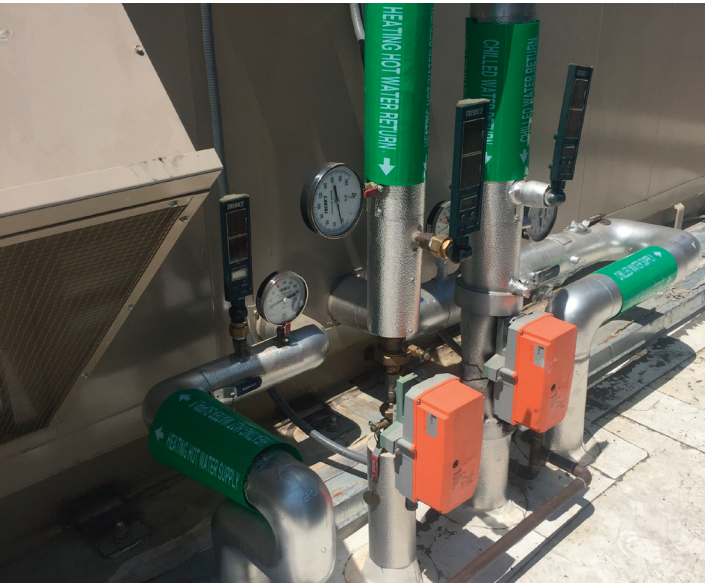
AHU Coil Connections at Gym

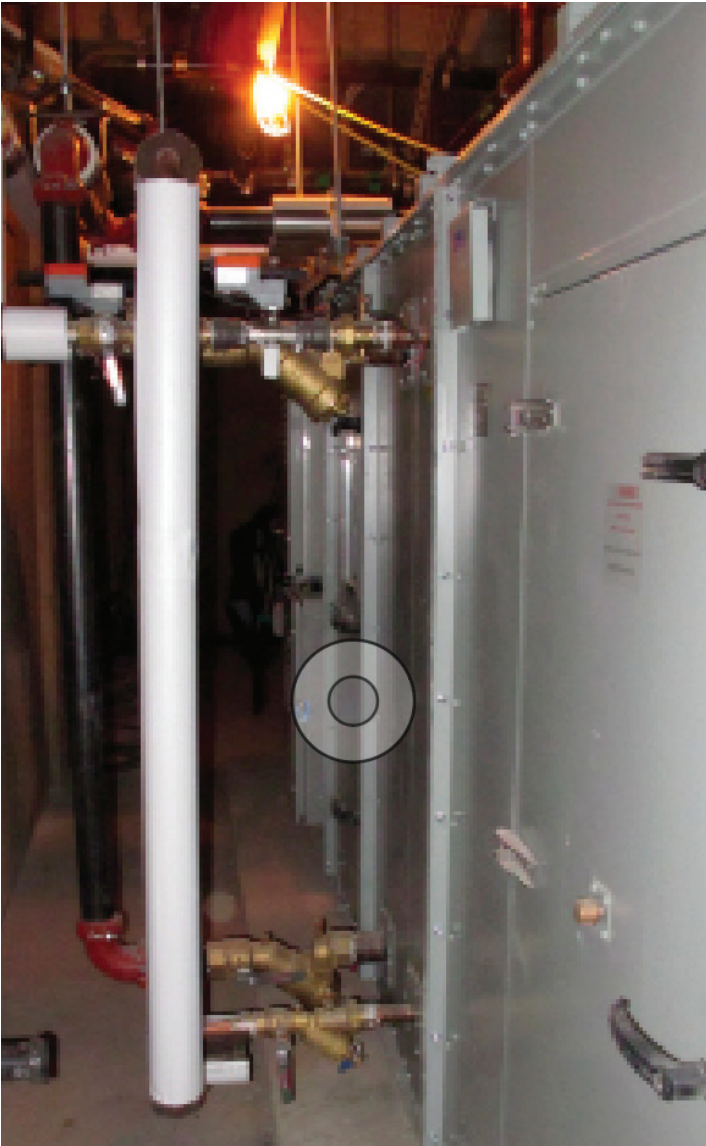
The Business building was renovated in 2013, and houses three (3) mechanical equipment rooms. There are two (2) Energy Labs variable speed air handling units serving the building. AHU-1 has a return fan module tagged as AHU-3, while AHU-2 has a return fan module tagged as AHU-4. The air handling units have both CHW and HHW coils. The air handling units are approximately 7 years old. ASHRAE suggests a useful life of 20-25 years for this type of air handling unit. The system employs VAV with reheat for individual zone temperature control. There are two cooling only split system units serving the IDF rooms with

AHU Coil Connections at Business

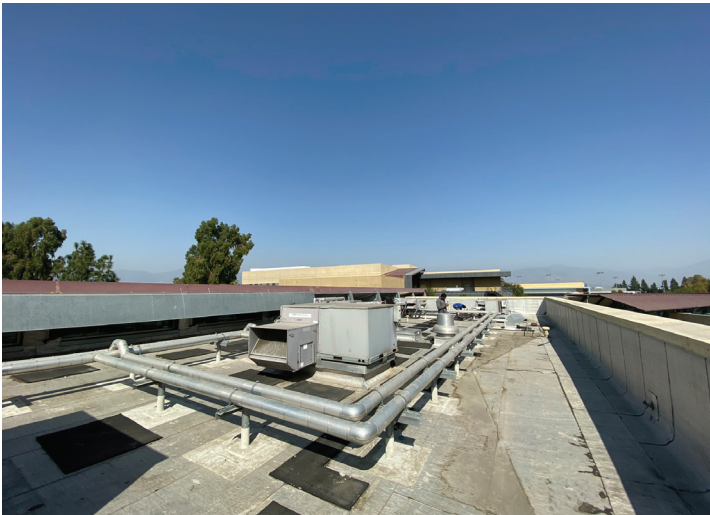
The Library building was constructed in 2012 is approximately 17 years old. There are seventeen (17) rooftop package units that are original to the building. Originally, they were DX cooling coils, but were converted to chilled water cooling coils and connected to the central cooling plant in 2013. ASHRAE suggests a useful life of 15 years for this type of package rooftop unit, but it is anticipated that this life expectancy will be extended for another ten years

CHWS&R Lines on Roof of Library Building

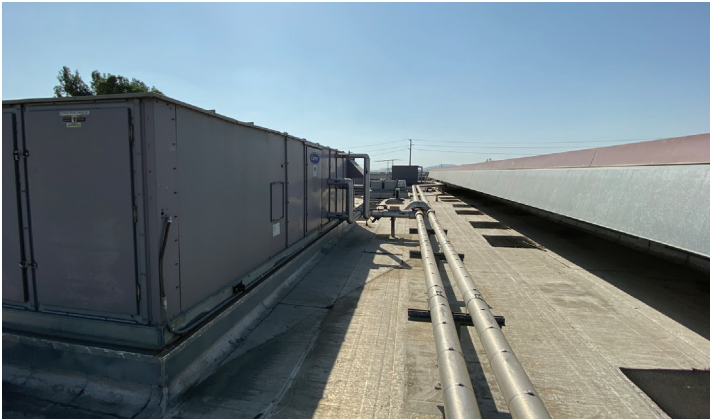
Air Handling Unit on Library Building

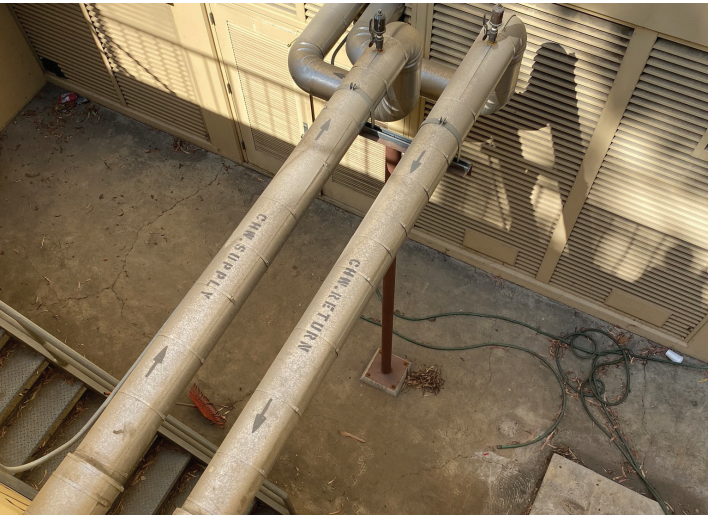
CHWS&R Lines at Liberal Arts Building

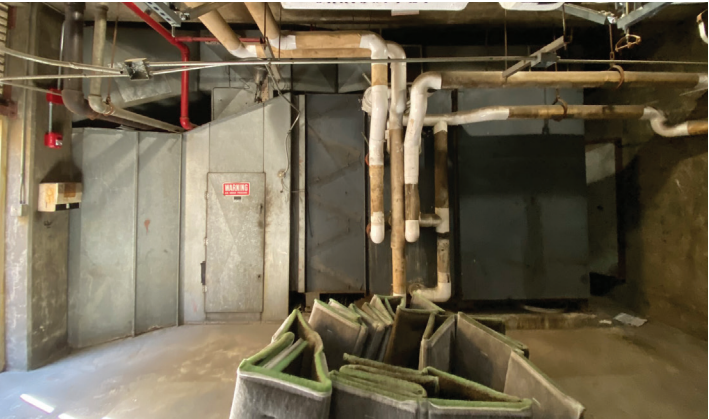
Multi-zone Units in Liberal Arts Basement

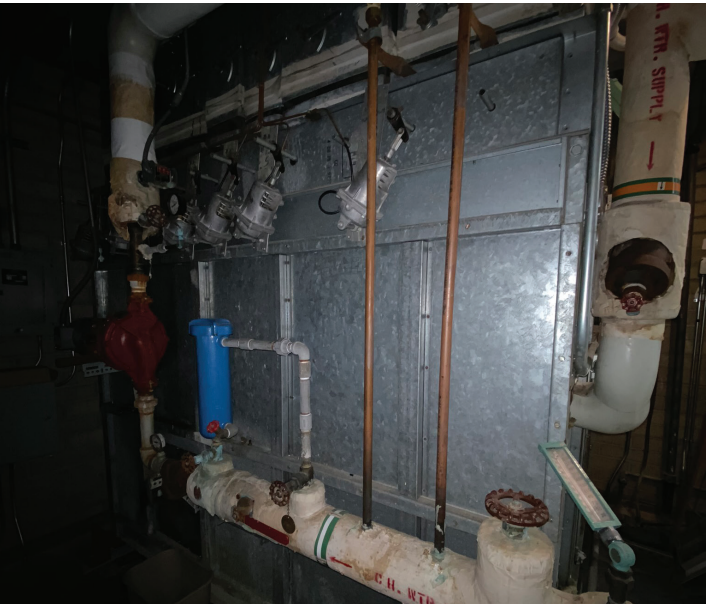
Pneumatic Controls in Planetarium Building

are pneumatic and should be replaced with a full DDC system.

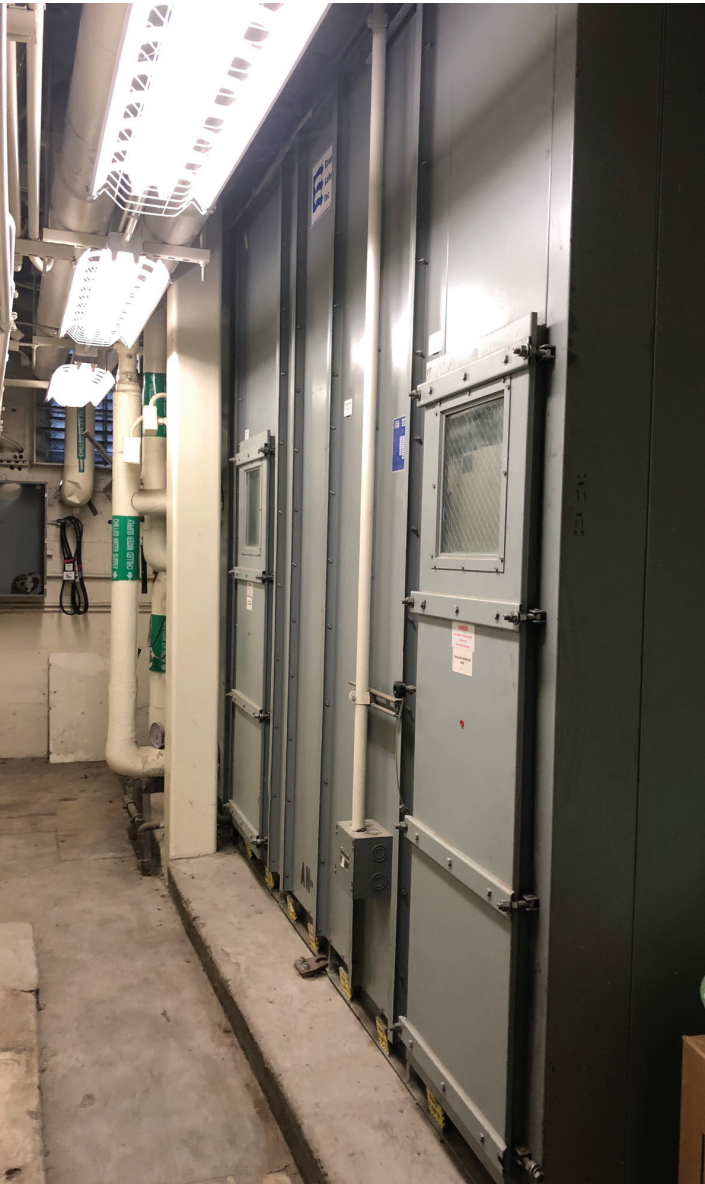
AHU in Auditorium Building

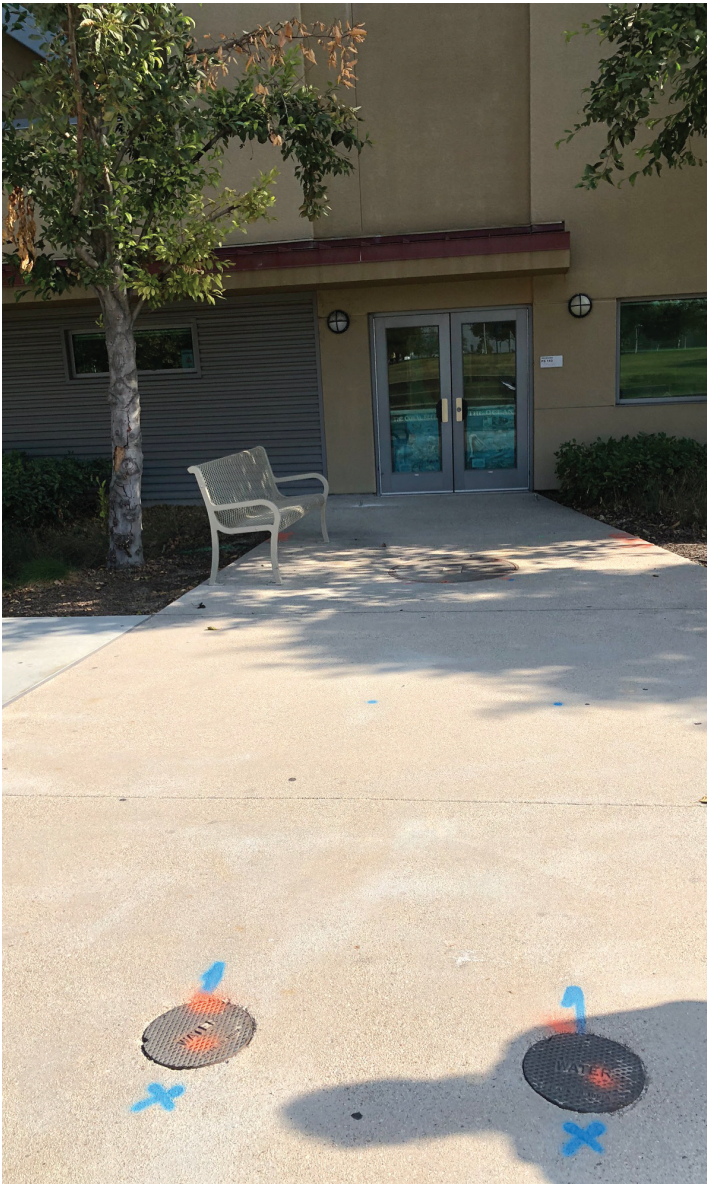
CHW Valve Connections to Chemistry/Physical Sciences

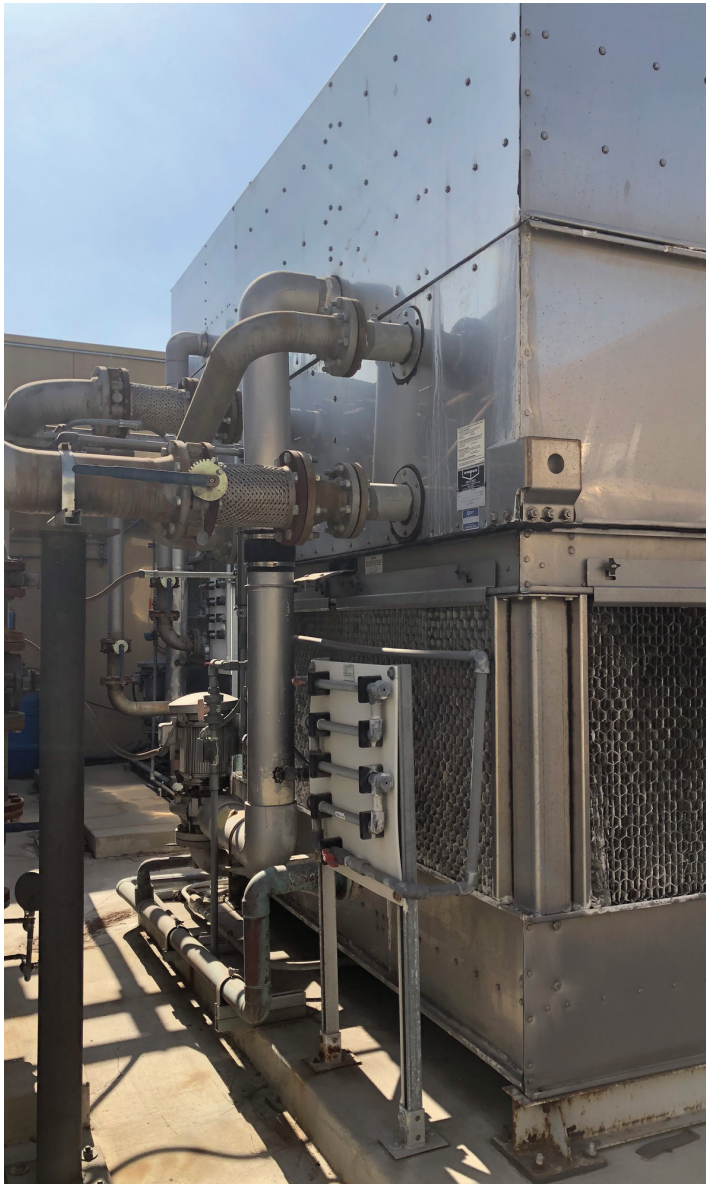
Abandoned Cooling Tower at Admin Student Services North Central Plant

in service. It is recommended to remove all non-functioning equipment and cap existing lines.

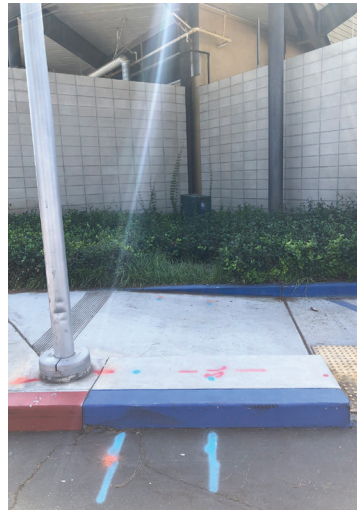
CHW Lines

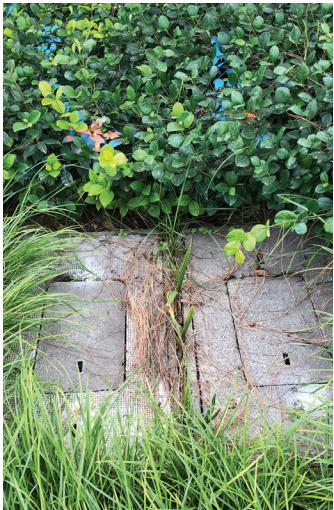
CHW Valves

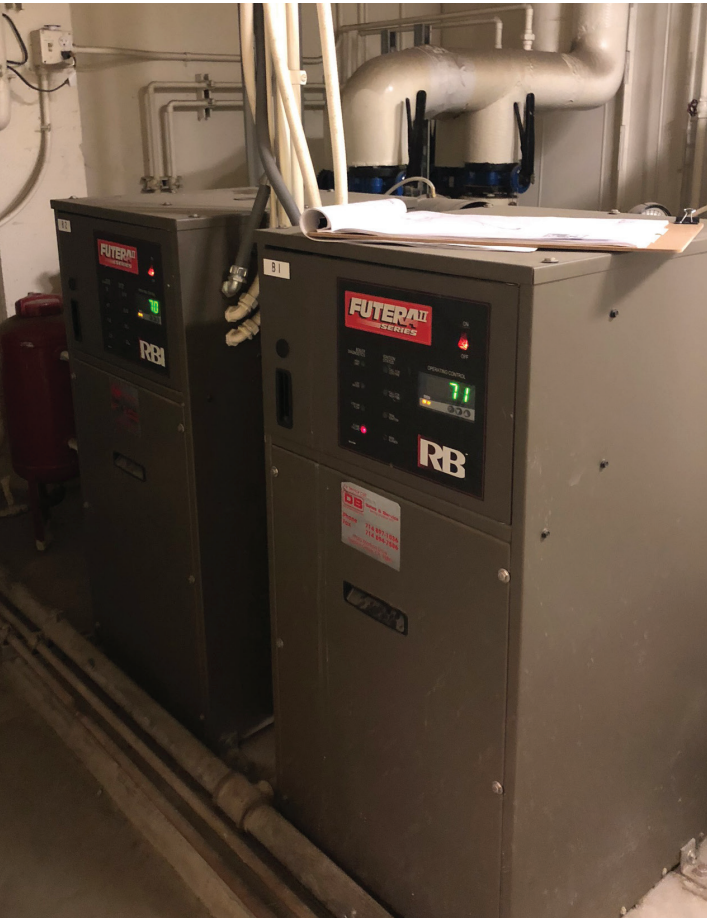
The Auditorium building is approximately 85 years old and houses two (2) mechanical equipment rooms. There is an air handling unit serving the building that is approximately 17 years old. A heating coil was installed in 2013. ASHRAE suggests a useful life of 20-25 for this type of unit. The rest of the HVAC system was renovated in 2013. During the renovation, thirteen (13) CHW/HHW fan coils were installed. They are new and need no replacement. The building also has two (2) small RBI Futera boilers, rated at 425MBH each. The boilers were installed in 2013, and are approximately 7 years old. ASHRAE suggests a useful life of approximately 20 years for this type of equipment. The system has a primary-secondary pumping arrangement. The secondary pumps are on VFDs.

Boilers in Auditorium

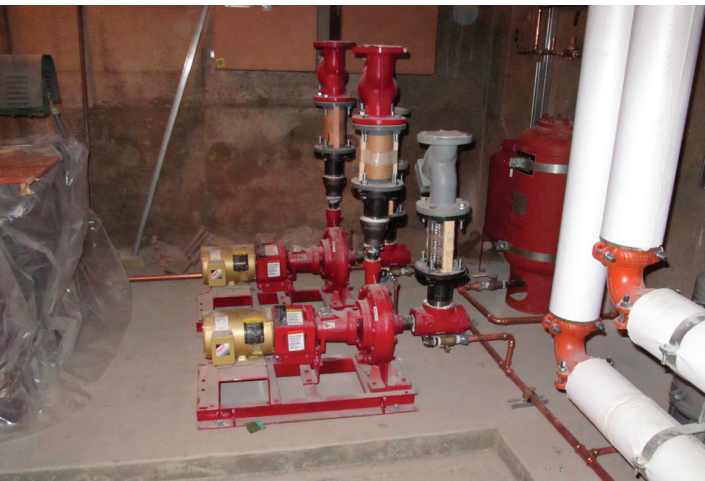
The Business building was renovated in 2013, and houses three (3) mechanical equipment rooms. There are four (4) single-zone air handling units serving the building. The air handling units are approximately 7 years old. ASHRAE suggests a useful life of 20-25 years for this type of air handling unit. The building also has two (2) small Raypack boilers, rated at 658MBH each. The boilers were installed as part of the renovation, and are approximately 7 years old. ASHRAE suggests a useful life of approximately 20 years for this type of equipment. The system has a primary-secondary pumping arrangement.

Building Pumps at Business

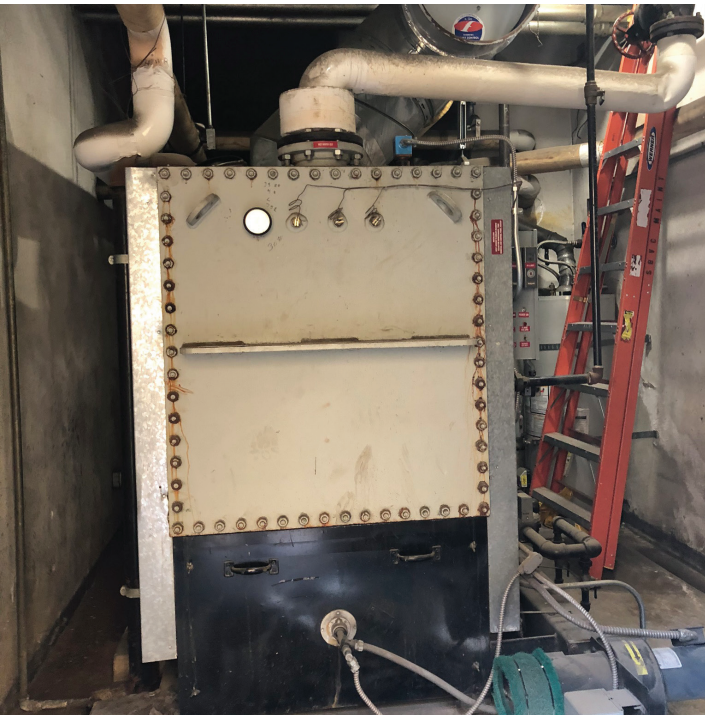
The building is served by a local heating plant, consisting of a 2,000MBH boiler, pumps, and accessories. The boiler was installed in 2003 and is approximately 23 years old. ASHRAE suggests a useful life of approximately 20 years for this type of equipment. Considering that the building will be demolished within the next 5 years, replacement is not recommended.

Boiler at Liberal Arts building

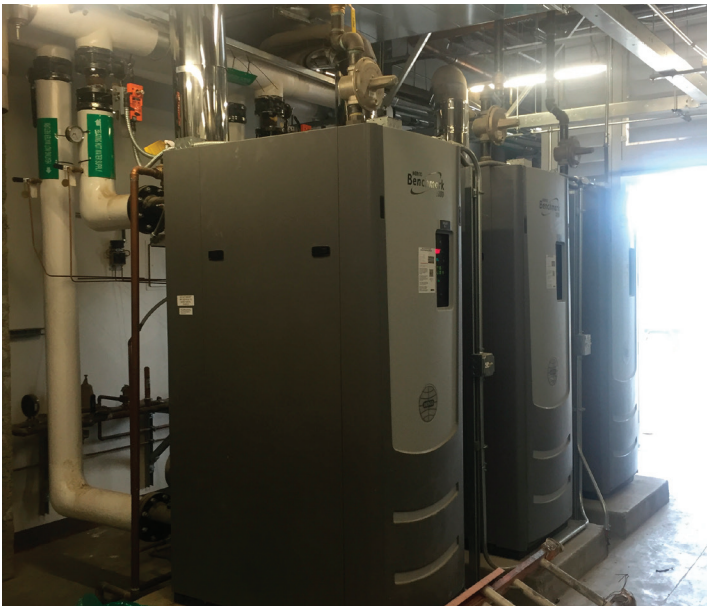
The Gymnasium building was constructed in 2016 and houses one (1) mechanical room for the local heating hot water (HHW) plant. There are three (3) small Aerco condensing type boilers serving the heating needs for this building, each rated at 1,759MBH. The boilers are approximately 4 years old and are in good condition.

Condensing Boilers at Gym

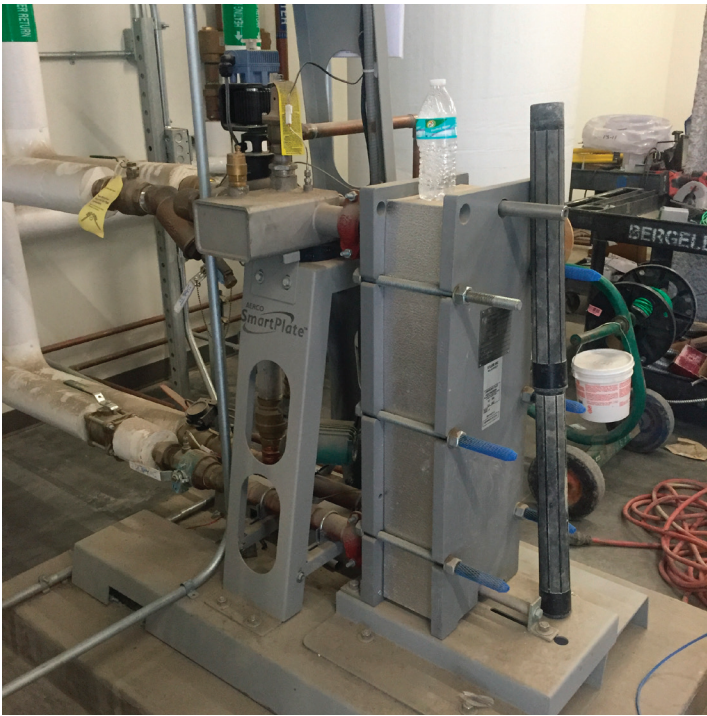
Heat Exchanger

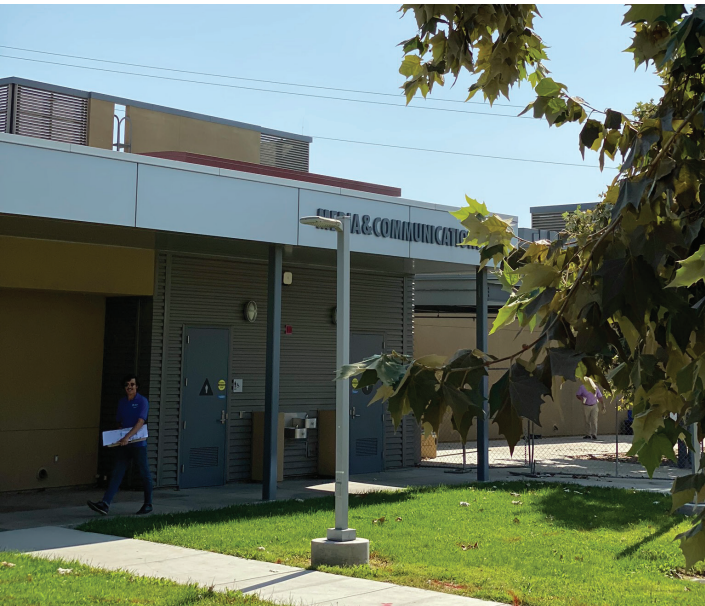
The Media / Communications building was constructed in 2010. There are two (2) outdoor rooftop boilers that provide a total of 522MBH to the building. The boilers are approximately 10 years old. ASHRAE suggests a useful life of approximately 20 years for this type of equipment and should be considered for replacement in the next 10-15 years.

Media Comm Rooftop Mechanical Equipment

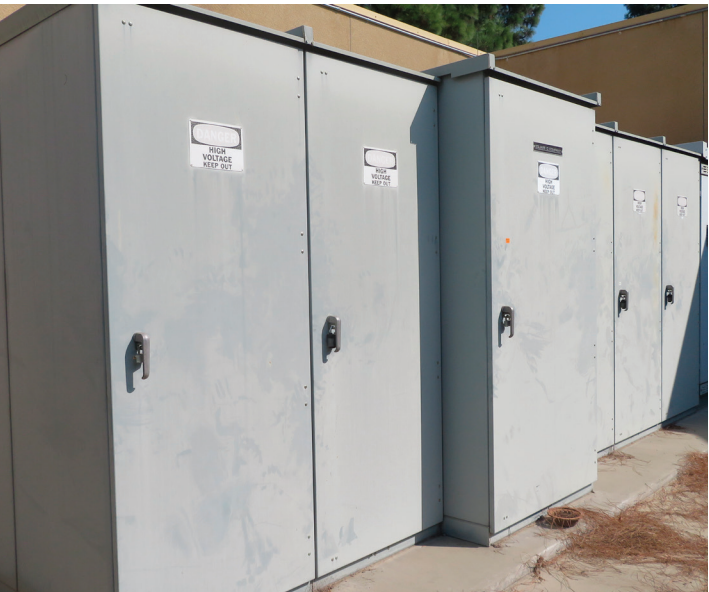
San Bernardino Valley College campus is currently served from a 4.16kV, 1200A 3phase, 3wire switchgear that derives its service from a 3,750KVA, 4.16kV SCE switch and transformer located in the utility yard on the north side of the campus. The switchgear comprises of a main 5kV, 600A, 3P breaker with a SCE main meter section and four 4.16kV, 600A fused interrupter switches housed in a seven sectional outdoor switchgear. The service is metered at 4.16kV and distributes power to substations in each building on campus through a series of manholes and medium voltage duct banks. The main switchgear was installed in 2003 with a main 5kV breaker and four 5kV feeder switches equipped with modern microprocessor relays and Square D power logic digital meters for monitoring energy usage and is in fairly good condition.

Main Switchgear in North Central Plant

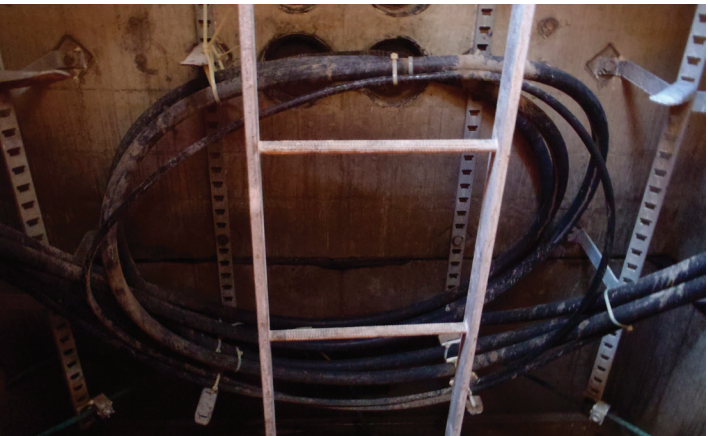
The electrical power distribution system at the campus was installed in 1990’s and is approximately 30 years old. Majority of the underground cables were installed in 1970, at the inception of the campus. The cables are approximately 35-40 years old and at the end of their useful life. Portion of feeders ‘1’ to ‘4’ have been replaced as part of building upgrade project but no major improvements have been undertaken to upgrade the existing power distribution system since the inception of the campus.

Electrical Manhole

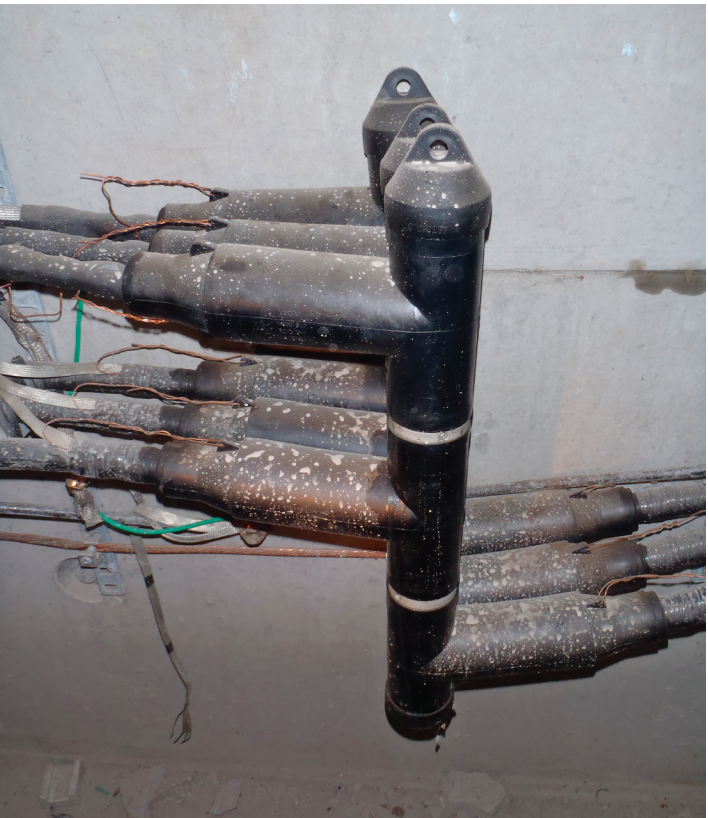
T-body Splice inside Electrical Manhole

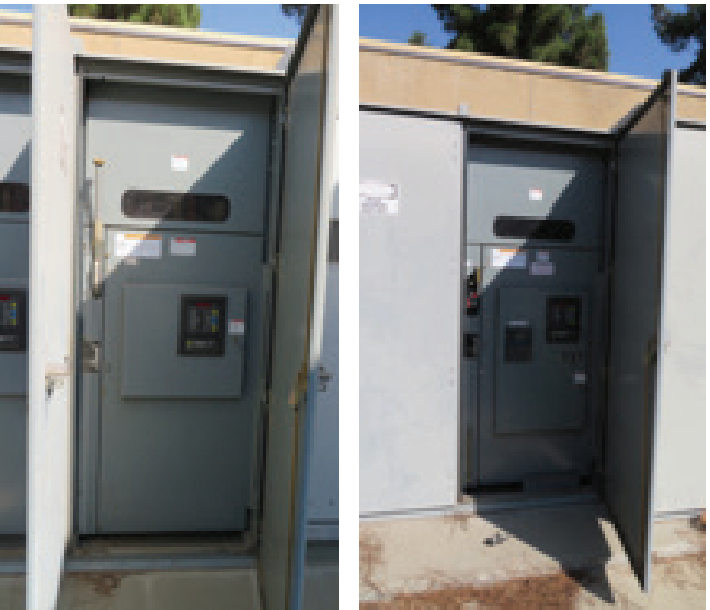
Feeder ‘1’ and ‘2’ originating from the main switchgear traverse parallelly towards south along the west side of the campus through a series of duct banks and manholes and extend upto manhole EMH-11. Radial feeders originating from modular splice connectors located in manholes serve facilities located on the west side of the campus.

Main Switchgear in North Central Plant

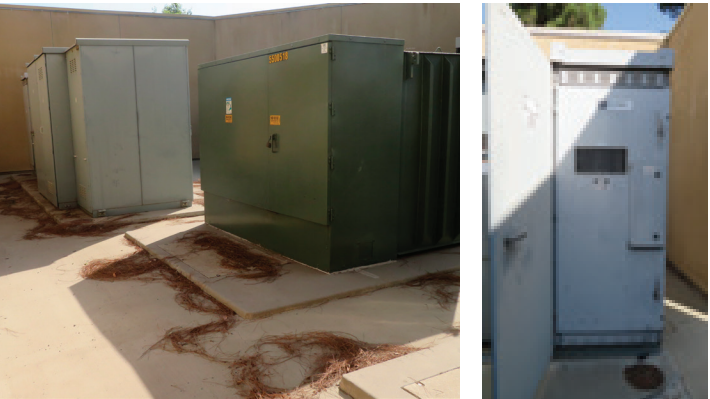
San Bernardino Valley College campus is currently served from a 4.16kV, 1200A 3phase, 3wire switchgear that derives its service from a 3,750KVA, 4.16kV SCE Transformer and switch located in the utility yard on the north side of the campus. The switchgear comprises of a main 5kV, 600A, 3P breaker with a SCE main meter section and four 4.16kV, 600A fused interrupter switches housed in a seven sectional outdoor switchgear. The service is metered at 4.16kV and distributes power to substations in each building on campus through a series of manholes and medium voltage duct banks. The main switchgear was installed in 2003 with a main 5kV breaker and four 5kV feeder switches equipped with modern microprocessor relays and digital meters and is in fairly good condition.

SCE Transformer at North Central Plant

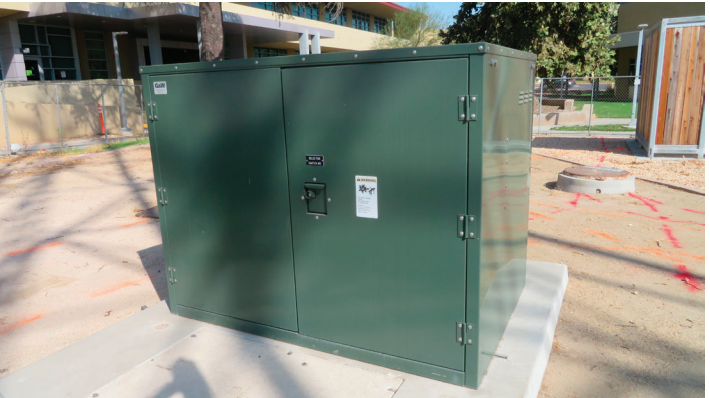
15kV, 600A, 5 position Selector switch SS8 has been recently installed as part of the Business Building Renovation project on the south side of facility adjacent to manhole EMH-8 that enables to isolate the power to Business Building, Media Communications Facility and Computer Services Building.

Selector Switch SS8

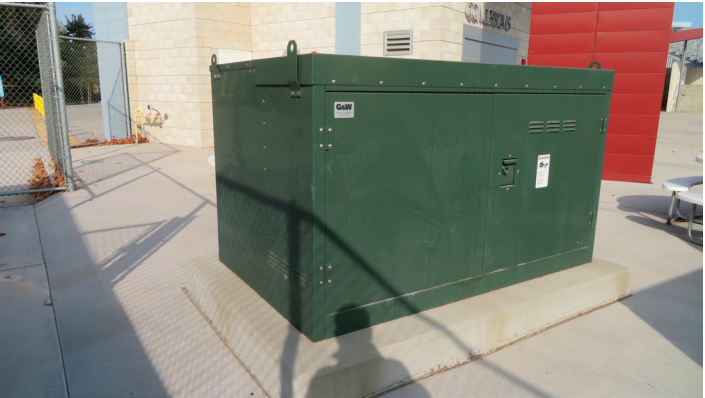
15kV, 600A, 6 position Selector switch SS9 has been recently installed as part of the Central Plant Project on the south side of Football Field that enables to isolate the power to Child Development Center, Football Field and Central Plant without affecting power to other buildings being served

Selector Switch SS9

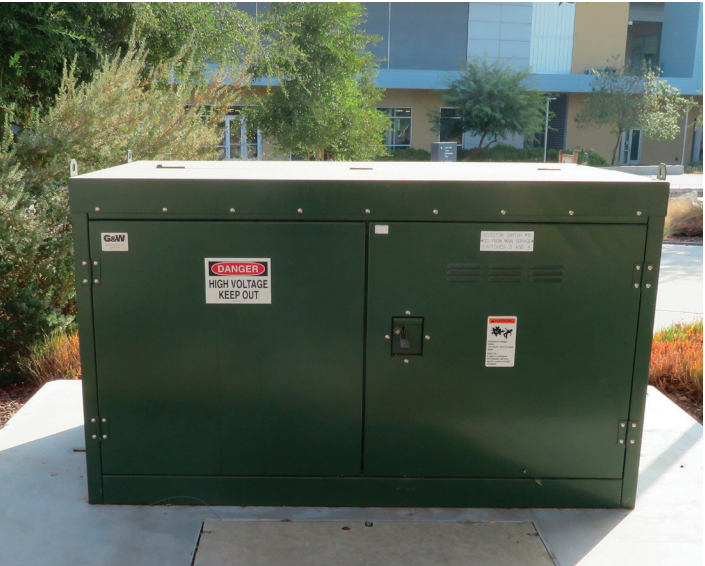
15kV, 600A, 6 position Selector switch SS10 has been recently installed as part of the Gymanisum Complex project is located on the west side of the Theatre Building that enables to isolate the power to the Gymansium

Selector Switch SS10

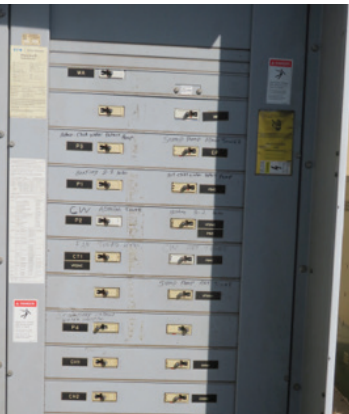
North Central Plant and Administration Student Services building located on the north side of the campus are presently served from feeder ‘4’ and has no redundancy of isolating the service to the building without affecting the other buildings being served from feeder ‘4’. Radial feeder originating from manhole EMH-1 traverses to the main switchgear electrical yard to serve a 1500kVA, 4.16kV-480Y/277V padmount liquid filled transformer. Radial feeder originating from secondary side of padmount transformer serves a 1600A, 480Y/277V Swichboard located in the electrical yard that serves the north central plant. Radial feeder originating from secondary side of padmount transformer traverses south and west to serve an 800A,

North Central Plant Transformer

480Y/277V switchboard located in the administration building. The padmount transformer and switchboard are in good working condition.

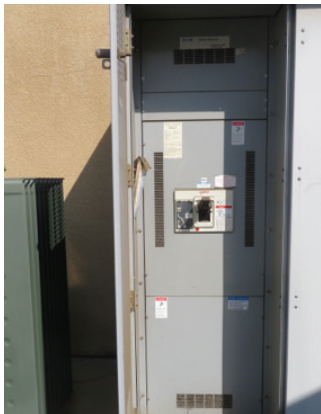
North Central Plant Switchboard

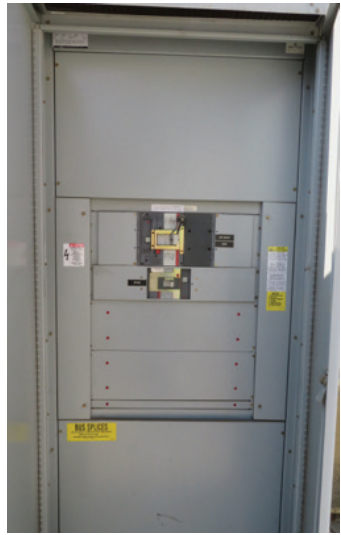
Art building located on the north side of the campus is presently served from feeder ‘4’ and has no redundancy of isolating the service to the building without affecting the other buildings being served from feeder ‘4’. Radial feeder originating from manhole EMH-1 traverses to the main switchgear electrical yard to serve a 1500kVA, 4.16kV-480Y/277V padmount liquid filled transformer. The primary side of the 1500kVA padmount transformer is double lugged inturn to serve a 750kVA, 4.16kV-480Y/277V padmount liquid filled transformer and 800A 480Y/277V switchboard.

Art Building Transformer at North Central Plant

Radial feeder originating from switchboard traverses south to serve an 800A, 480Y/277V switchboard located in the arts building. The padmount transformer and switchboards are approximately 10-15 years old and in excellent working condition.

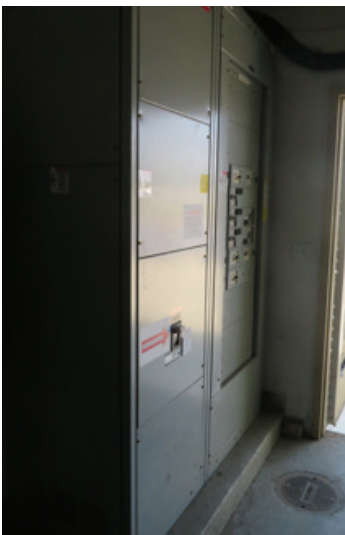
Art Building Main Switchboard at North Central Plant

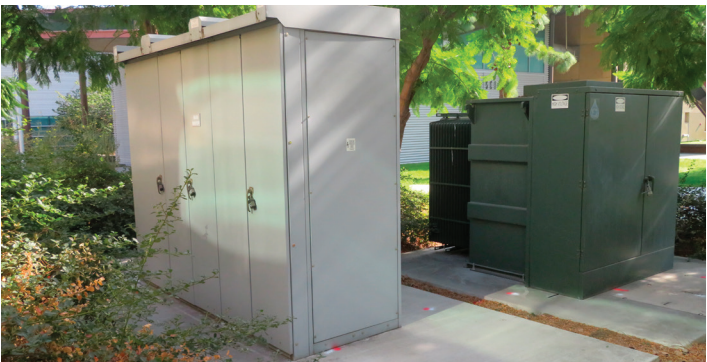
Physical Sciences Outdoor Padmount Transformer and Main Switchboard

redundancy of isolating the service to the building without affecting the other buildings being served from feeder ‘3’. Radial feeder originating from manhole EMH-15 traverses north east to serve a 1500kVA, 4.16kV-480Y/277V padmount transformer and a 2500A, 480Y/277V switchboard located outdoor on the east side of the facility. The padmount transformer and switchboard are approximately 10-15 years old and in good working condition.

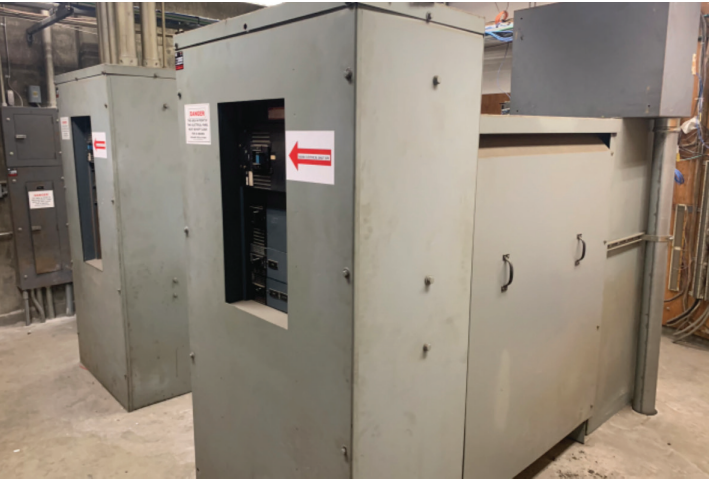
Liberal Arts Building Load Interrupter Switch and Transformer

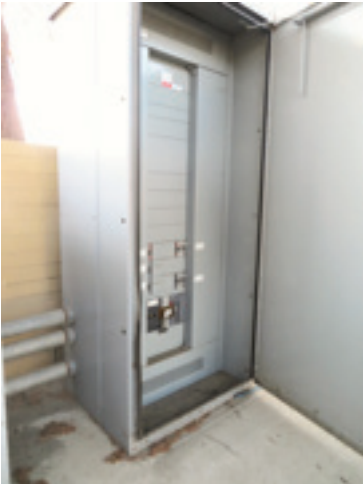
Technology Lab/Shop Load Interrupter Switch and Transformer

Radial feeder originating from manhole EMH-13 traverse north to serve a 5kV load interrupter switch, 300kVA, 4.16kV-480Y/277V dry type transformer and 800A, 480Y/277V switchboard that serves the technology lab/shops. Electrical distribution system for the technology lab/

shops is approximately 15-20 years old and in fair working condition.

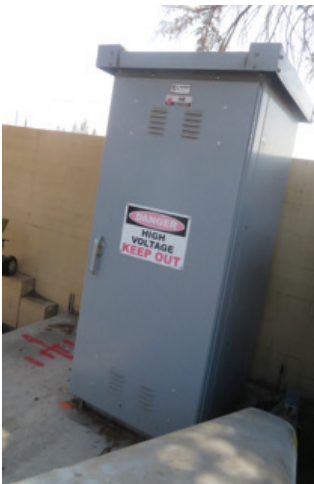
Technology Lab/Shop Main Switchboard

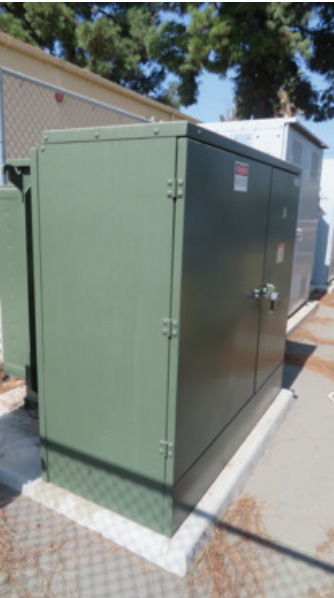
Technology Bungalow/ Classroom Outdoor Padmount Transformer

Radial feeder originating from manhole EMH-13 traverse north to serve a 750kVA, 4.16kV-480Y/277V padmount transformer and 1200A, 480Y/277V switchboard housed outdoor in an electrical enclosure that serves the technology bungalows and classrooms. Electrical distribution system for the technology bungalows and classrooms is approximately 5 years old and in excellent working condition.

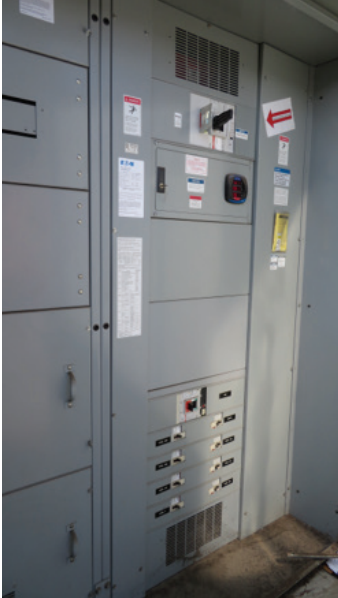
Technology Bungalow/ Classroom Outdoor Switchboard

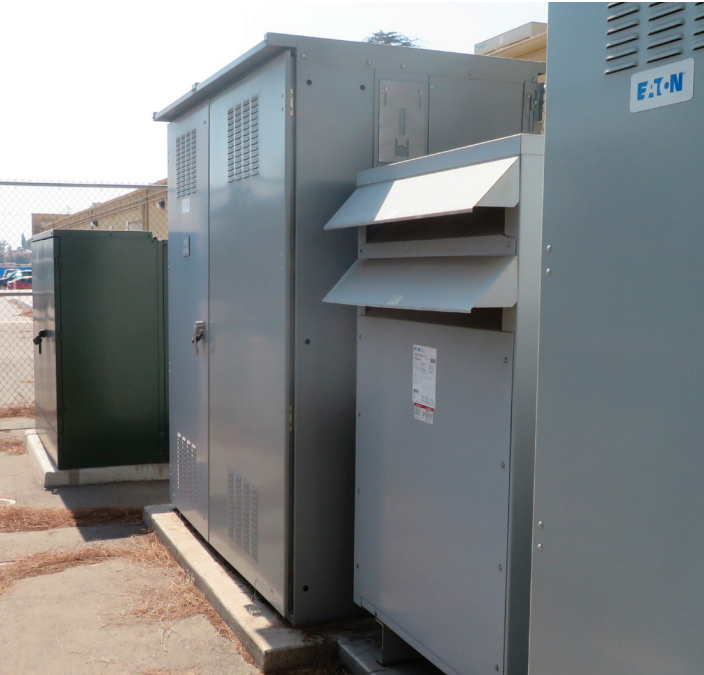
Technology Bungalow/Classroom Outdoor Equipment Yard

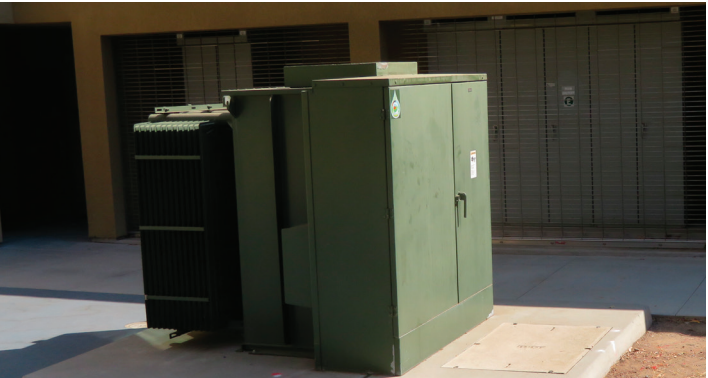
North Hall Outdoor Padmount Transformer and Main Switchboard

North facility located on the west side of the campus is presently served from feeder ‘1’ and has no redundancy of isolating the service to the building without affecting the other buildings being served from feeder ‘1’. Radial feeder originating from manhole EMH-6 traverses northwest to serve a 1500kVA, 4.16kV-480Y/277V padmount transformer and 2500A, 480Y/277V switchboard installed in the outdoor enclosure at the facility. 1500kVA padmount transformer and 2500A switchboard are approximately 10 years old and in good working condition.

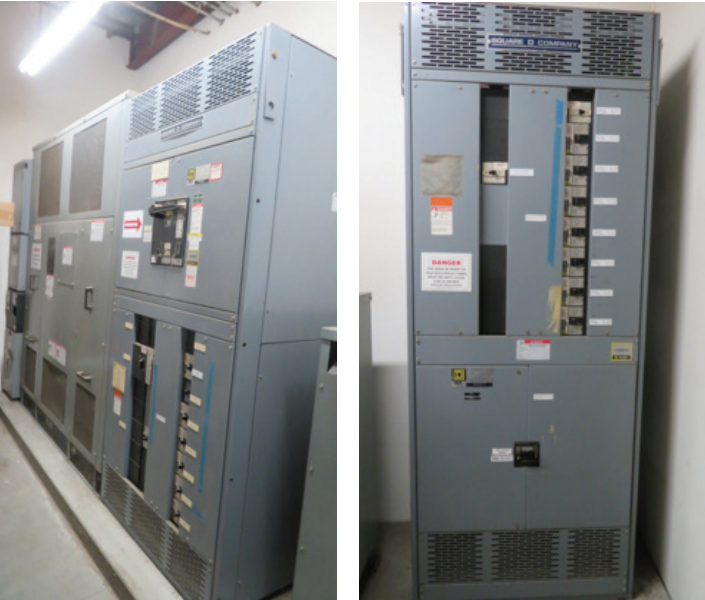
Substation at Library Electrical Room      Library Electrical Room

Library Building located on the south west side of the campus is presently served from feeder ‘1’ and has no redundancy of isolating the service to the building without affecting the other buildings being served from feeder ‘1’. Radial feeder originating from manhole EMH-6 traverses west to serve a 5kV Load interrupter Switch, 750kVA, 4.16kV-480Y/277V transformer and 1200A, 480Y/277V Switchboard. 5kV load interrupter switch, transformer and switchboard are approximately 15 years old and in good working condition.

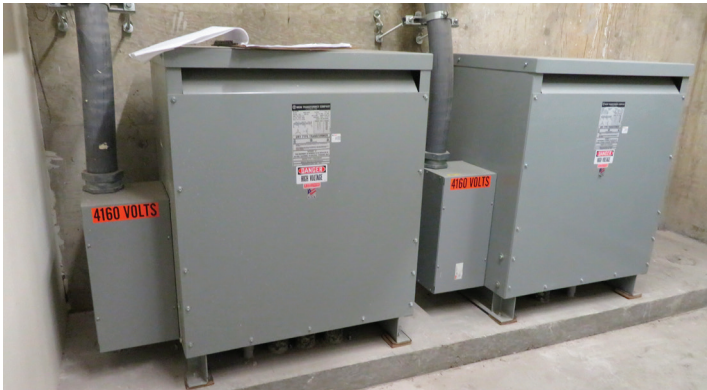
Business Electrical Room

Business Hall located along the south west side of the campus is presently served from selector switch 8 which in turn is derives it service from feeders ‘1’ and ‘2’. The building has redundancy of isolating the service to the building without affecting the other buildings. Radial feeder originating from manhole EMH-8 traverses south to serve two 5kV substations located in the basement electrical room of the facility. 5kV duplex Load interrupter Switch, 225kVA, 4.16kV-480Y/277V dry type transformer and 350A, 480Y/277V Switchboard and a 5kV duplex Load interrupter Switch, 225kVA. 4.16kV-208Y/120V dry type transformer and 750A, 208Y/120V Switchboard are presently installed in the basement electrical room that presently serve the building. Business Hall was recently renovated in 2013 and the electrical distribution system is new and in excellent working condition.

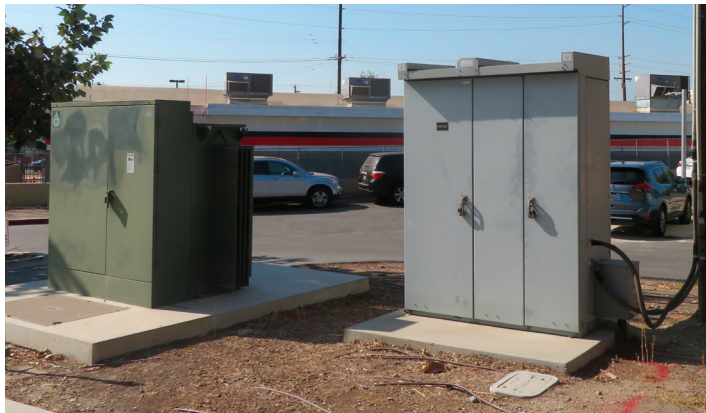
Computer Services Building Outdoor Padmount Transformer And Main Switchboard

Computer Services building located along the south west side of the campus is presently served from selector switch 8 which in turn is derives it service from feeders ‘1’ and ‘2’. The building has redundancy of isolating the service to the building without affecting the other buildings. Radial feeder originating from manhole EMH-8 traverses westto serve a, 150kVA, 4.16kV-208Y/120V padmount transformer and 208Y/120V Switchboard. Transformer and switchboard are approximately 10-15 years old and are in good working condition.
