# Utility Infrastructure Master Plan

## San Bernardino Valley College

P2S Project #0191

Issued September 2, 2020

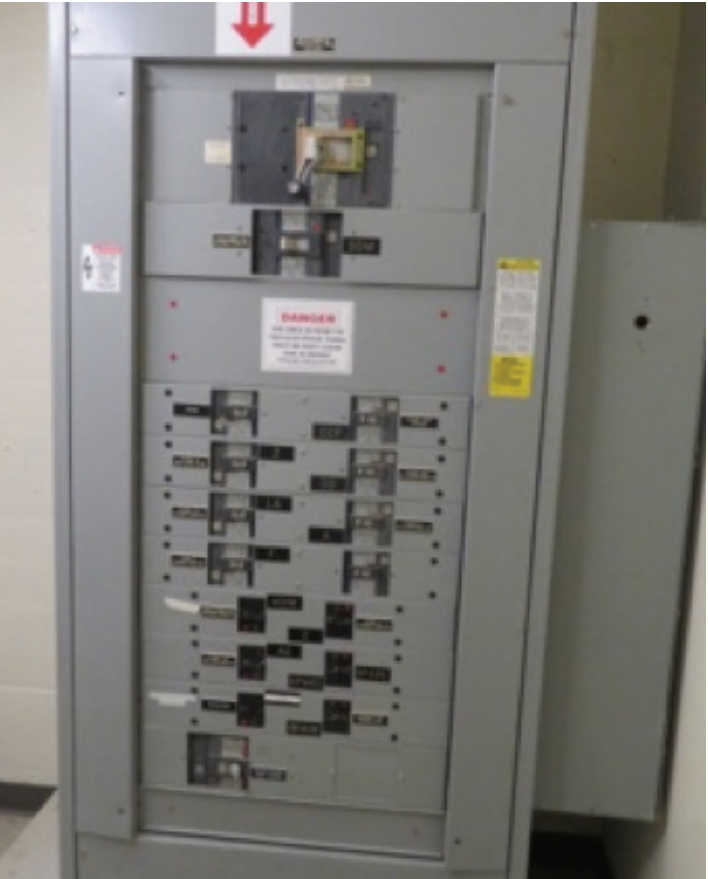
Theatre Complex Main Switchboard

Theatre Complex located along the central quad of the campus is presently served from selector switch SS10 which in turn is derives it service from feeders ‘3’ and ‘4’. The facility has redundancy of isolating the service to the building without affecting the other buildings. Radial feeder originating from selector switch 10 serves a 750kVA, 4.16kV-208Y/120V padmount transformer located on the east side of the facility. Radial feeder originating from transformer traverse west to serve a 1200A, 208Y/120V Switchboard installed inside the first floor electrical room of the facility. Transformer and switchboard are approximately 15 years old and are in good working condition.

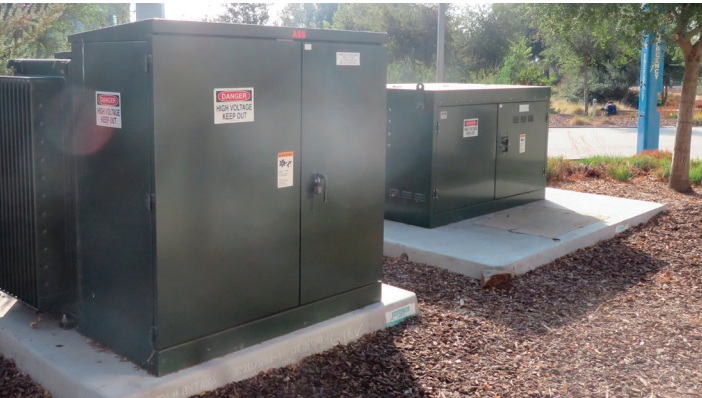
Selector Switch SS10 and Gymnasium Complex Outdoor Padmount Transformer

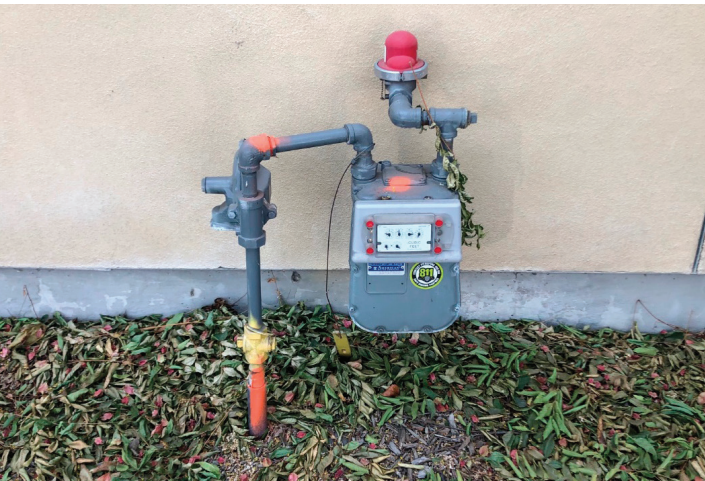
The AD/SS building is fed via an 3/4” line where it is regulated and metered before entering the northeast side of the building. This line is also protected via an earthquake valve.

Gas feed with gas meter, GPR, and EQV entering AD/SS Building

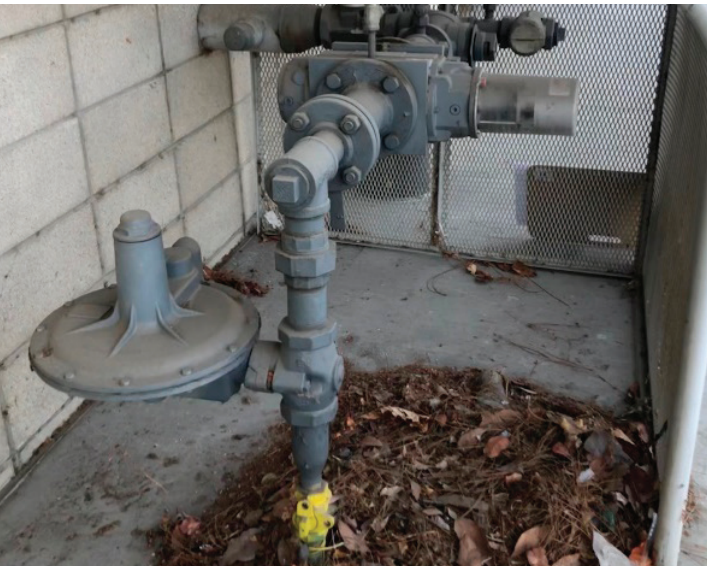
The Art Center is fed via an 1” line where it is regulated and metered before entering the northeast side of the building. This line is also protected via an earthquake valve. The entire assembly is enclosed in a locked fence.

Gas feed with gas meter, GPR, and EQV entering Art Center Building

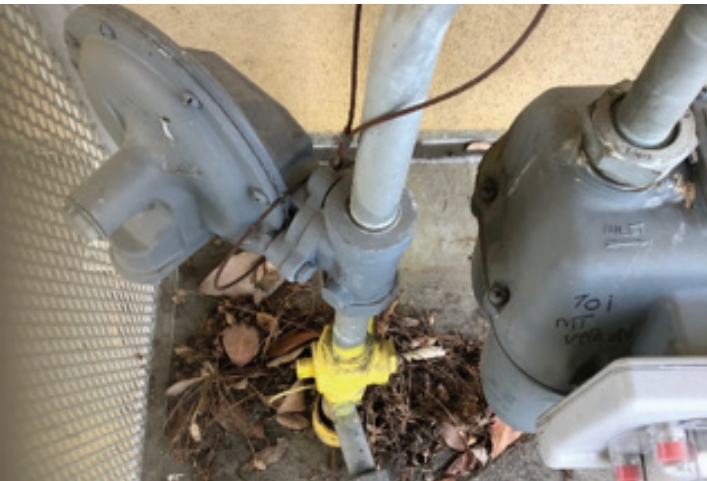
A second building in the Art Center also has its own gas connection. It is fed via a 3/4” line that is metered and regulated before entering the northwest corner of the building. This assembly is protected by a locked enclosure. This building connection is not protected by an earthquake valve.

Gas feed with gas meter and GPR entering Art Center Building

Based on as-built drawings and field observations, a large portion of the gas distribution is steel piping. It is recommended to upgrade this piping to PE piping for extended life expectancy. Additionally, it was observed that several buildings on campus lack earthquake valves. To meet current code requirements, earthquake valves should be installed on the gas feeds serving following buildings:

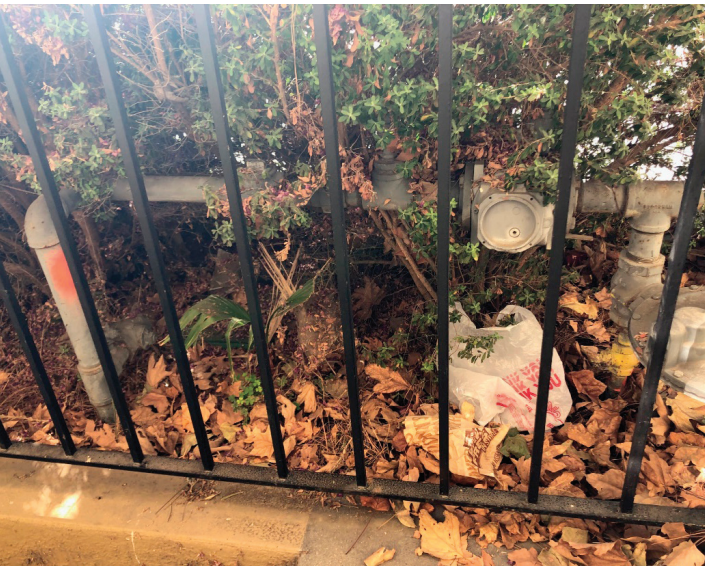
The Auditorium is fed via a 1” line that is regulated and metered before entering the south side of the building. This building connection is not protected by an earthquake

Gas feed with gas meter and GPR entering Auditorium Building valve.

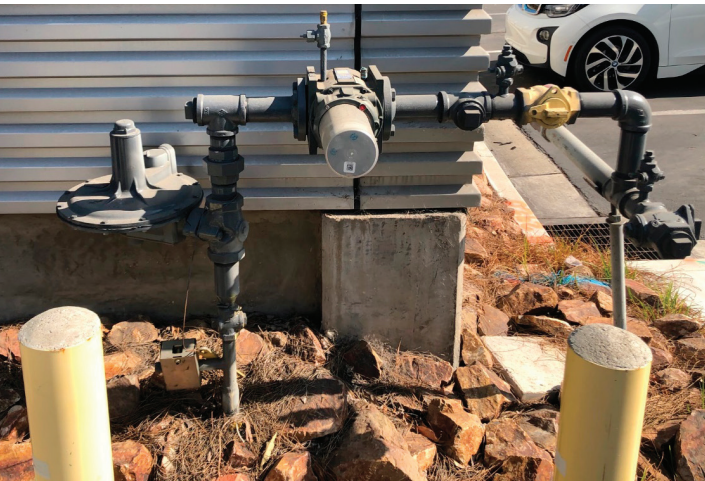
The power station location on the northwest corner of campus is fed via a 1-1/4” line located on the southeast corner of the enclosure. This line is metered and regulated

Gas feed with gas meter and GPR entering Power Station

before entering the station. The power station connection is not protected by an earthquake valve.

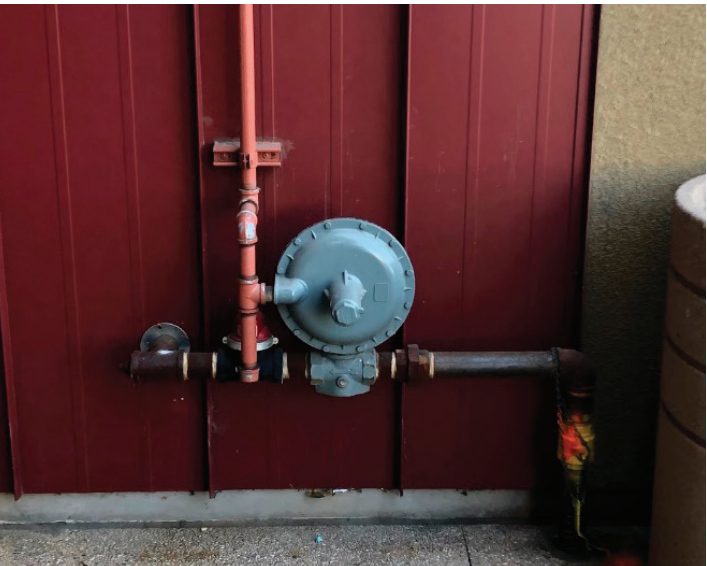
Gas feed with gas meter and GPR entering Physical Sciences Building

The Physical Sciences building is via a 2” line where it is regulated before entering the northwest side of the building. This buildingconnection is not protected by an earthquake valve.

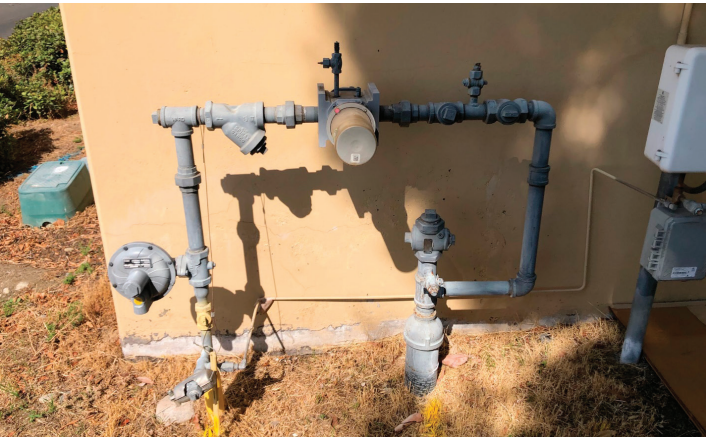
Gas feed with gas meter and GPR entering Liberal Arts Building

The Liberal Arts building is fed via a 1” line where it is regulated and metered before entering the southwest corner of the building. This building connection is not protected by an earthquake valve.

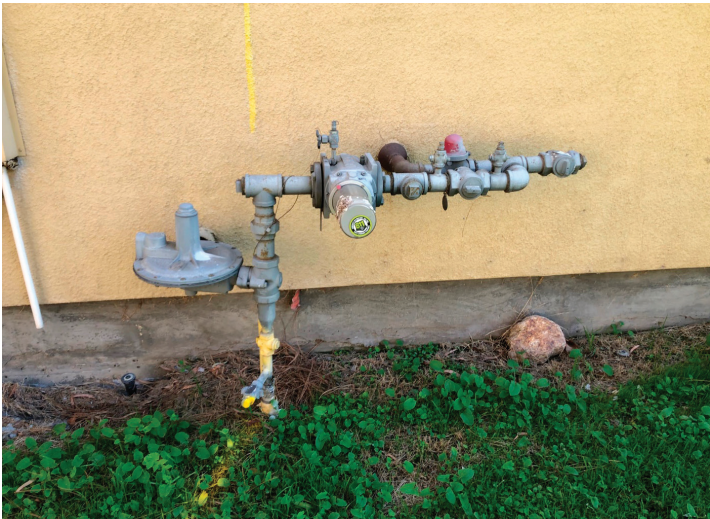
Gas feed with gas meter, GPR and EQV entering Library Building

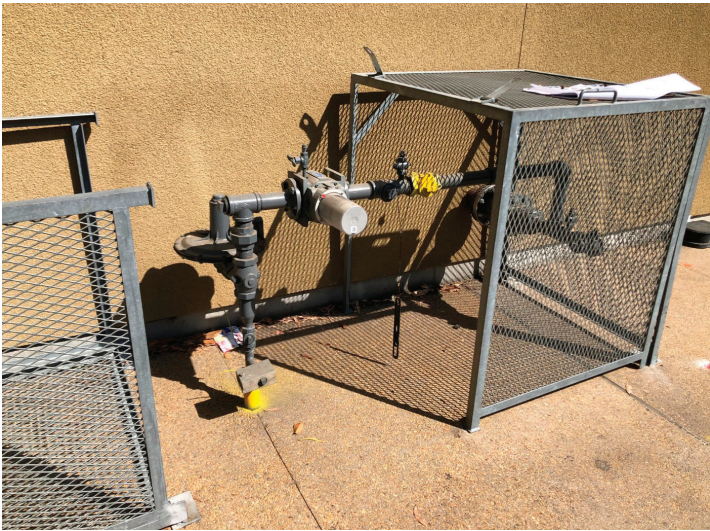
Gas feed with gas meter and GPR entering North Hall

The North Hall building is fed via a 1” line where it is metered and regulated before entering the building on the southwest side. This feed assembly is protected by a locked enclosure.

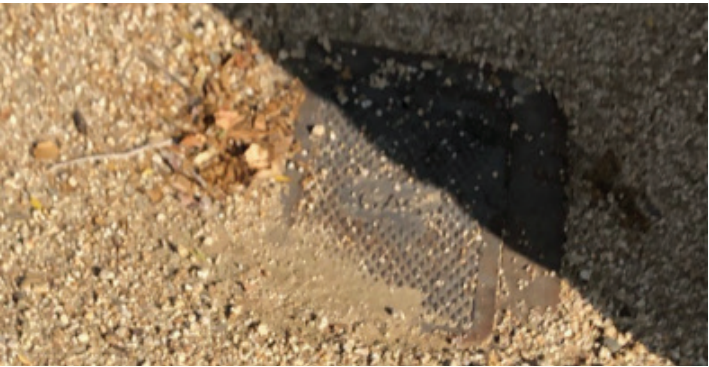
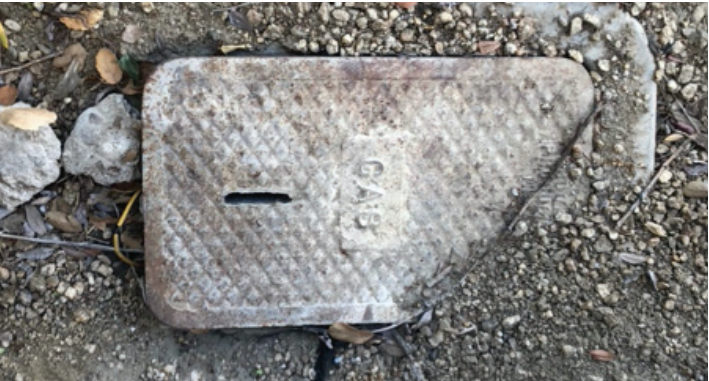
Gas vault outside Planetarium Building

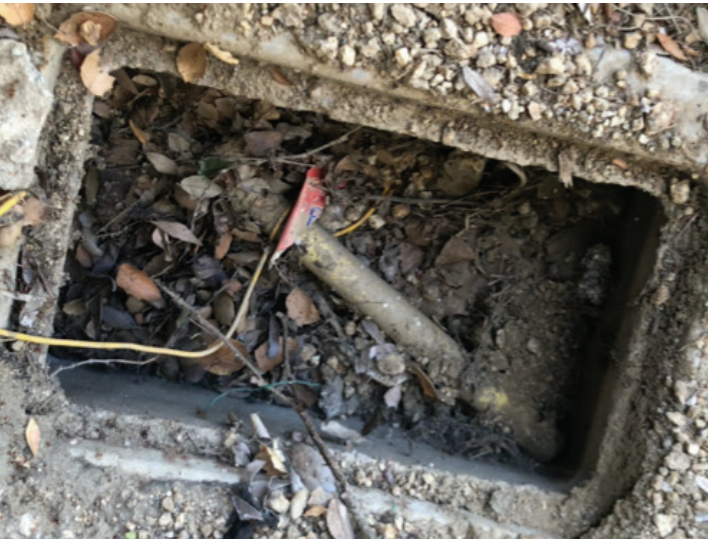
Gas feed entering Planetarium

This building connection is not protected by an earthquake valve.

The Planetarium is fed via a 3/4" line. This line enters several gas vaults before entering the south side of the building. This building connection is not protected by an earthquake valve.

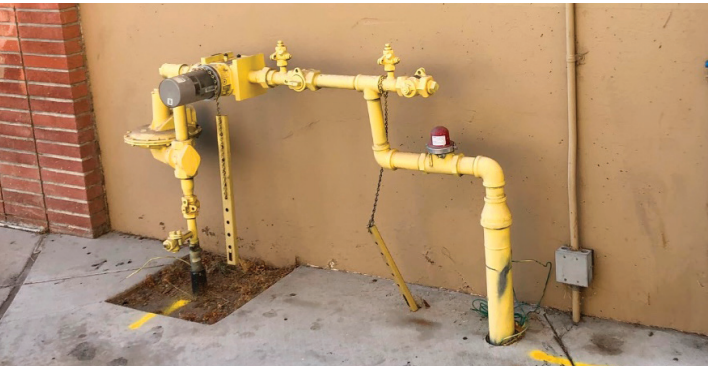
Gas feed with gas meter, GPR and EQV entering Business Building

The Business building is fed via a 1-1/2” line where it is metered and regulated before entering the the north east corner of the building. This line is protected via an earthquake valve.

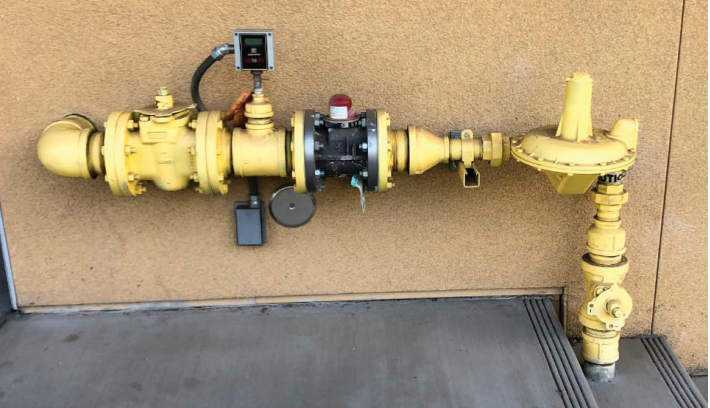
Gas feed with gas meter, GPR, and EQV entering Gymnasium

The Gym is served by two feeds. A 3” MPG line is regulated and metered before entering the southwest side of the building. This line is protected via an earthquake valve. The second connection is a 2” MPG line that is regulated before entering the northwest side of the building.

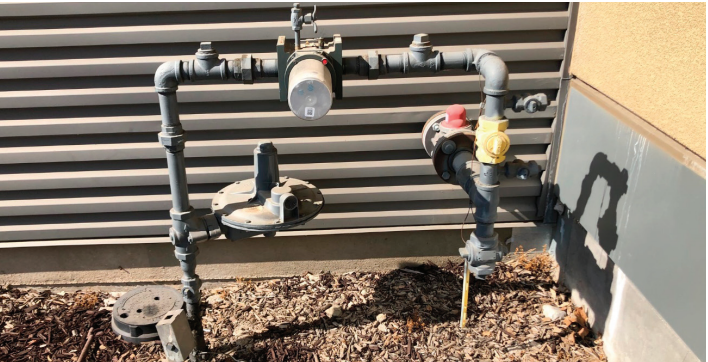
Gas feed with gas meter, GPR, and EQV entering Media Commons Building

The Media Communications building is serves via a 1” HPG

line where it is regulated and metered before entering the south side of the building. This line is protected via an

earthquake valve.

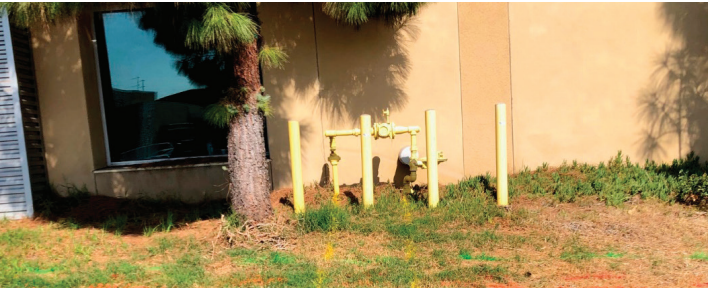
Gas meter and GPR assembly outside southern side of the Campus Center

The Campus Center and Book Store are fed via two connections, both located on the southwest side of the building. HPG enter a gas meter, regulator and earthquake valve, MPG is then routed parallel to the southwest side of

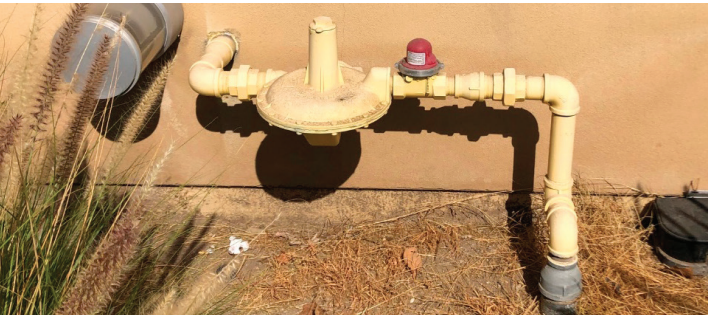
First gas feed with EQV and GPR entering Campus Center

The first building connection is a 3” medium pressure line that enters a earthquake valve and regulator before enter the center of the building.

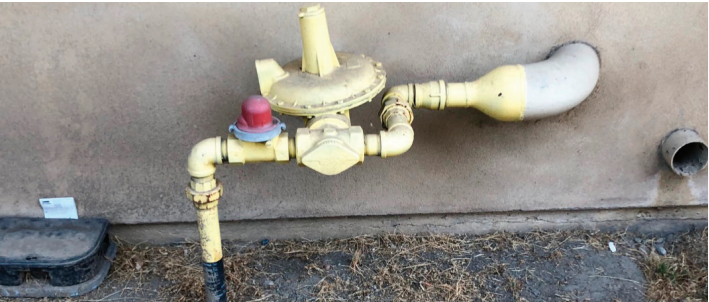
Second gas feed with EQV and GPR entering Campus Center

The second feed is a 1-1/4” medium pressure line that also enters an earthquake valve and regulator before enter the building.

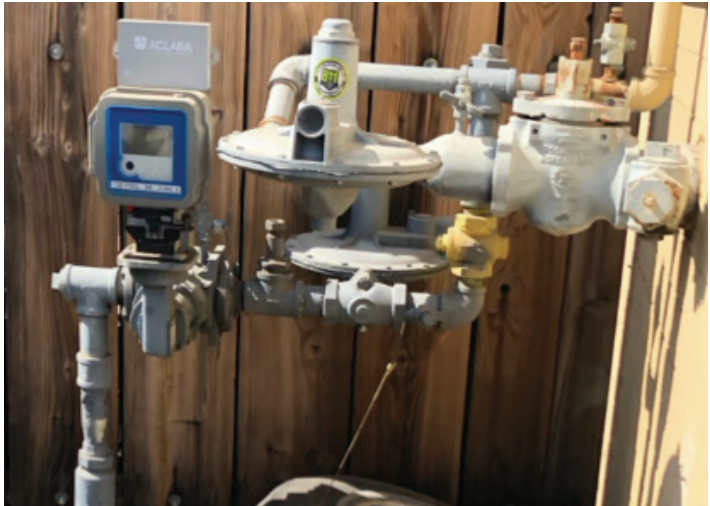
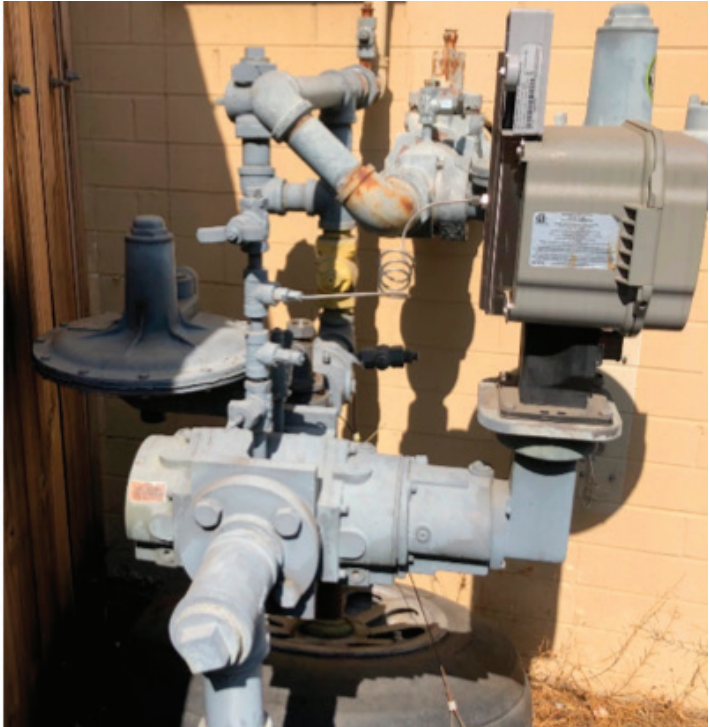
Gas feed with gas meter and GPR entering Applied Technologies Building

The Applied Technologies building is served via a 5”

line. This line is regulated once before splitting into two feeds. The first feed enters the building. The second feed is regulated once more before entering the building. This building connection is not protected by an earthquake

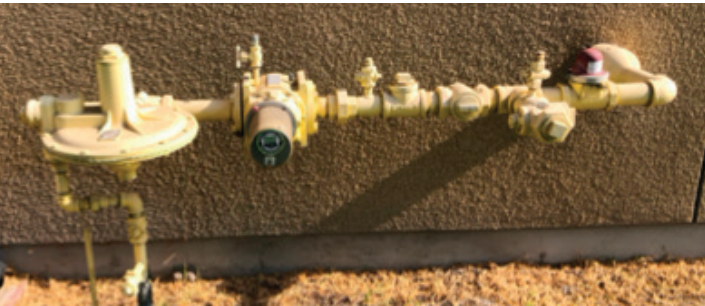
Gas feed with gas meter, GPR, and EQV entering Health and Life Sciences Building

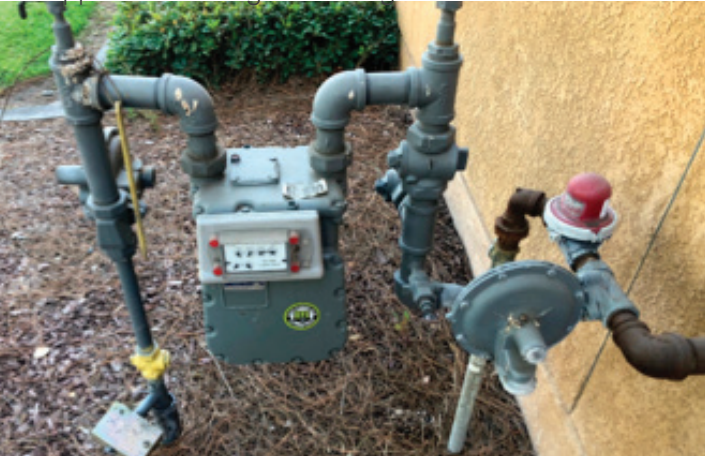
Gas feed with gas meter, GPR, and EQV entering Child Development Center

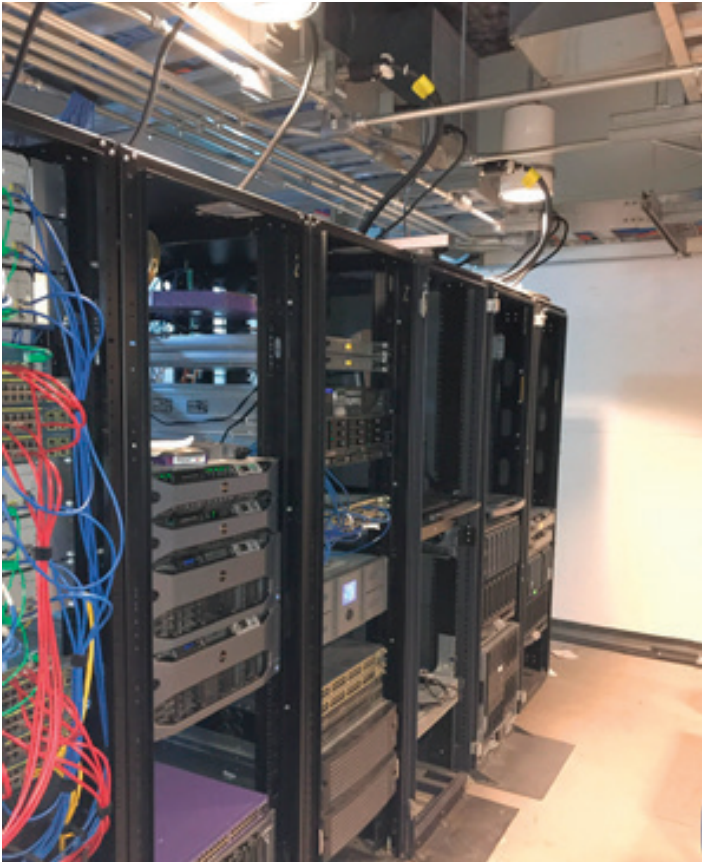
CSB – Main Core

The main telecommunications services to the campus are served from a MDF or “Main Distribution Frame”, located on the south side of the campus near the on-site antenna donor tower, between the Business Building and the Media Communications Building. The CSB server room/MDF consists of a mix of 4-post racks, network server cabinets, wall mounted telecommunications terminations and main core for the campus fiber distribution. The server/network racks and cabinets are laid out in two aisles and air cooled, to cover the entire room, with no dedicated “hot” and “cold”

aisles. There is also a centralized battery backup/ generator system for all the network equipment located just outside of the CSB building in case of power failure. There is a VOIP phone system serving the campus and is distributed via the fber to the individual campus buildings; with the main equipment is located in the CSB building.

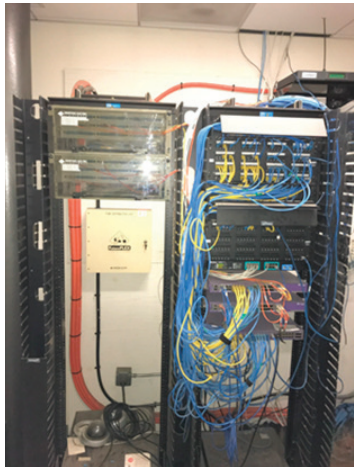
Administration and Student Services (AD/SS) – IDF AD100F

Based on the overall on-site evaluation, some areas will need to be reviewed and analyzed in more detail to come up with a plan of action for future correction; Administration-#AD100F, Tech Building-#110, CTS building and CSB building, are all listed within the conclusion statement as IDF/server rooms that need additional attention. The Administration-#AD100F server room has a lot of network equipment and fire panels within, that are loosely

connected and there appears to be a lot of abandoned low voltage cable. The Tech Building-#110 appears to have been a main distribution area at one time; this room has multiple fiber and copper feed cables that need to be identified, also redressed and protected from potential damage. The CTS has minimal cable protection and most of the station cabling is loosely supported in the ceiling. The CSB building will need to be assessed further to come up with a game plan to get the fiber splice cabling off of the floor, and into a cabinet or wall mounted enclosure; a detailed evaluation should be undertaken on all of the existing cabling within the building to make sure it is protected and identified for future expansion. At the time of the site walk review, all the existing manholes were identified and verified with the existing map. Most of the areas evaluated during the on-site were in good condition except for some of the campus legacy buildings; some of the legacy buildings IT rooms will just need some additional attention, in regard to protecting the cabling from damage by vendors accessing the rooms; some of the fiber interconnections currently have minimal protection from damage. An evaluation of individual telecommunications rooms in each of the buildings and our associated findings and recommendations is provided at the end of the section.

Based on the overall evaluation of the campus, a list of the individual recommendations, for each building were developed. Some of the overall recommendations include cleaning out the IT server rooms, providing additional protection for the fiber and copper infrastructure (within the racks and on the backboards) and addressing room temperature in some of the out lying rooms that do not currently have controlled temperature environments. Per discussion on site some of the fiber infrastructure has damaged or broken strands, that do not currently function as intended. A noticeable mix of fiber strands are used throughout the campus, in several of the IT server rooms, and a detailed list of tested fiber strands could help alleviate future project delays, by providing a room by room detail of good fiber strands to use. The labeling of the fiber and copper feed cabling was in place in most of the rooms, but it would also help to have the labeling verified and at the least reviewed for accuracy. Again, in general most of the IT server rooms were clean and accessible, but it is never a good idea to store overstock materials or stage excess paperwork in and around the server rooms; continual access to areas with exposed cabling can be a potential problem, not only with access to the rack/cabinet, but with network loss because of unforeseen accidents.

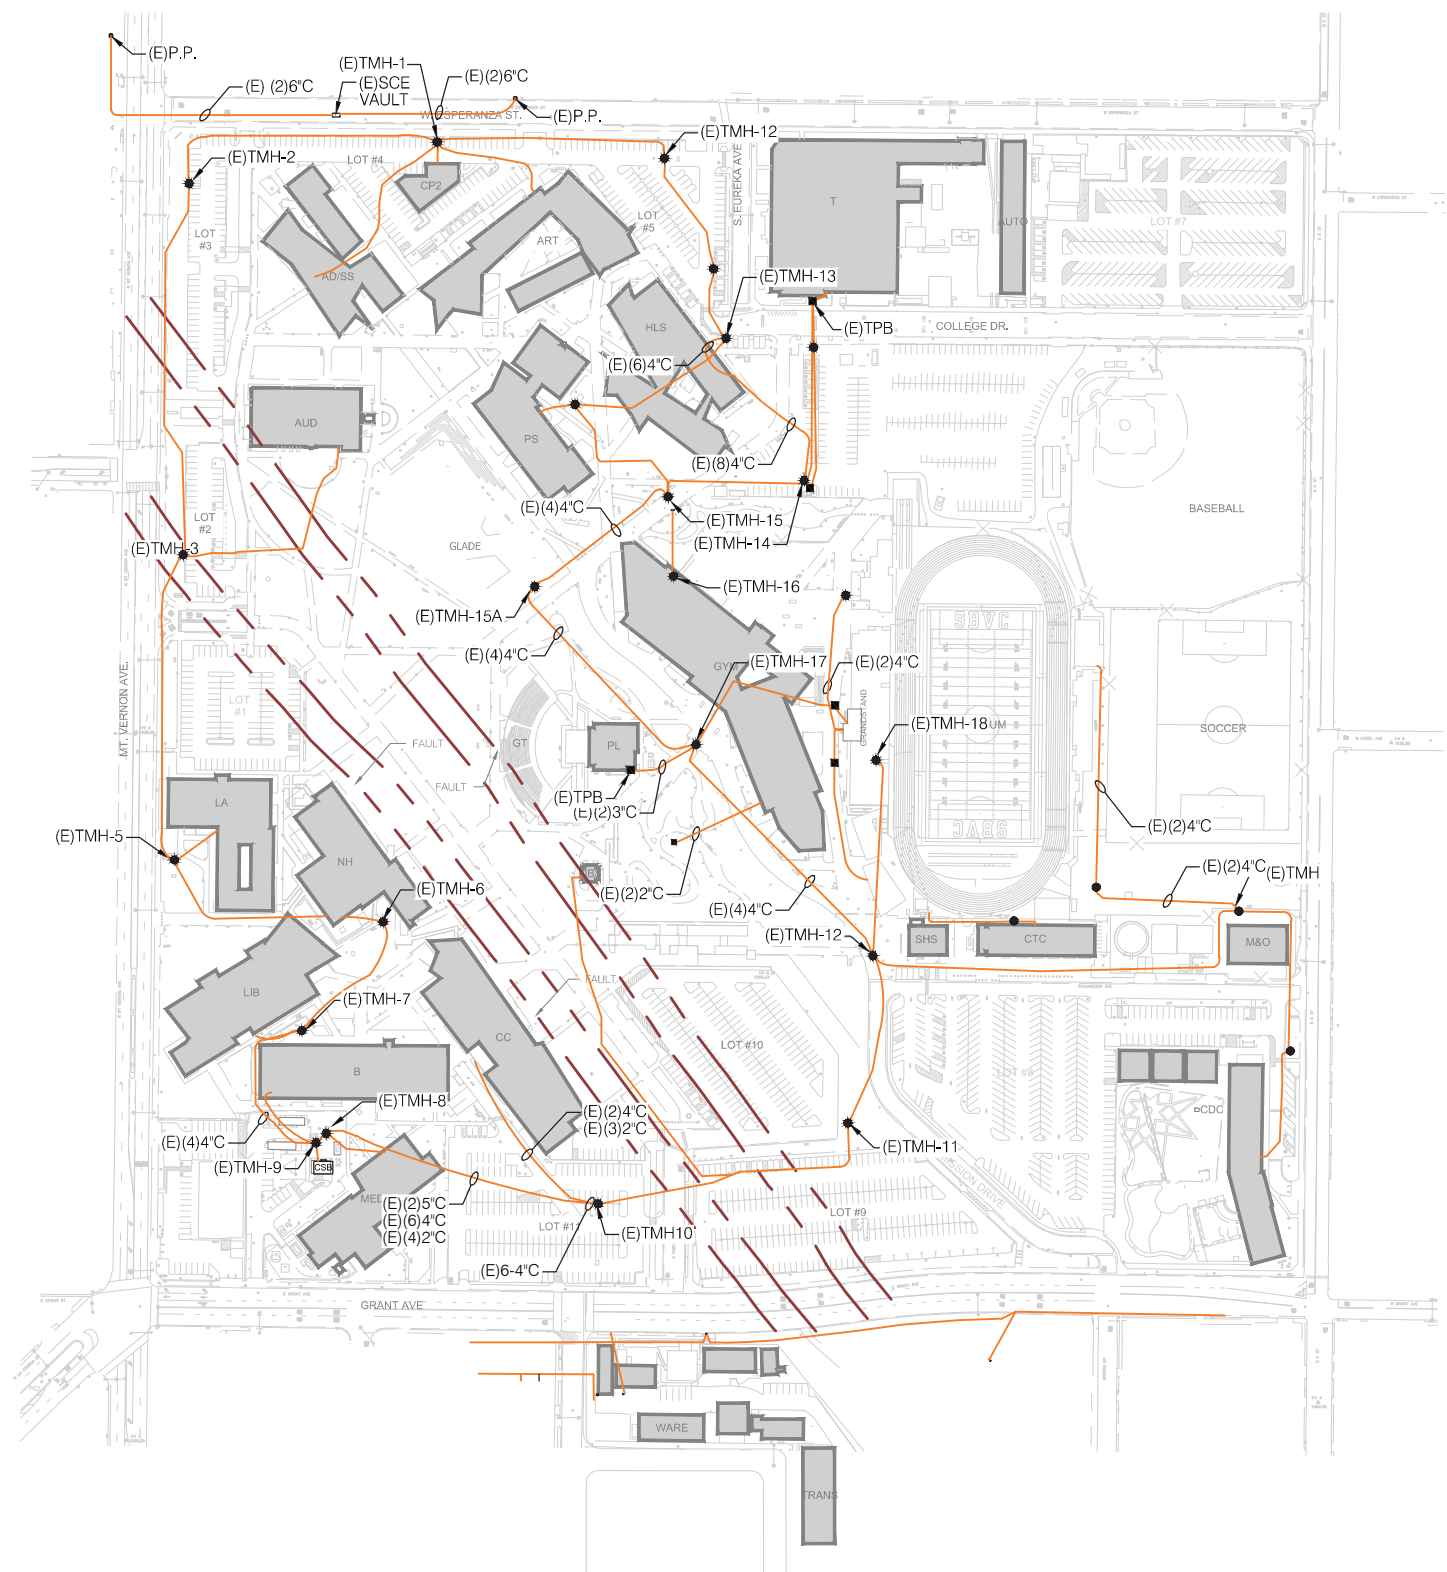
EXISTING TELECOM DISTRIBUTION SYSTEM

The main telecommunication services are derived from both Verizon and AT&T. The incoming service runs along the MT Vernon Avenue, and enters from the Northwest side of the campus, and then transitions to Esperanza street through a series of underground vaults as it enters the campus from that side of the campus. The campus services that come in from Esperanza street then around the perimeter, via underground vaults, and then into the Main Distribution Frame (MDF) located in CSB.

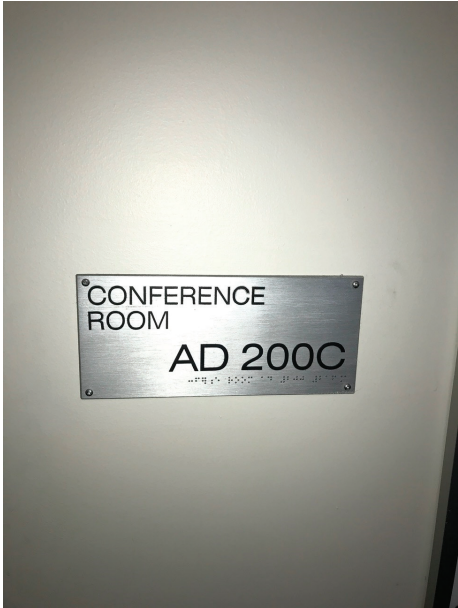
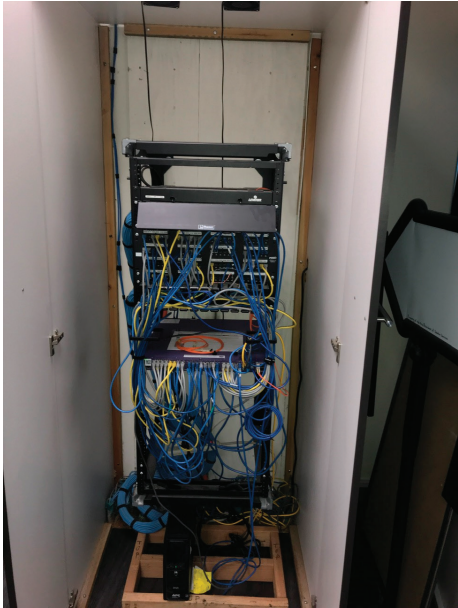
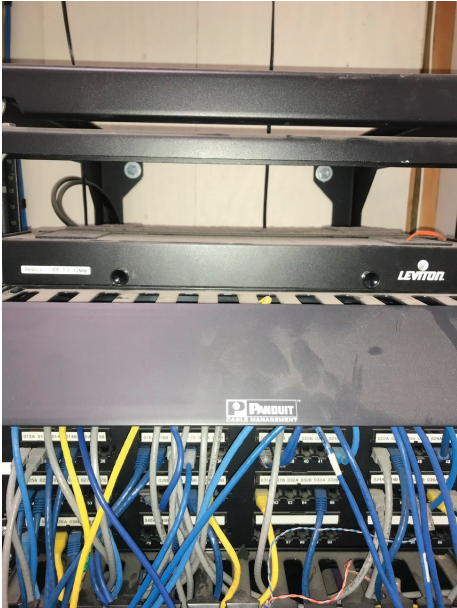
Administration and Student Services (AD/ SS) –  
2nd Floor #208A

Contains (1) wall mounted rack with pedestal below and wire management (horizontal).

- Ground wiring should be reviewed and corrected.
- Fire stop in conduits.

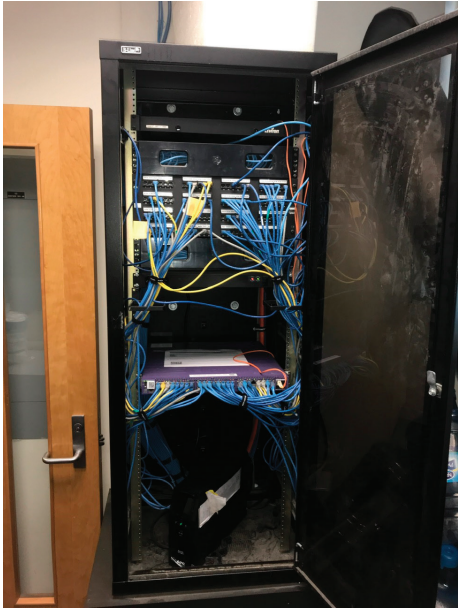
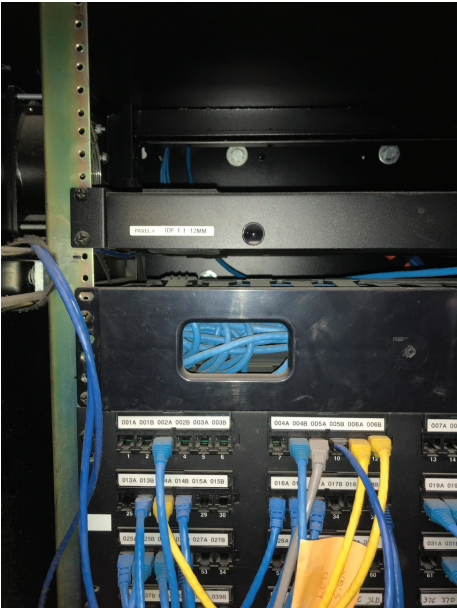
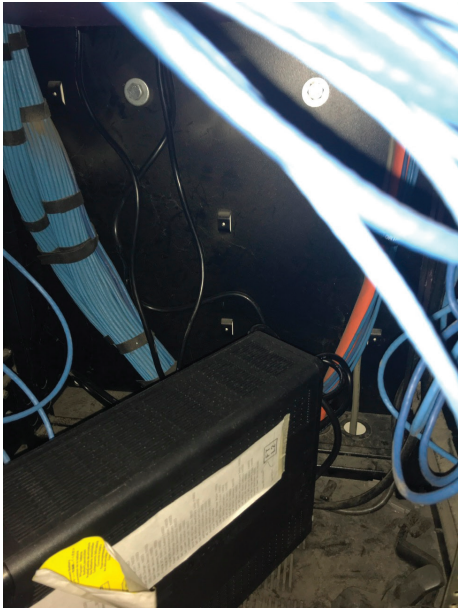
Administration and Student Services (AD/ SS) –  
Room #206E

Contains (1) wall mounted rack with pedestal below and wire management (horizontal).

- Ground wiring should be reviewed and corrected.
- Fire stop in conduits.

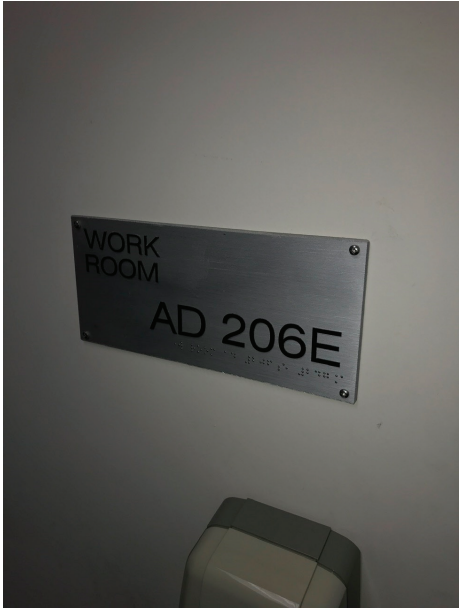
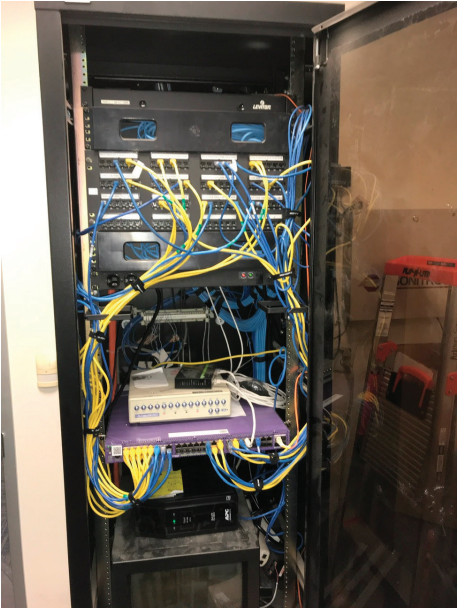
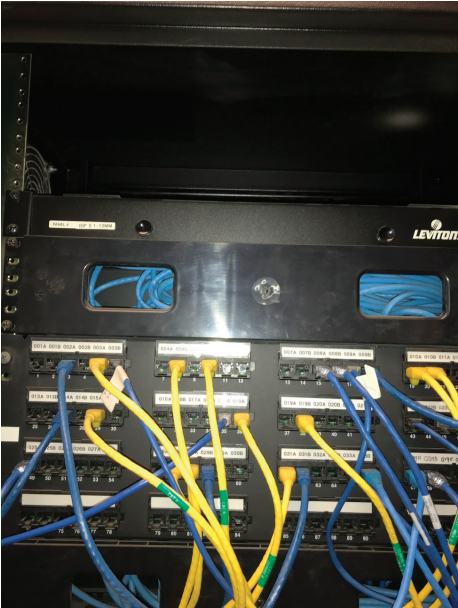
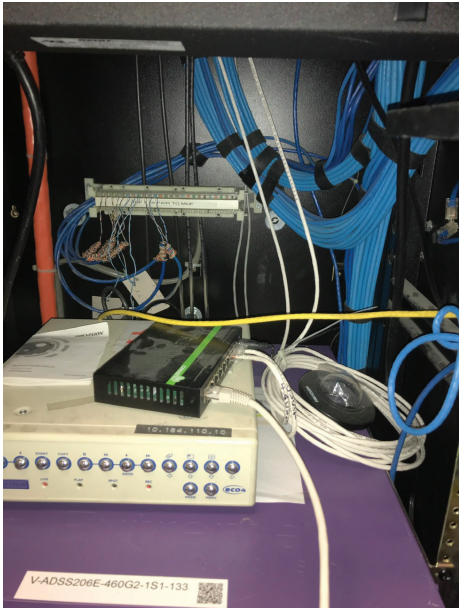
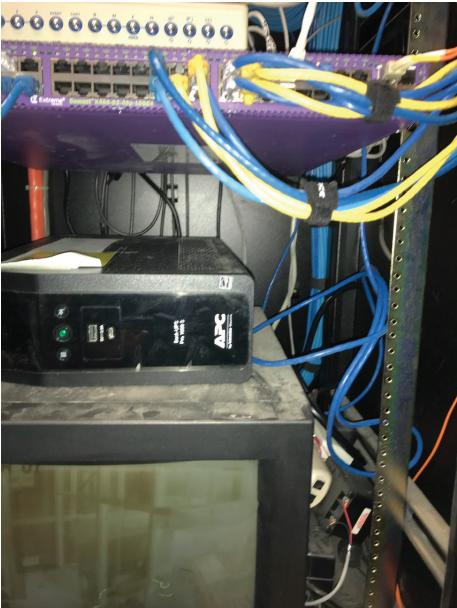
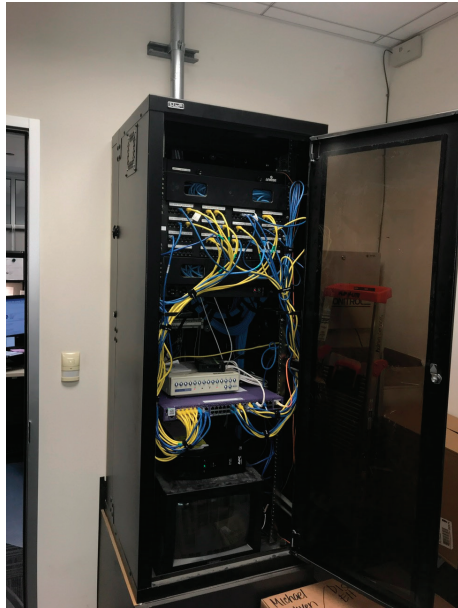
Administration and Student Services (AD/ SS) – Office 2.1

Contains (1) wall mounted rack with pedestal below and wire management (horizontal).

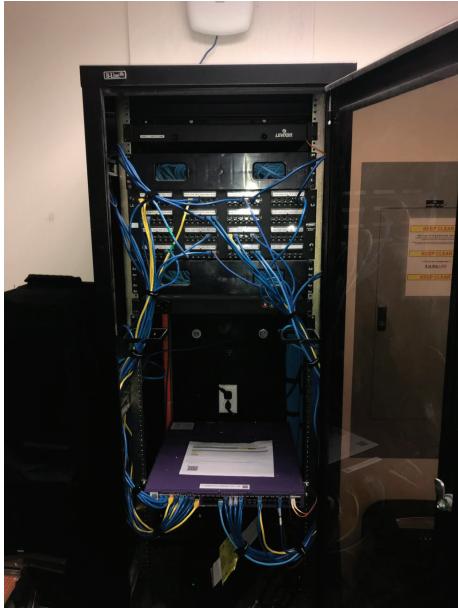
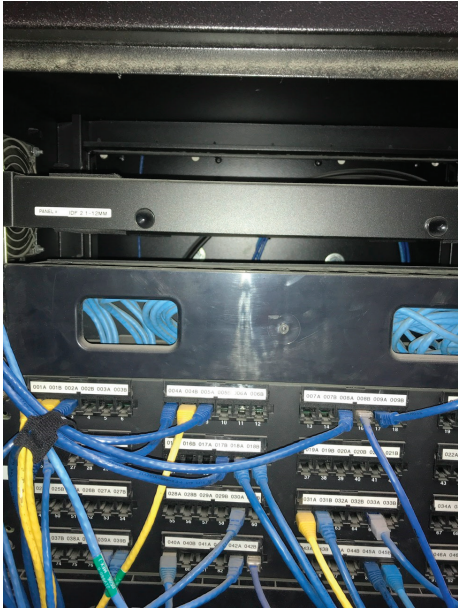
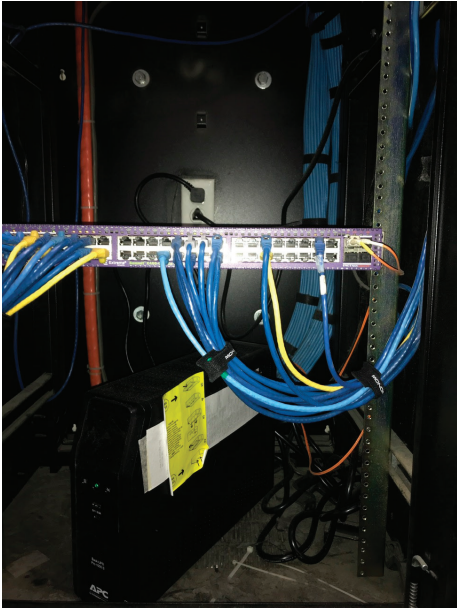
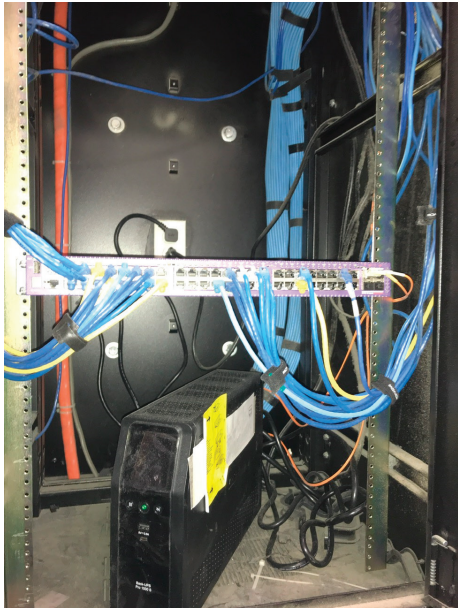
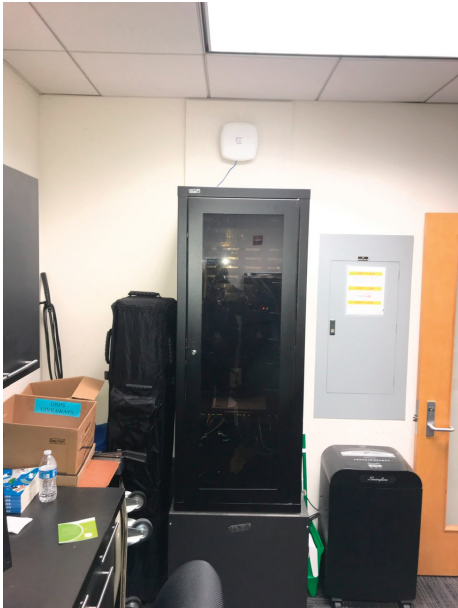
Administration and Student Services (AD/ SS) – 103U

Contains (1) 2-Post rack, wire management (horizontal/ vertical) and ladder tray to the wall.

- The room has clutter in and around the 2-Post rack.
- Vertical wire managers are missing the front covers.
- There is no fire stop in any of the existing floor conduits.
- Ground wiring should be reviewed.

RECOMMENDATIONS:

- Clutter should be removed from around the 2-Post rack to help protect the cabling.
- Fiber cabling should be protected better coming into the rack.
- Ground wiring should be reviewed and corrected.
- Fire stop in conduits.

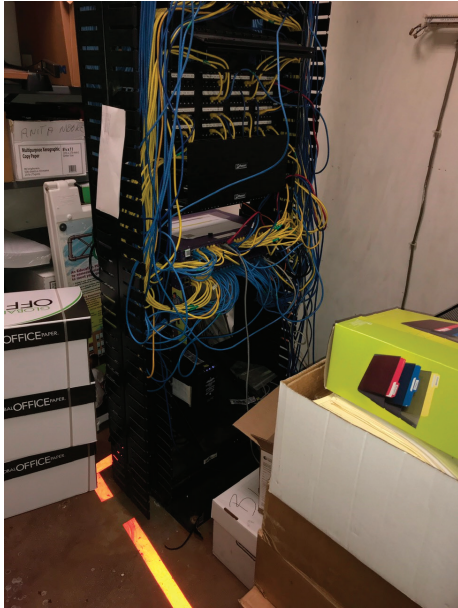
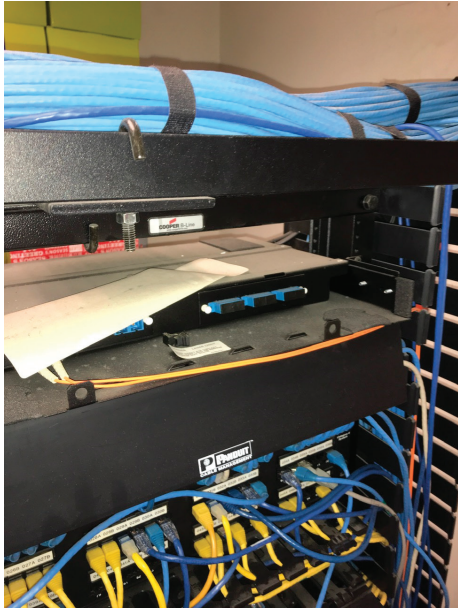
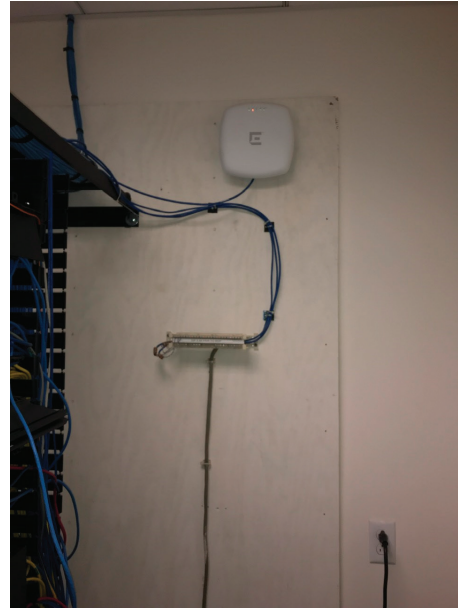
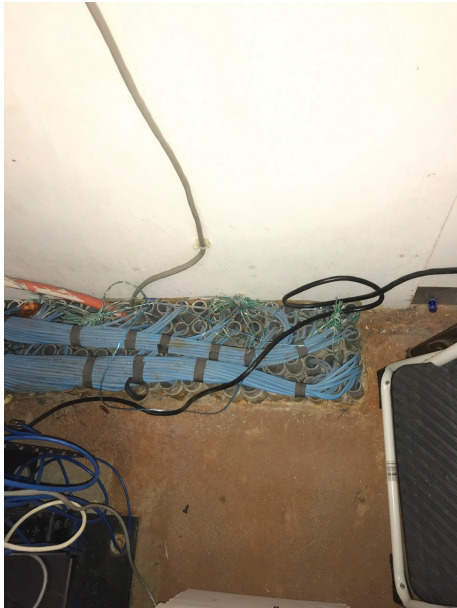
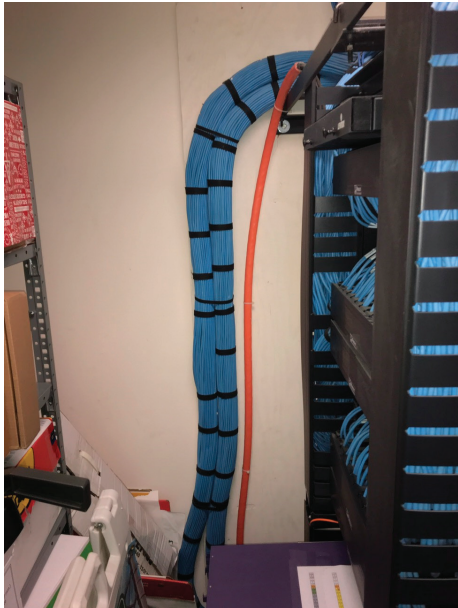
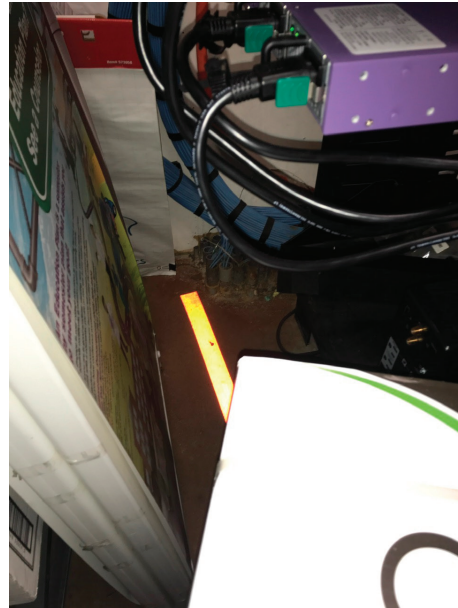
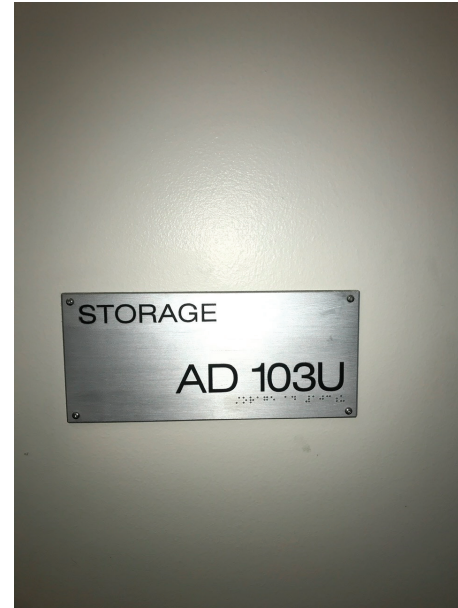
Administration and Student Services (AD/ SS) – 203

Contains (1) wall mounted rack with pedestal below and wire management (horizontal).

RECOMMENDATIONS:

- Ground wiring should be reviewed and corrected.
- Fire stop in conduits.

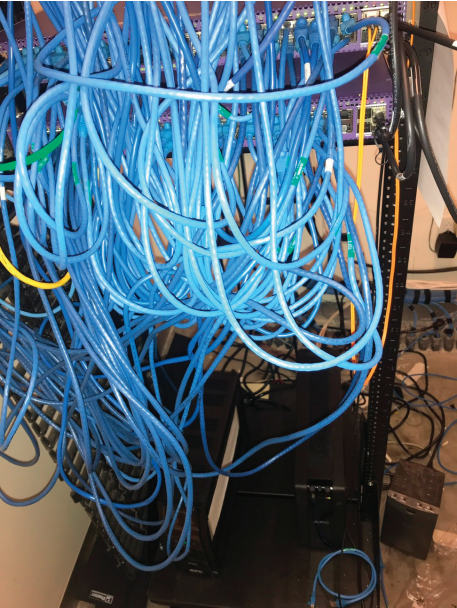
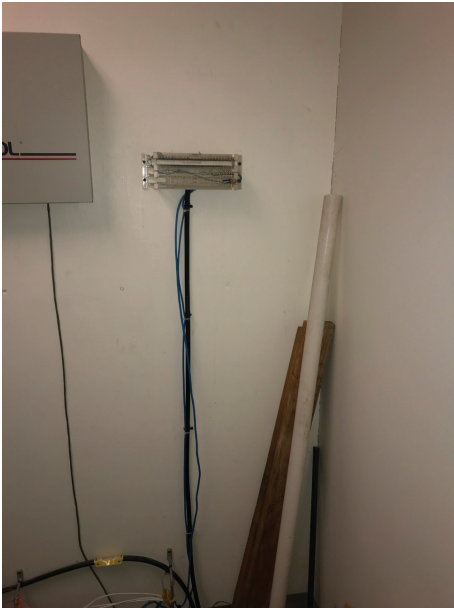
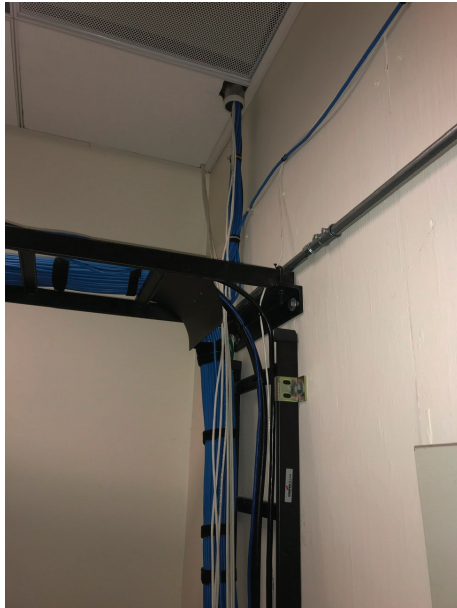
Art & Gallery (ART) – MDF #116

Contains (1) 2-Post rack, wire management (horizontal/vertical) and ladder tray to the wall.

RECOMMENDATIONS:

- Fiber jumpers should be protected better within the wire management.
- UPS equipment not in use should be removed.
- The clutter behind the rack should be removed.
- Ground wiring should be reviewed and corrected.
- Fire stop in conduits.
