# Utility Infrastructure Master Plan

## San Bernardino Valley College

P2S Project #0191

Issued September 2, 2020

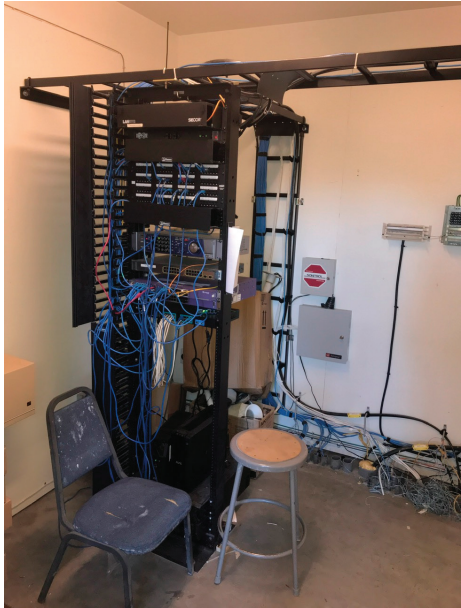
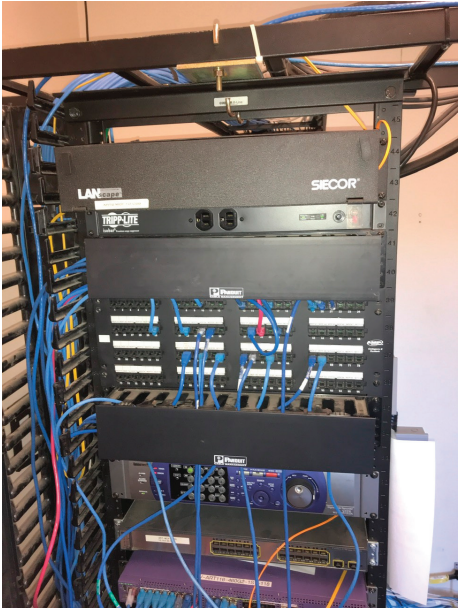
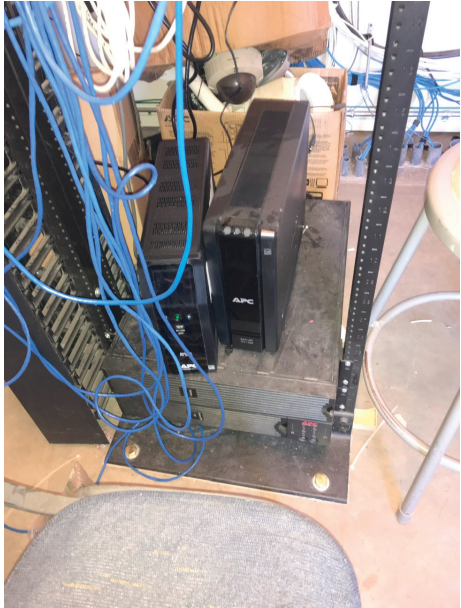
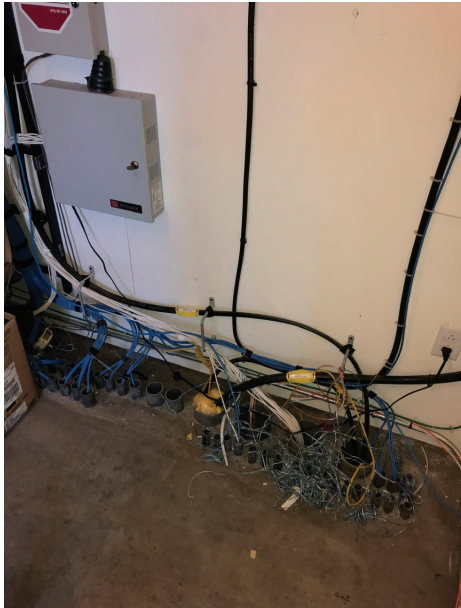
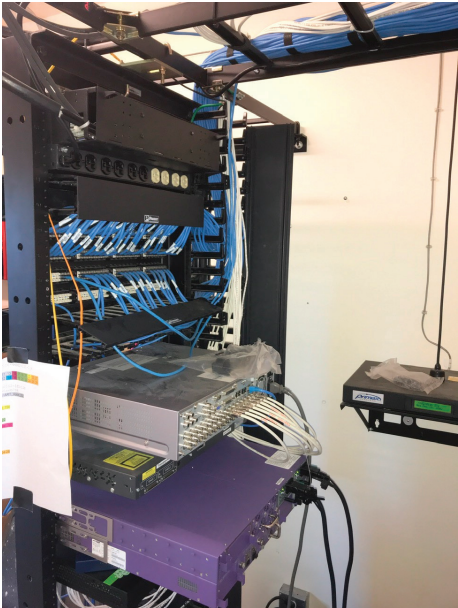
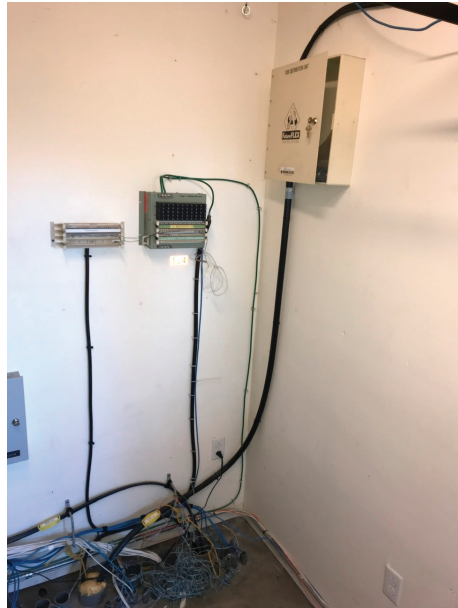
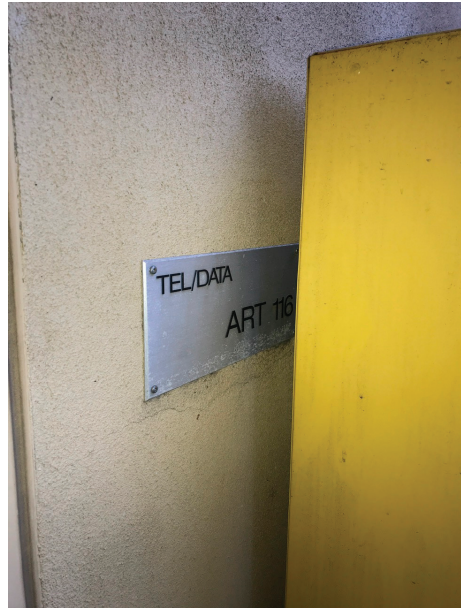
Auditorium Building (AUD) AO15

The Auditorium building is a multi-floor building, approximately 26,200 square feet. Built in 1965.

RECOMMENDATIONS:

- Ground wiring should be reviewed and corrected.
- Fire stop in conduits.

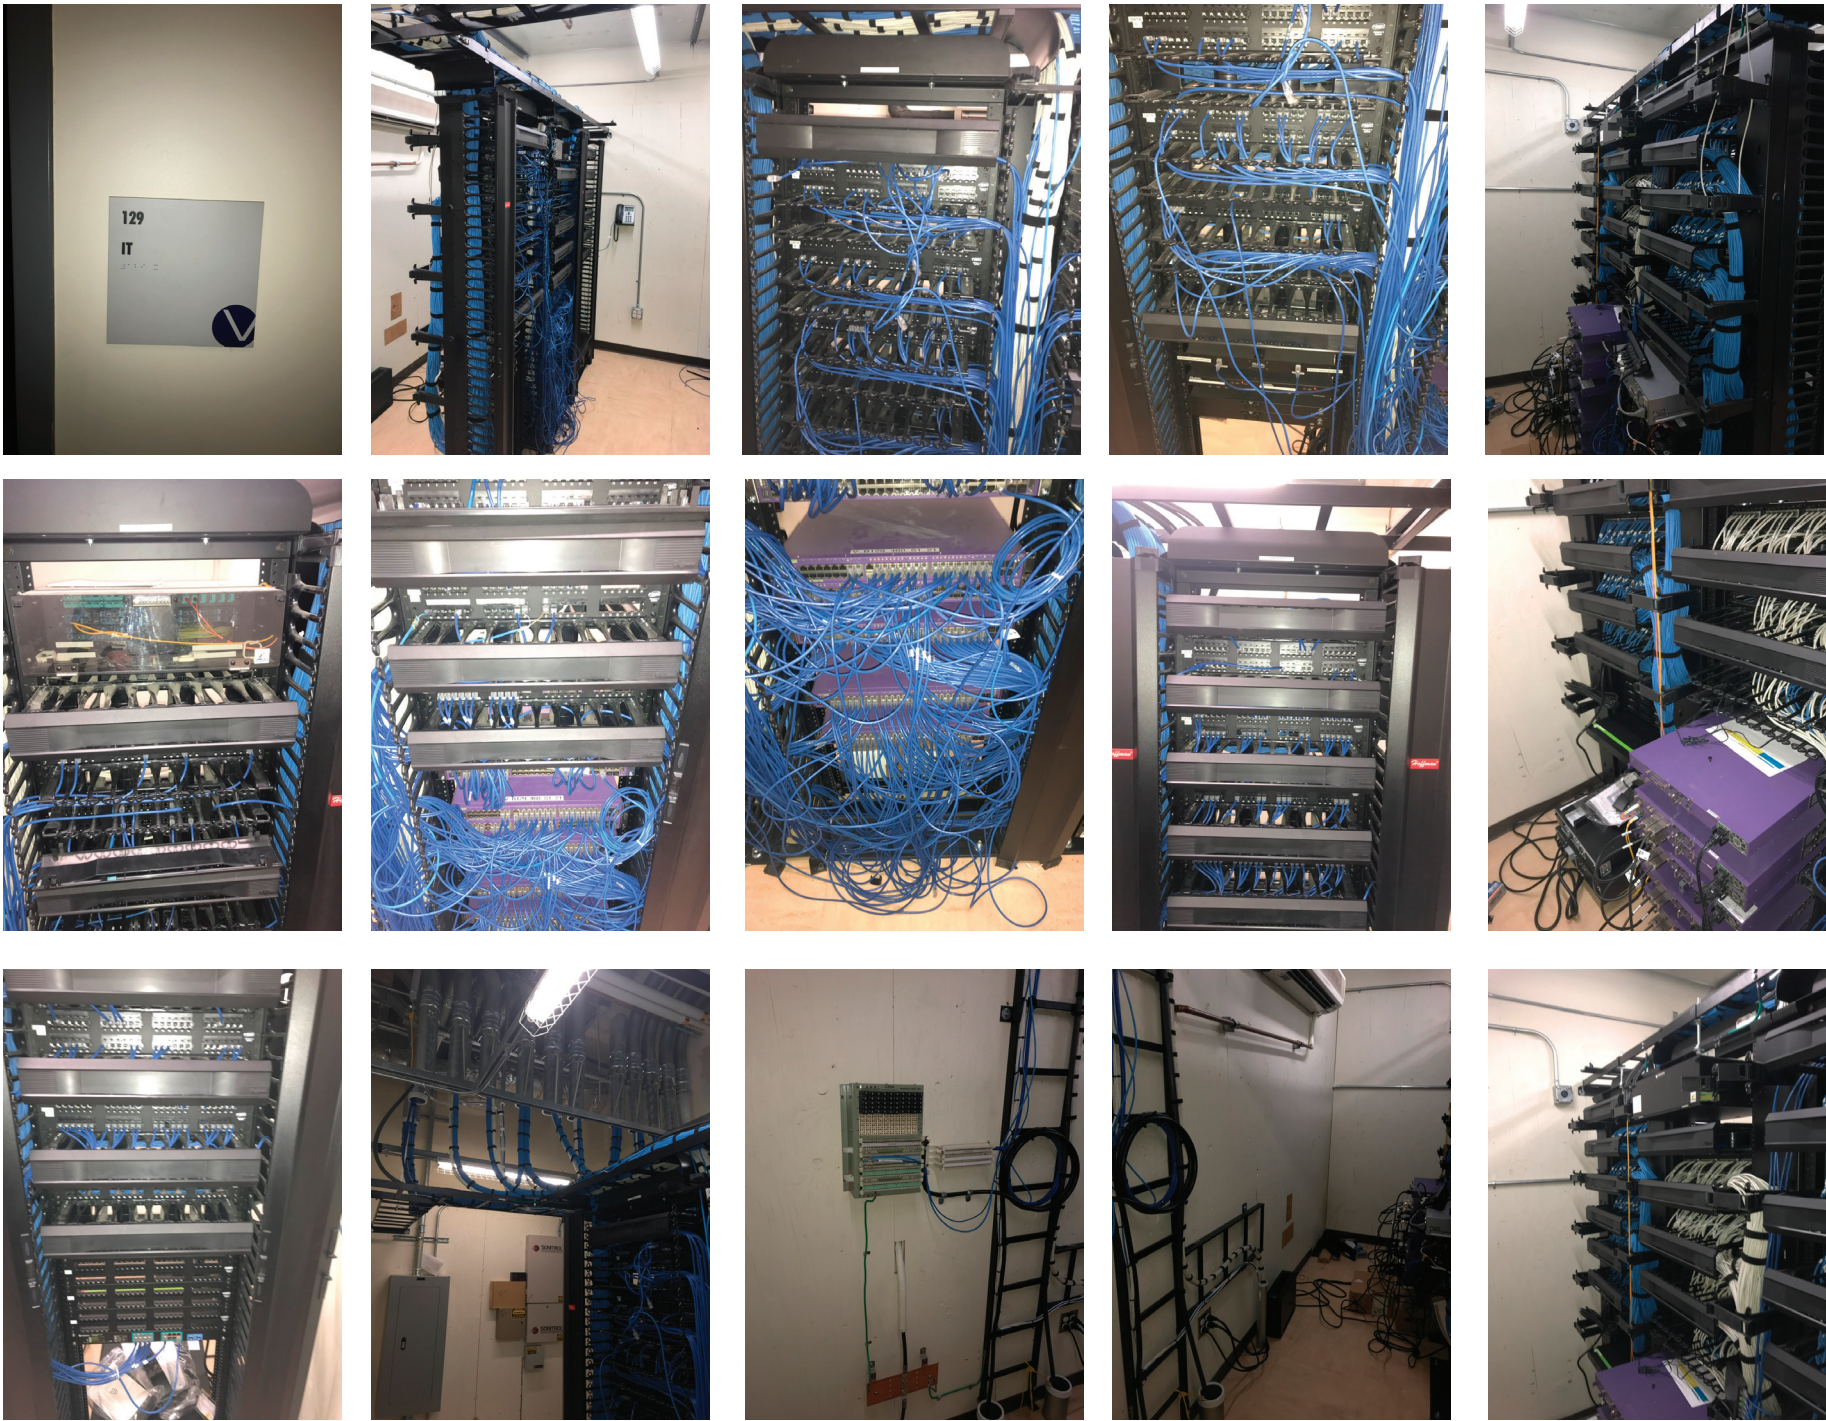
Business Building (B) – Room #209

Contains (2) 2-Post racks, wire management (horizontal/vertical) and ladder tray to the wall.

- UPS equipment not in use should be removed.
- The clutter behind the rack should be removed.
- Ground wiring should be reviewed and corrected.
- Fire stop in conduits.

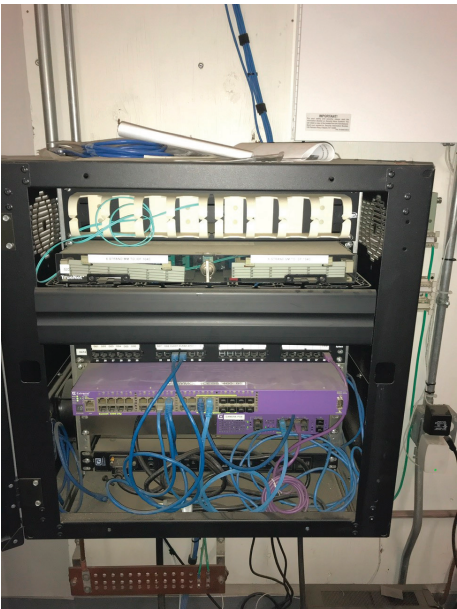
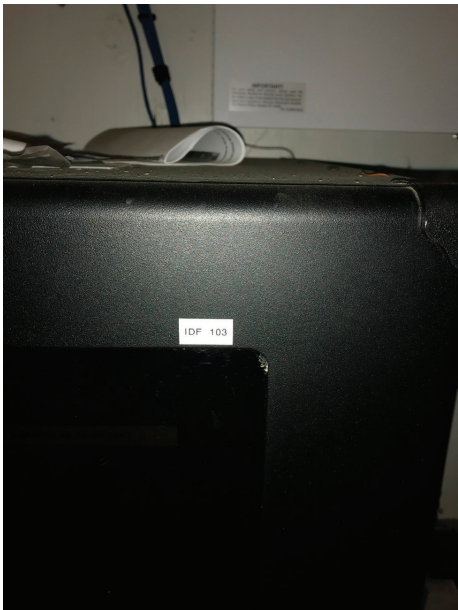
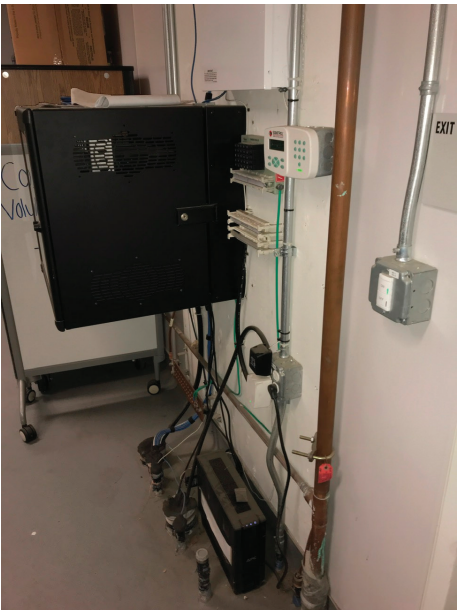
Computer Technology Services (CTS)

The Computer Technology Services building is a one-story building, approximately 10,000 square feet. Year built unknown.

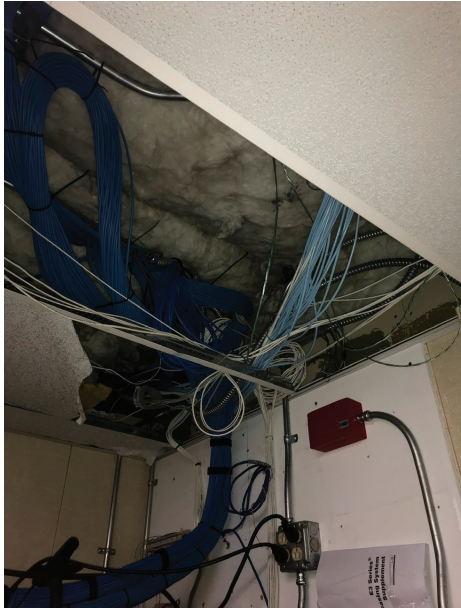
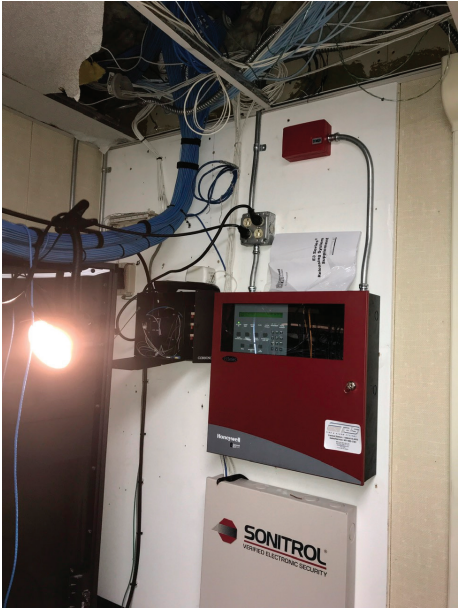
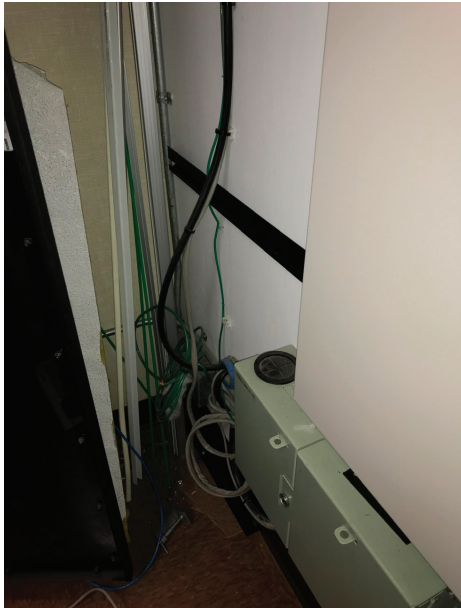
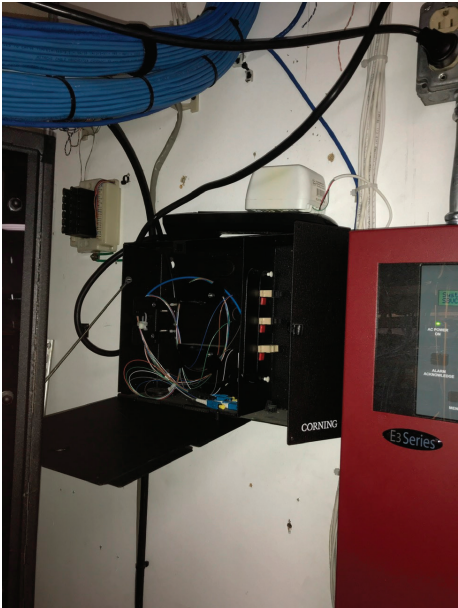
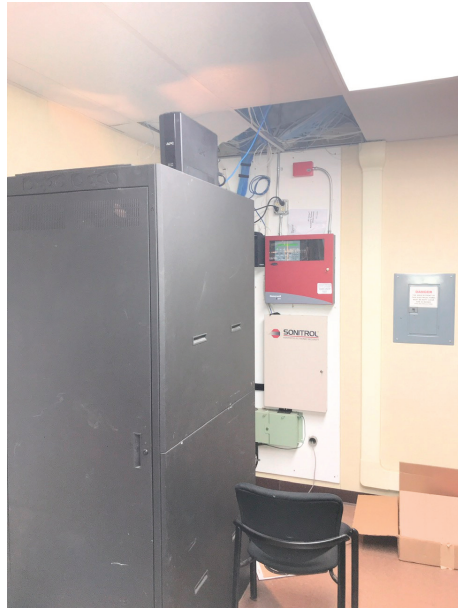
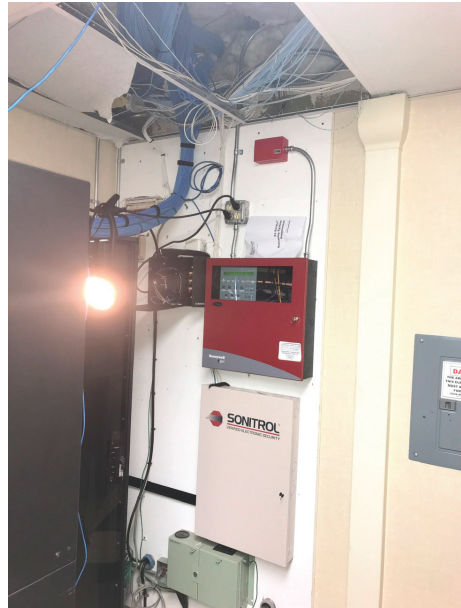
CSB – Main Fiber Core

Contains multiple loor mounted cabinets and 2-Post server racks the support the campus services.

- Some of the fiber cabling coming in from the street is currently coiled on the ground.
- Some of the patch cabling is laying on the ground.
- External light sources are being used.
- Cable wire management covers are missing throughout.
- Some interconnections between the racks are outside of the wire management and ladder tray.
- Grounding needs to be reviewed.
- There is no fire stop in the existing floor conduits.

- Rack and cabinet assessment for distribution reference.
- Patch cabling should be dressed within the wire management.
- Protect the fiber cabling and fiber jumpers.
- Grounding needs to be reviewed and corrected.
- Fire stop in conduits.
- Improve the lighting throughout in order to better service the networks.

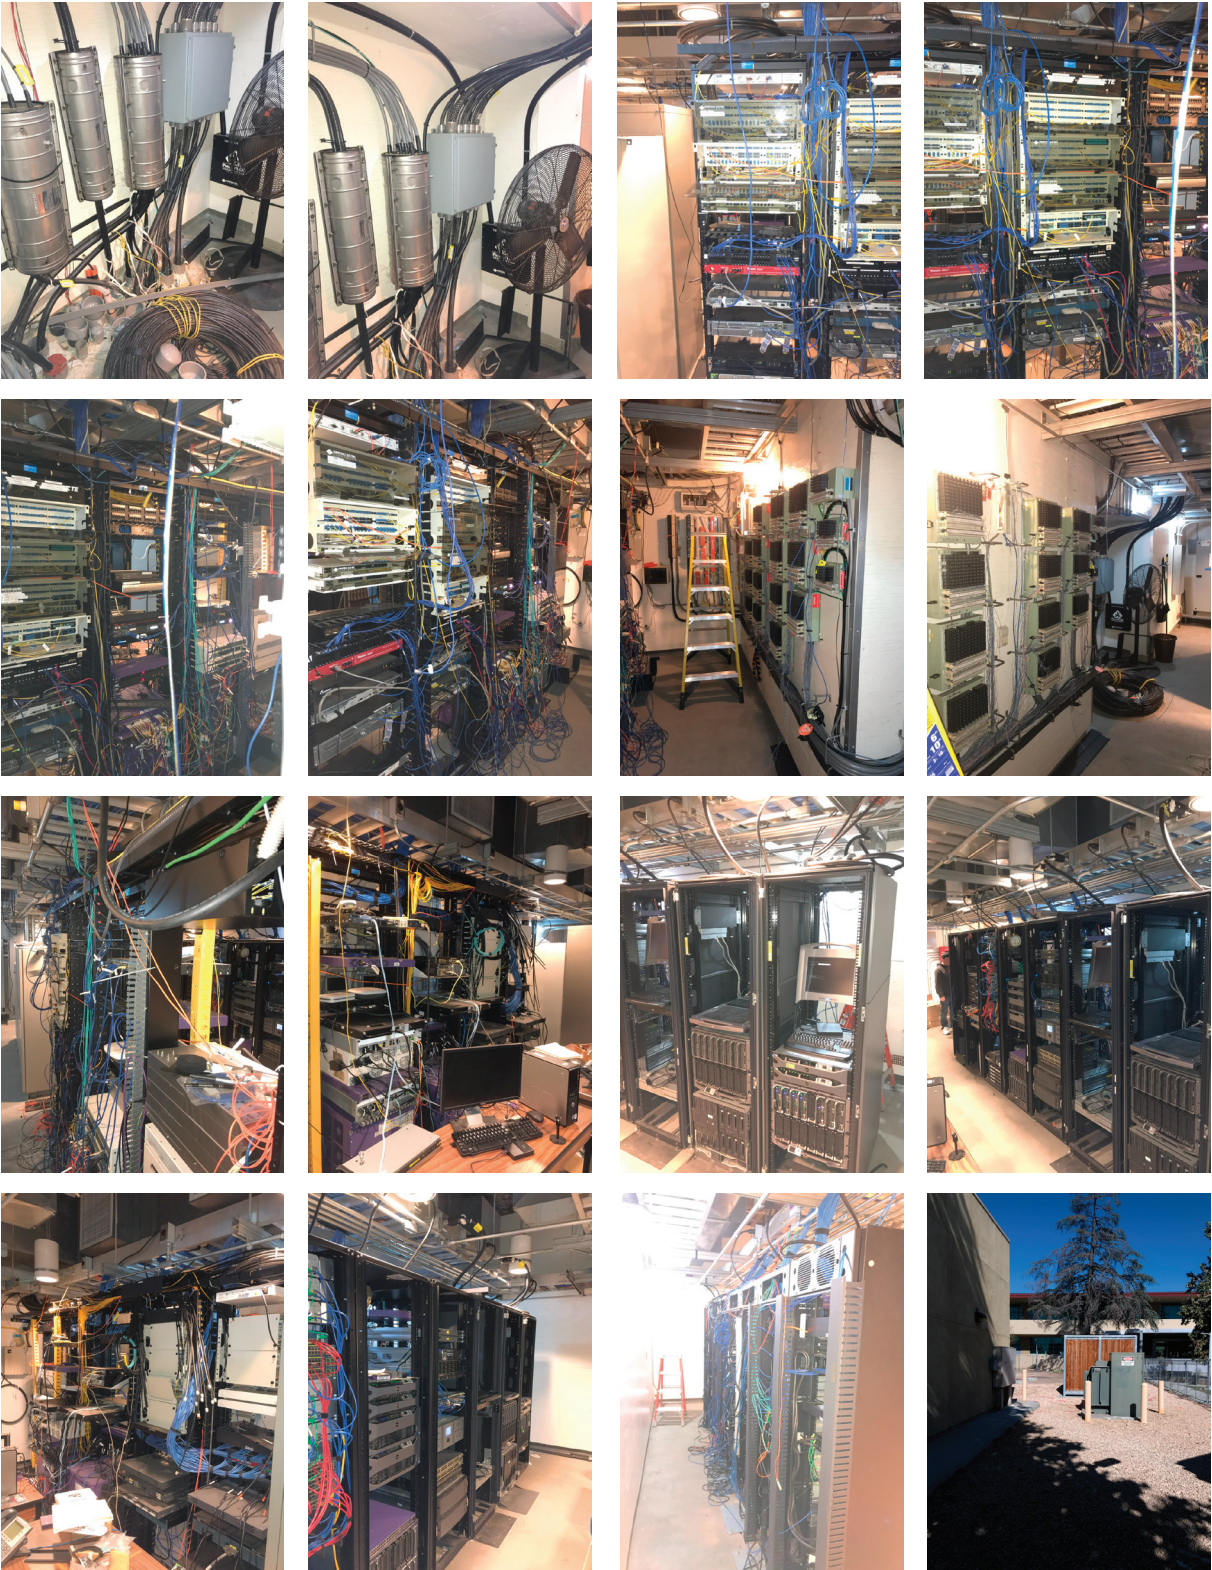
Field Equipment Room

Contains (1) wall mounted cabinet and wire management (horizontal).

- Install a shelf for the UPS unit to get it off the ground.

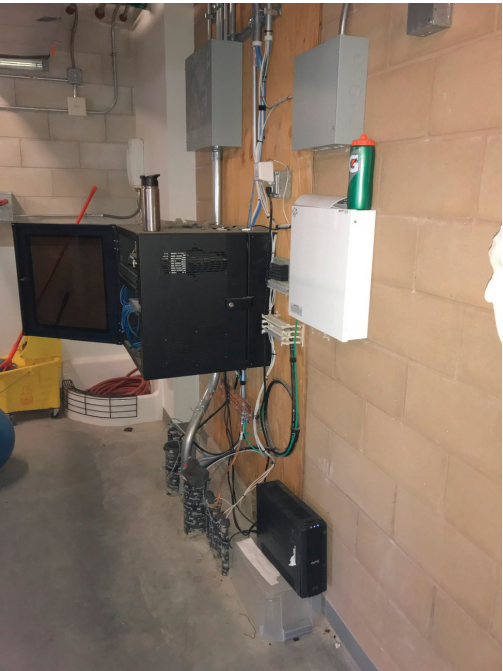
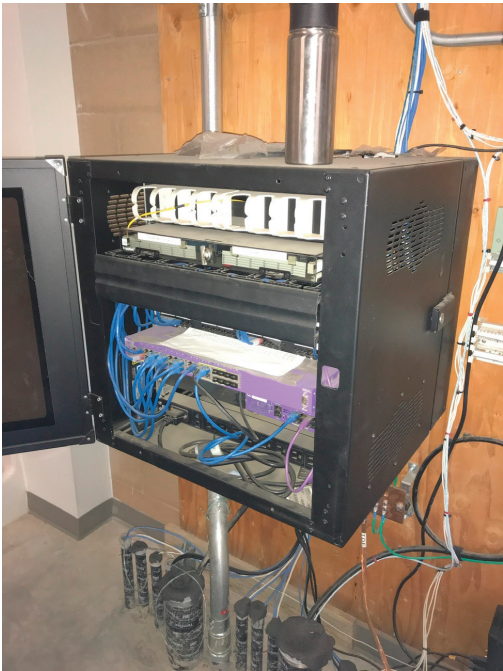
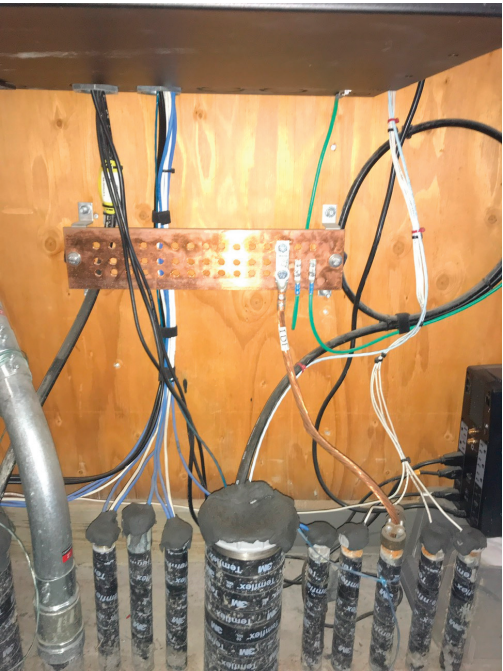
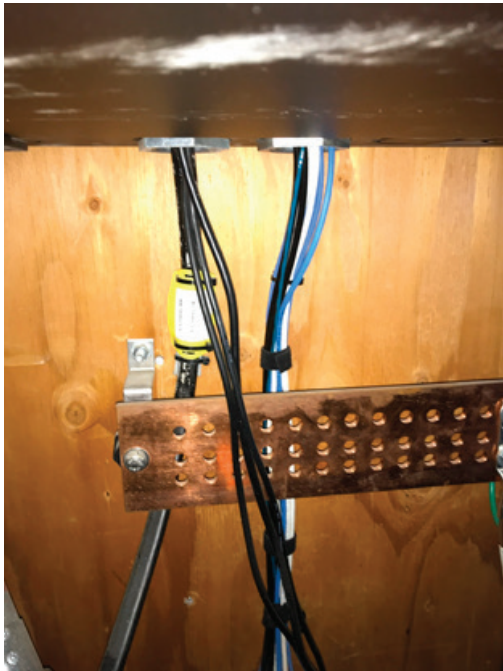
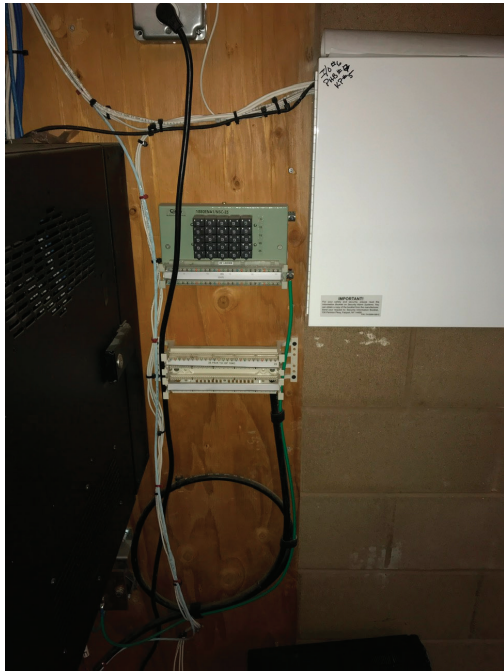
GYM Building (GYM) – IDF 138A

The GYM building is a three-story building, approximately 108,500 square feet. Built in 2016.

- Fire stop conduits.

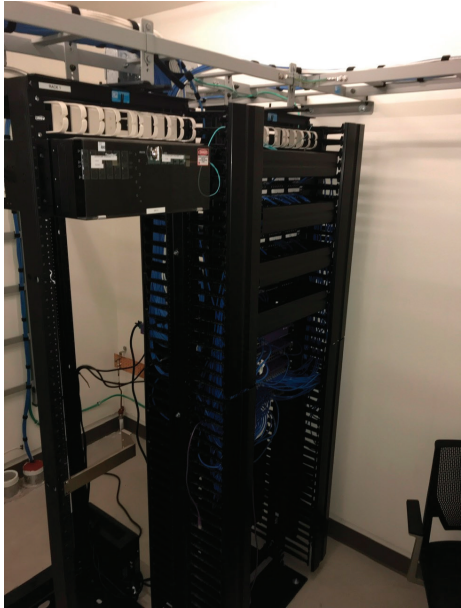
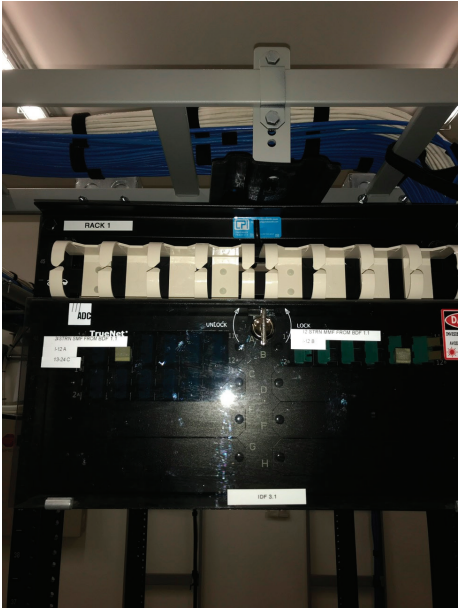
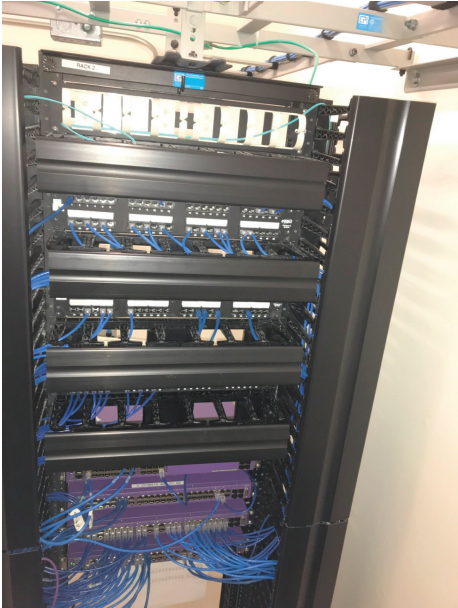
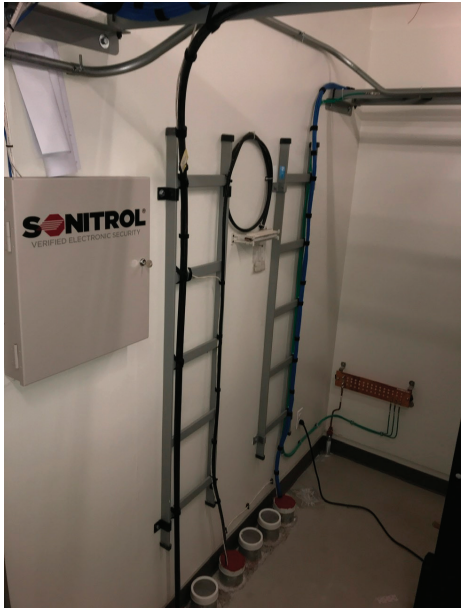
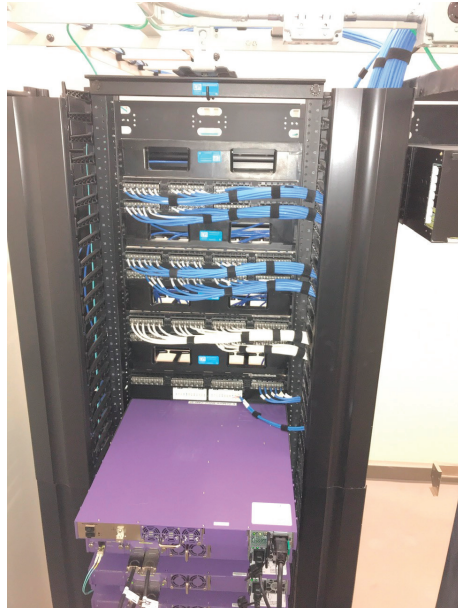
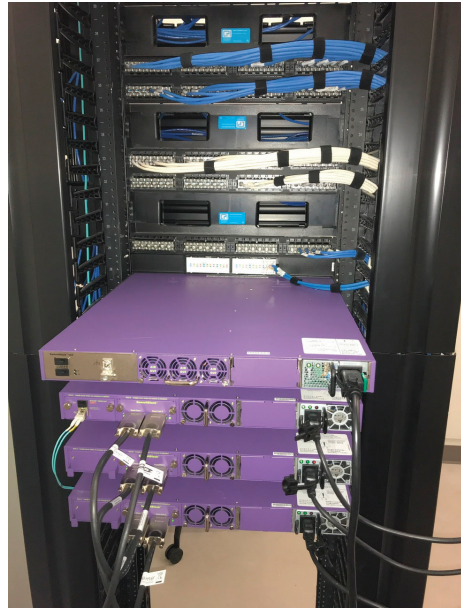
GYM Building (GYM) – 1st Floor – Room 126

Contains (1) 4-Post rack and (2) 2-Post racks, wire management (horizontal/vertical) and ladder tray to the wall.

- Fire stop conduits.

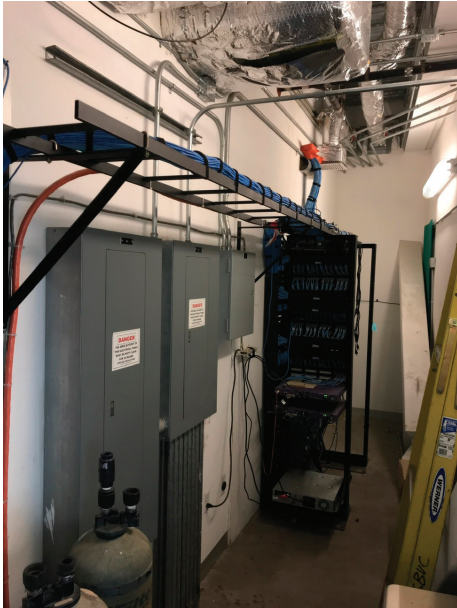
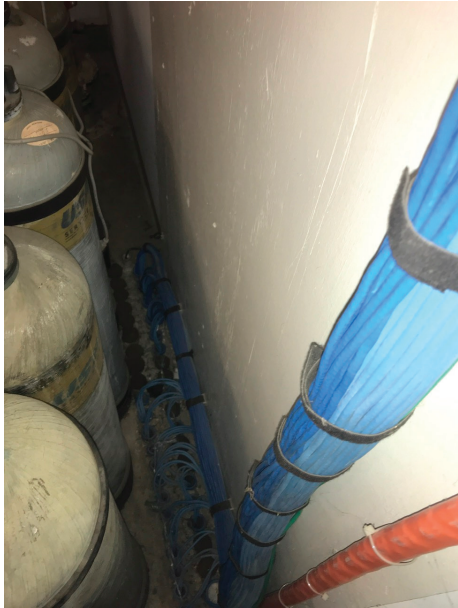
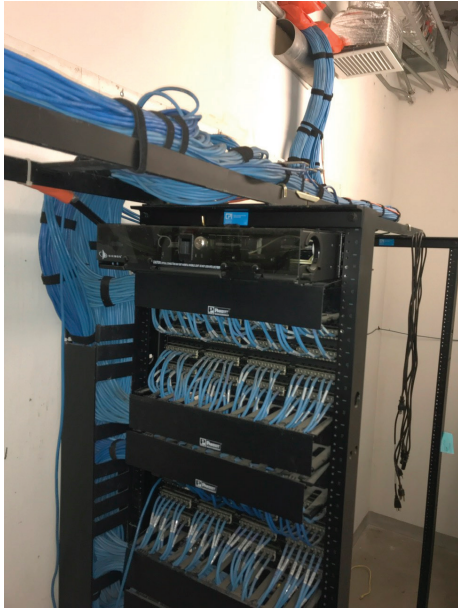
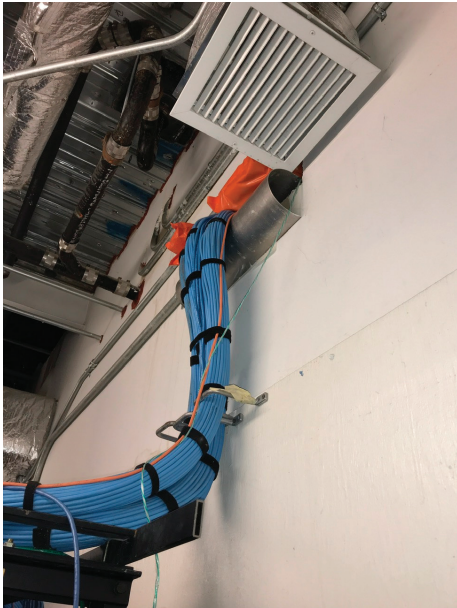
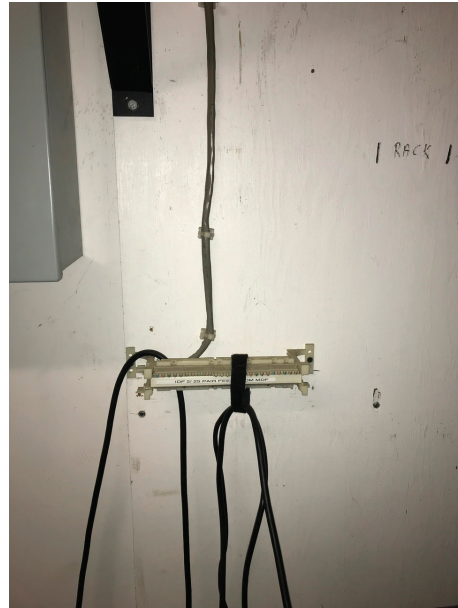
Health & Life Science Building (HLS) Room #128

Contains (2) 2-Post racks, wire management (horizontal/vertical) and ladder tray to the wall.

- Fire stop conduits.
- Dress the jumper cables into the wire management.
- Replace the vertical wire manager cover.

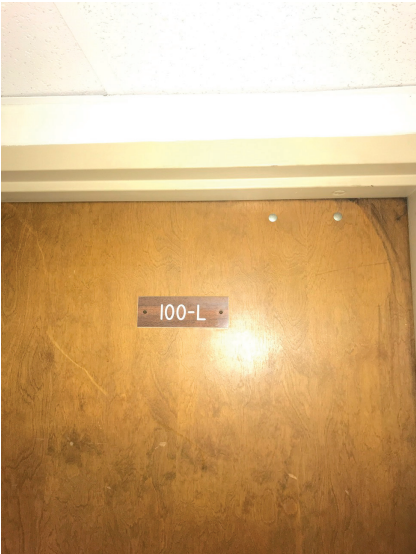
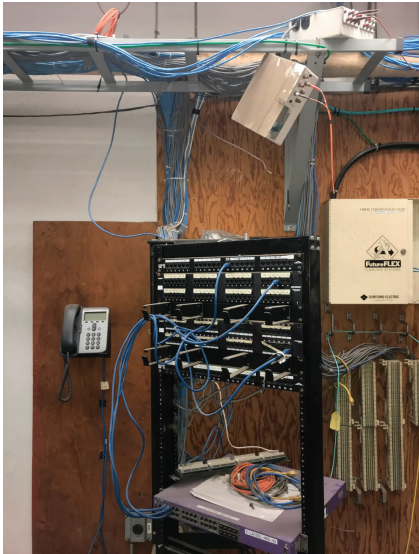
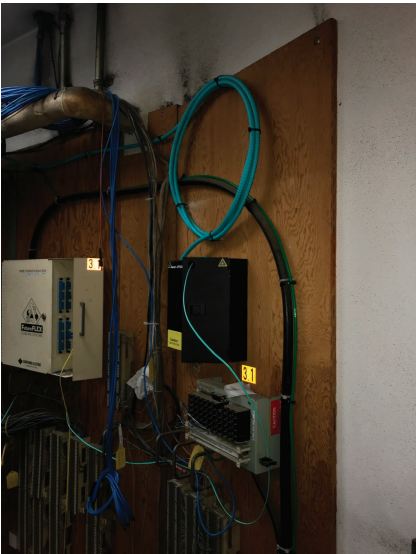
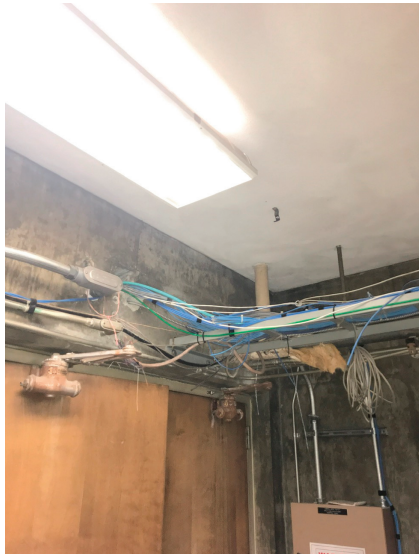
Liberal Arts Building (LA) – Room #101

Contains (2) 2-Post racks, wire management (horizontal/vertical) and ladder tray to the wall.

- Fire stop conduits.
- Dress the jumper cables into the wire management.
- Replace the vertical wire manager cover.

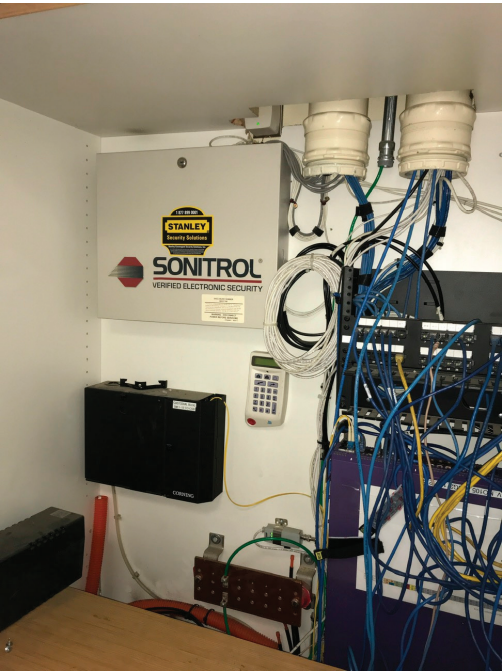
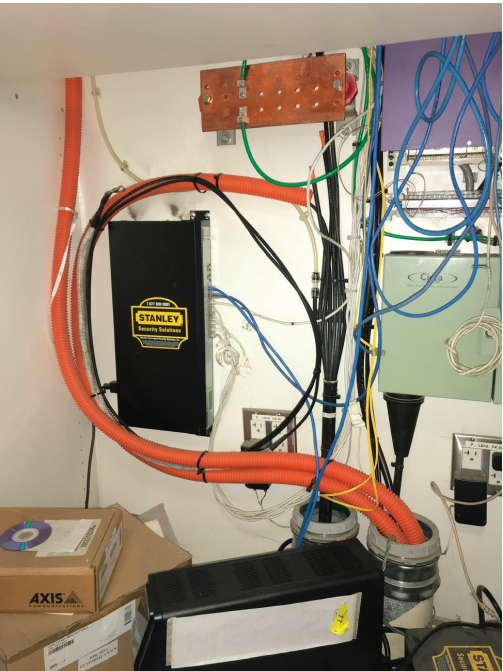
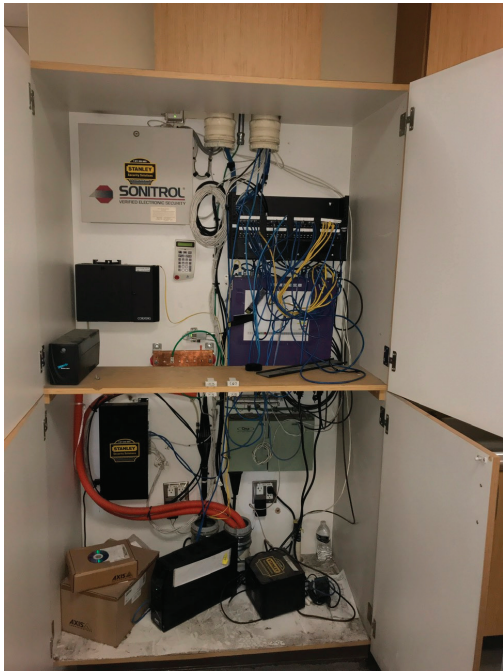
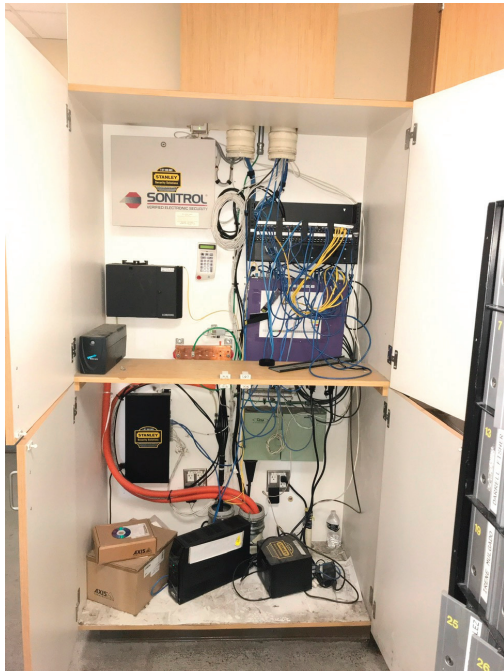
Maintenance and Operation (M&O) – Across the street – Room #113

Contains (1) Wall mounted rack and wire management (horizontal), for the patch panel only.

- There is no fire stop in the existing conduits.
- Some clutter within the cabinet.
- Lots of loose jumper cables.

- Fire stop conduits.
- Dress the jumper cables within the wire management.

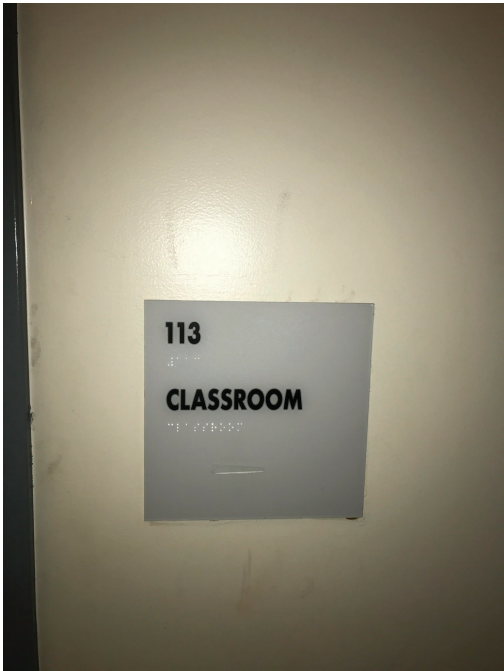
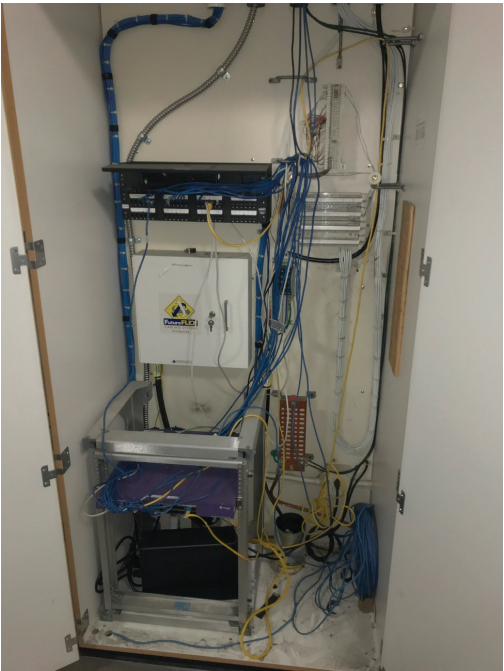
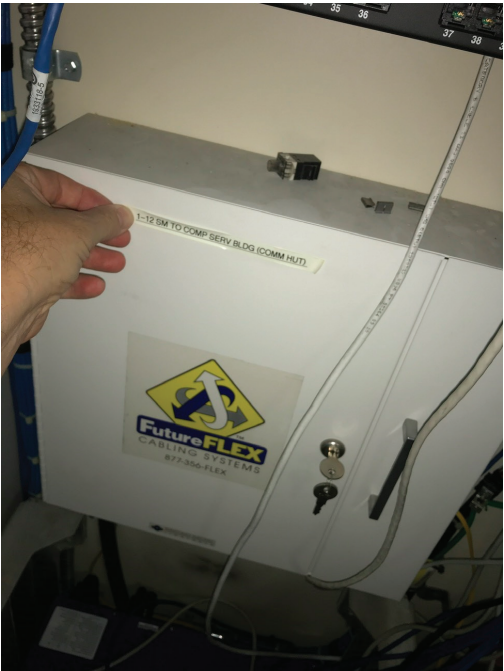
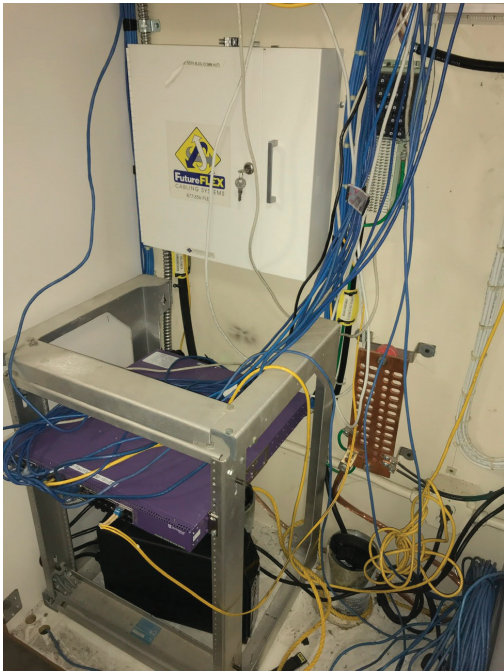
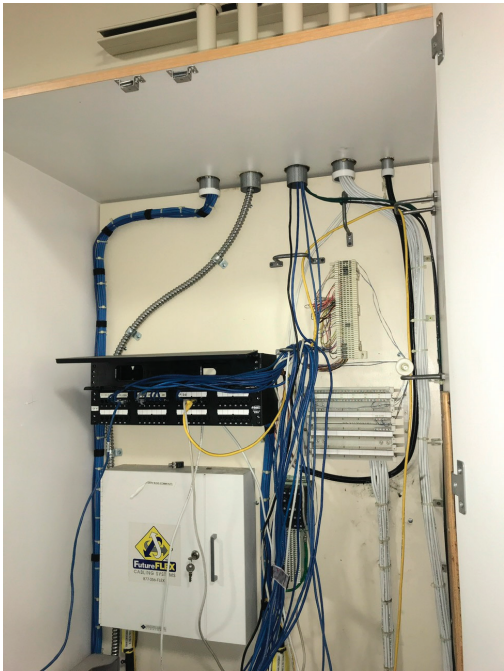
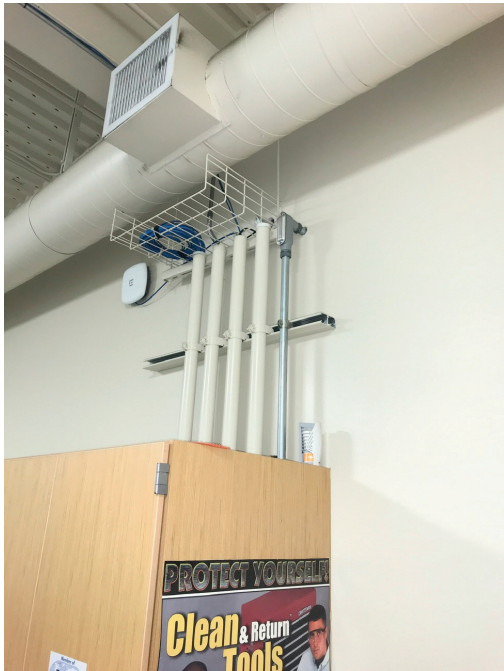
Media Communications Building (M/C) #150

The Media Communications building is a one-story building, approximately 18,300 square feet. Built in 2009.

- There is no fire stop in the existing conduits.
- Jumper cables have slack in front of all the rack mounted devices.
- Multiple cables are hung loosely throughout the room.
- Lots of clutter around the rack.

- Fire stop conduits.
- Dress the jumper cables into the wire management.
- Protect the fiber jumper feeding into the racks and servers.

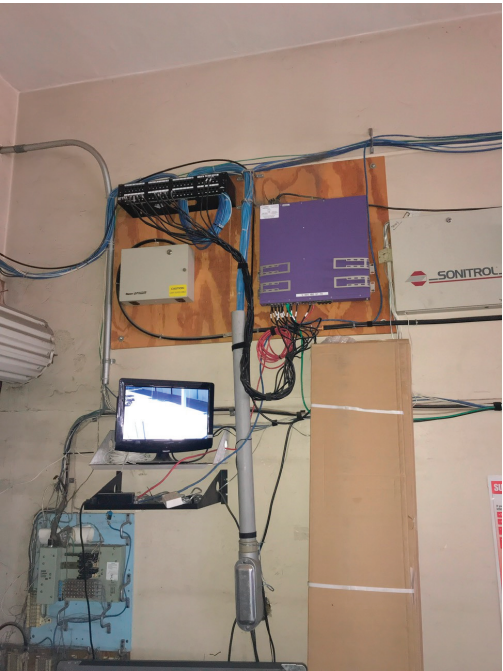
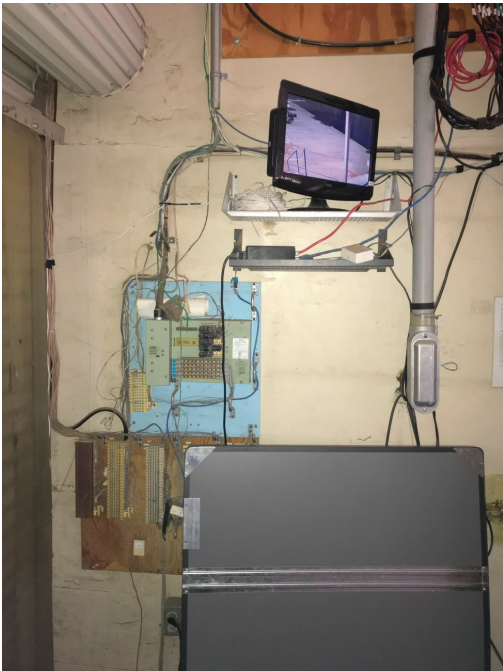
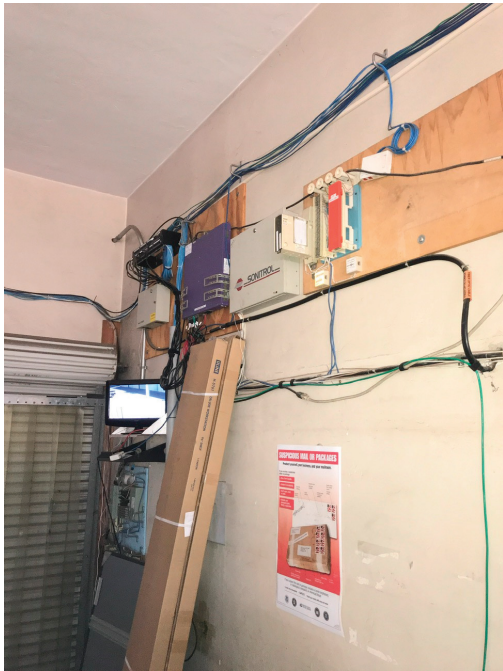
Technical Building (Tech) – Room #110

The Technical building is a one-story building, approximately 66,200 square feet. Built in 1963. Room overheats – over occupied.

- There is some fire stop in the conduits.
- Jumper cables are loosely dressed throughout the room and into the wire management.
- Some clutter around the rack and in the room.
- Appears to be a lot of abandoned cabling.
- Appears that the fiber cabling needs to be reviewed and corrected.
- The rack in place take up the majority of the room with minimal use.
- No wire management for any of the cabling.

- Install and enclosed cabinet with temperature control for the network equipment.
- Fire stop horizontal conduits.
- Dress the jumper cables – wire management is needed for the existing rack and backboard.
- Protect the fiber jumper feeding into the racks and servers.
- Remove the UPS unit not in use.
- Replace the tie wraps with Velcro.
- Evaluate and remove abandoned cabling in the room – including other systems.
- Protect the service cabling feeding into the room.
- Evaluate and correct the overall temperature in the room.
- Remove the clutter from in and around the room.

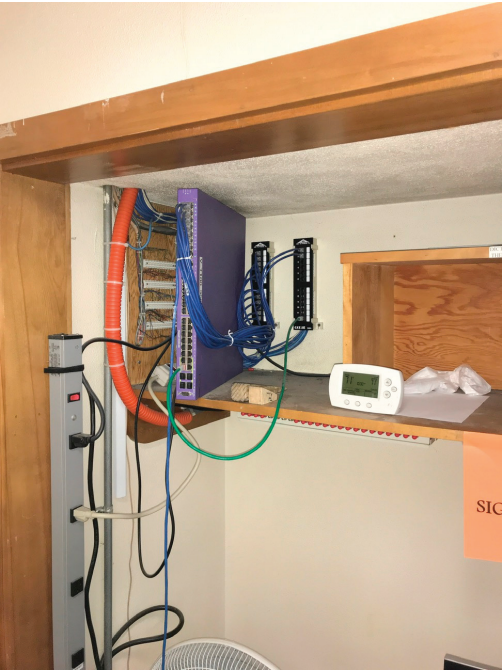
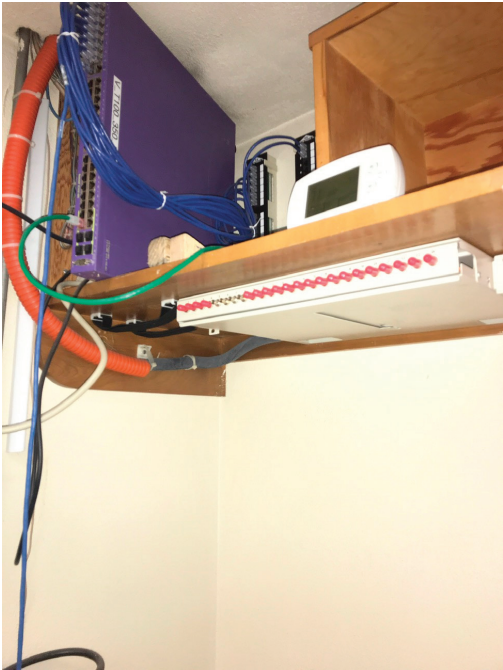
Technical Building (Tech) – Room #112

Contains (1) Wall mounted cabinet and wire management (horizontal).

- Wire management for the inside of the cabinet to help protect the cabling.

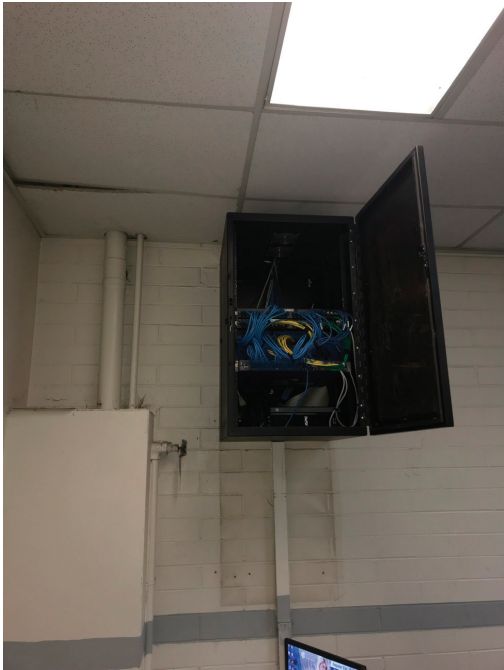
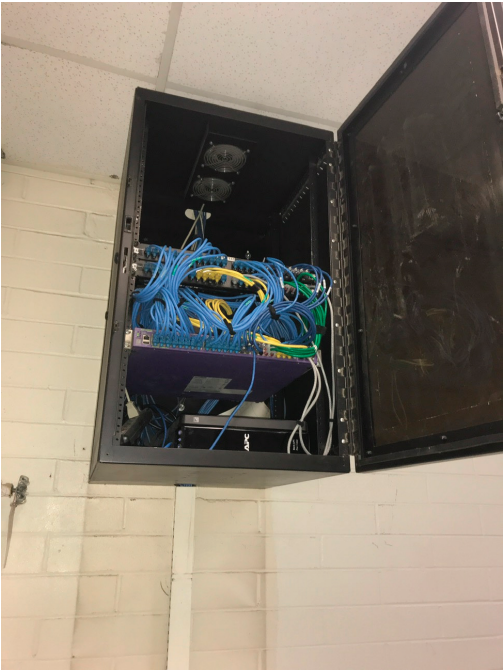
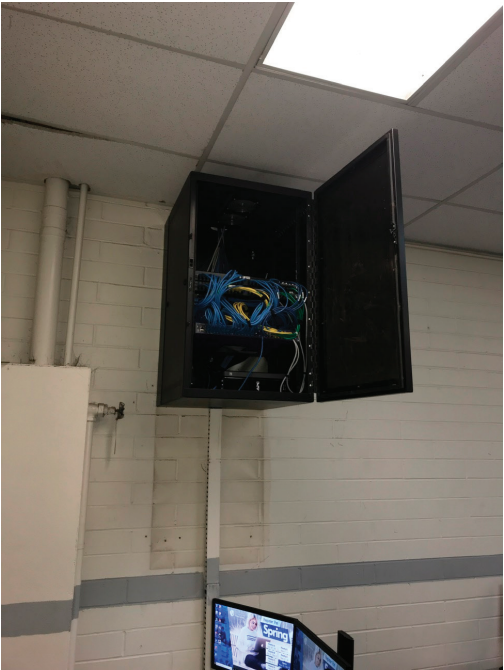
Technical Building (Tech) – Aeronautics Lab

Contains (1) Wall mounted frame rack and wire management (horizontal).

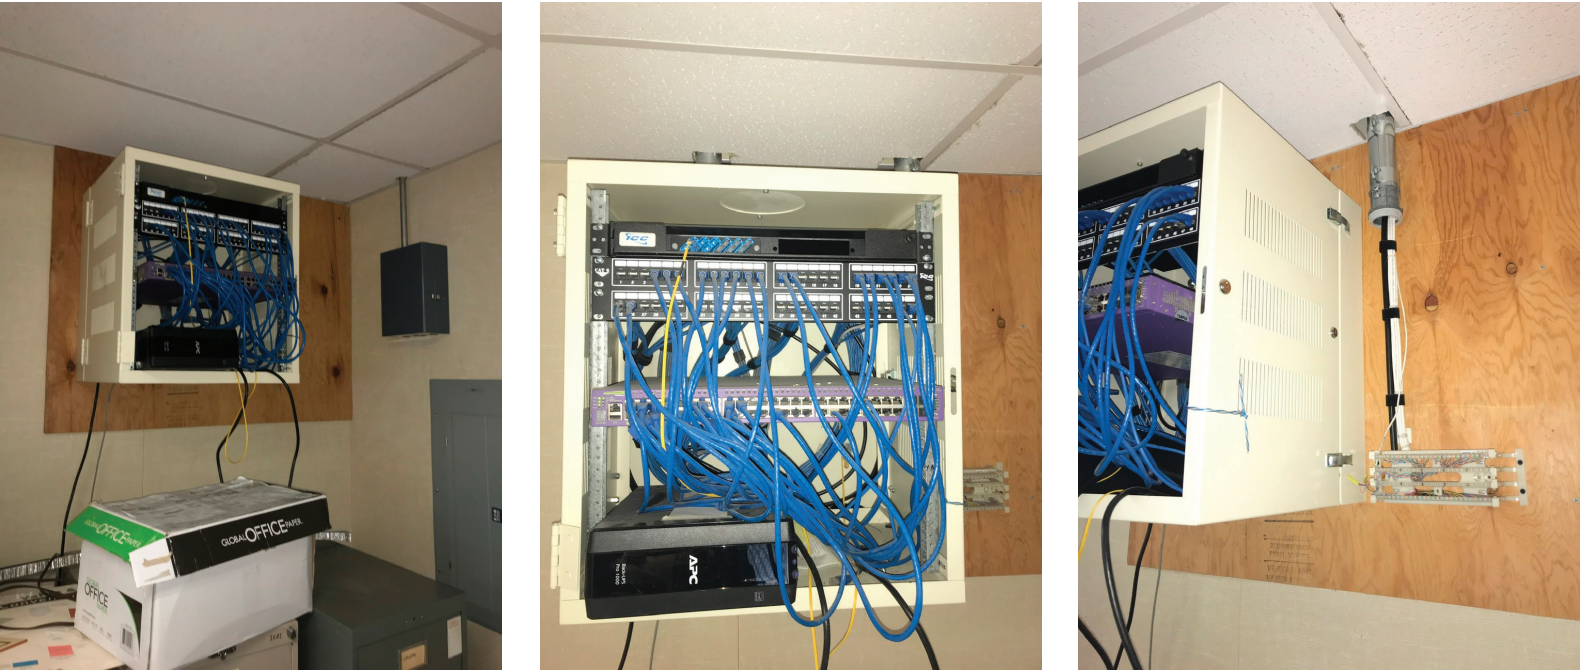
Technical Building (Tech) – Portable T125

Contains (1) Wall mounted cabinet; no door.

RECOMMENDATIONS:

- Wire management for the inside of the cabinet to help protect the cabling.
