# Utility Infrastructure Master Plan

## San Bernardino Valley College

P2S Project #0191

Issued September 2, 2020

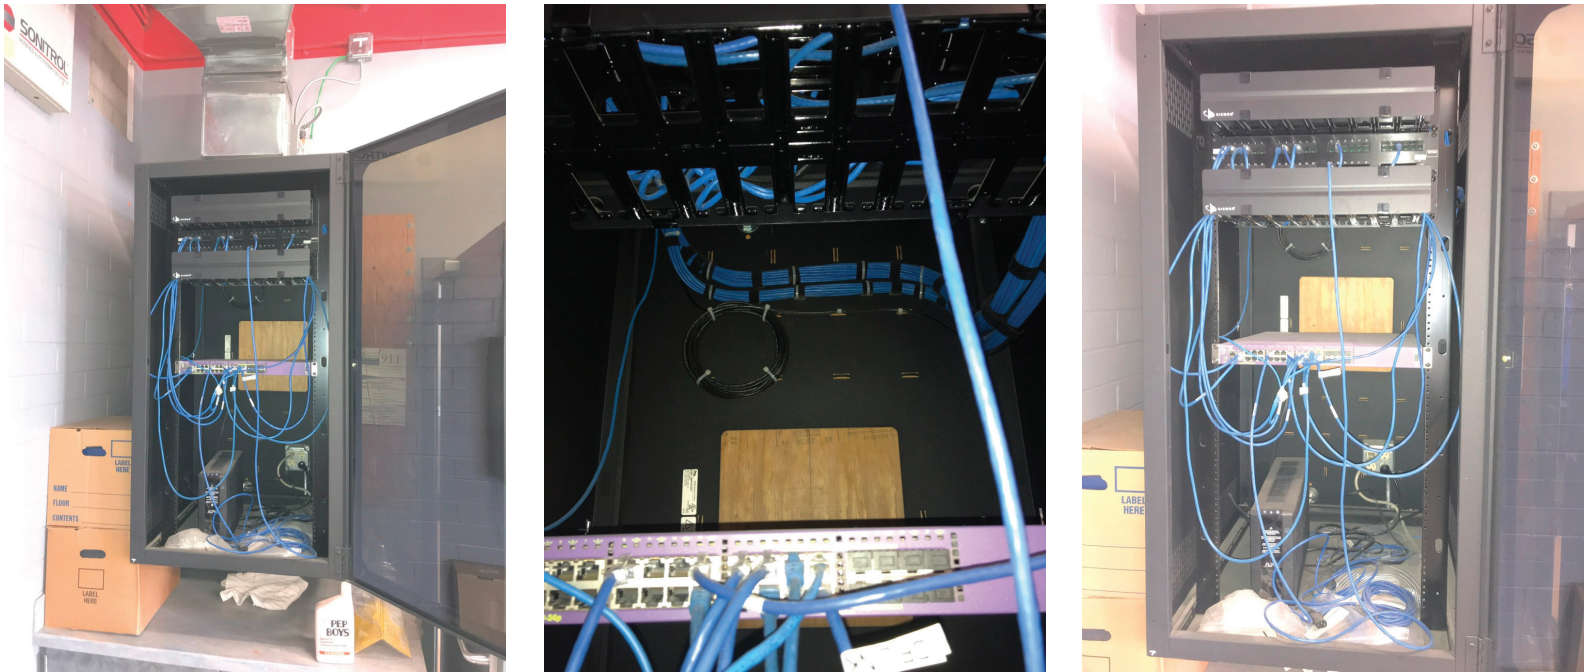
Technical Building (Tech) – Classroom T122

Contains (1) Wall mounted cabinet; no door.

- Dress the cabling within the cabinet.

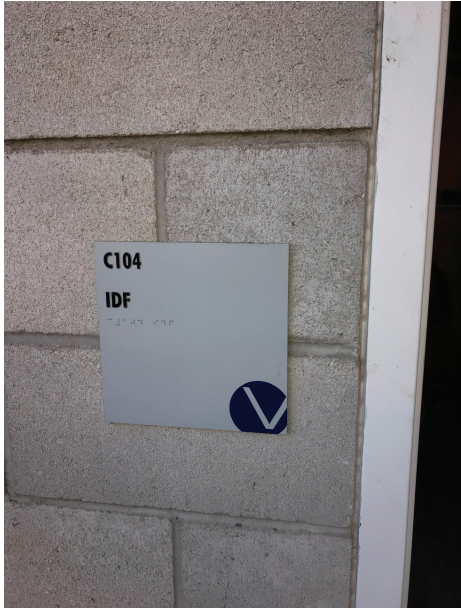
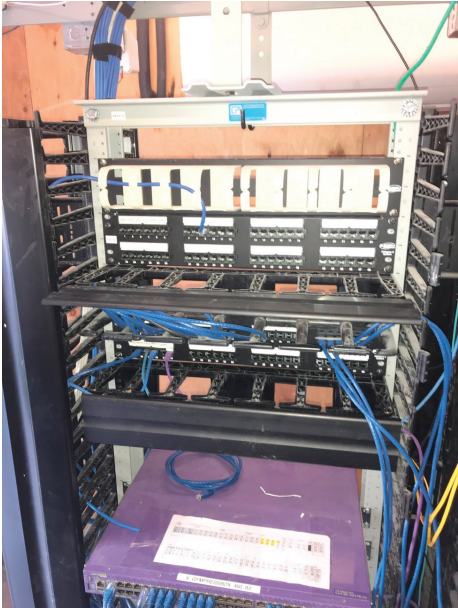
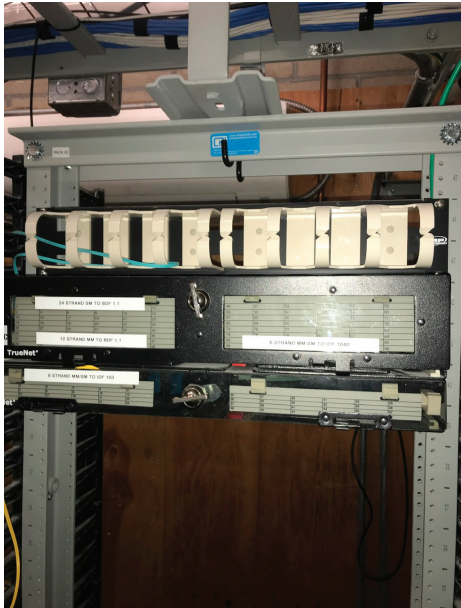
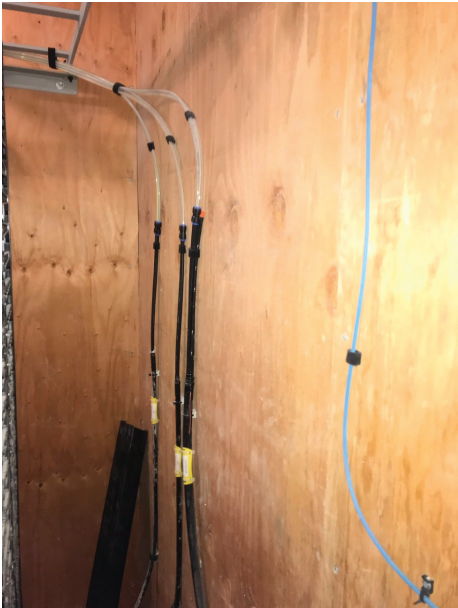
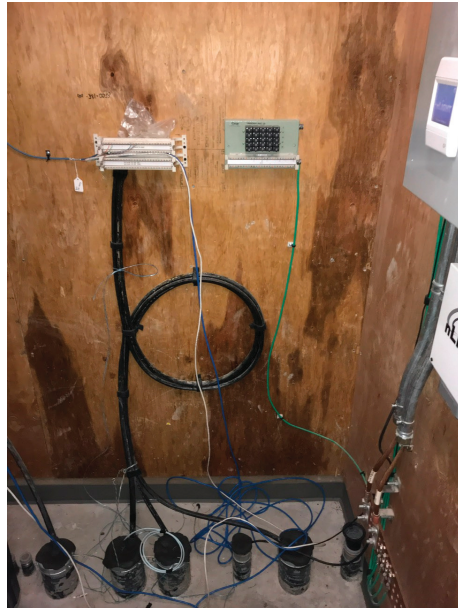
- There is some fire stop in the conduits.
- Jumper cables are loosely dressed into the wire management.

- Fire stop conduits.
- Dress the jumper cables into the wire management.
- Protect the fiber jumper feeding into the racks and servers.

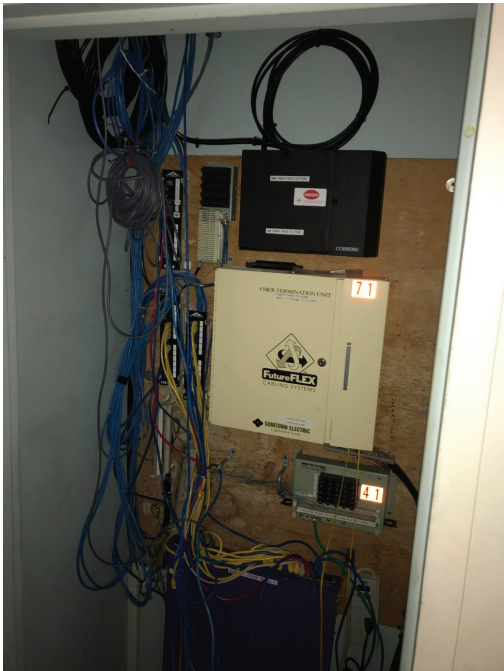
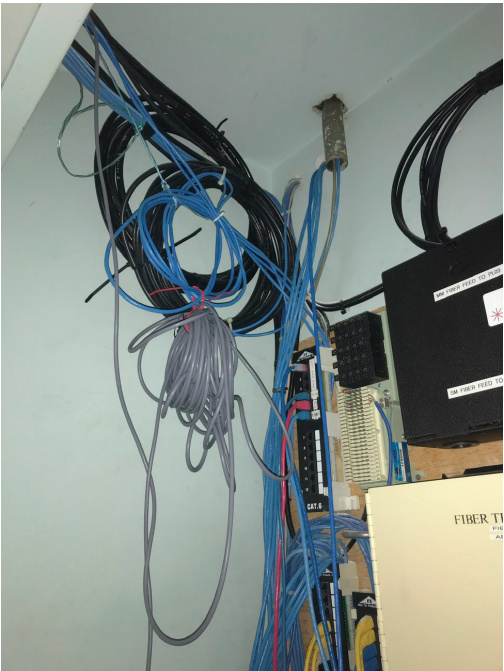
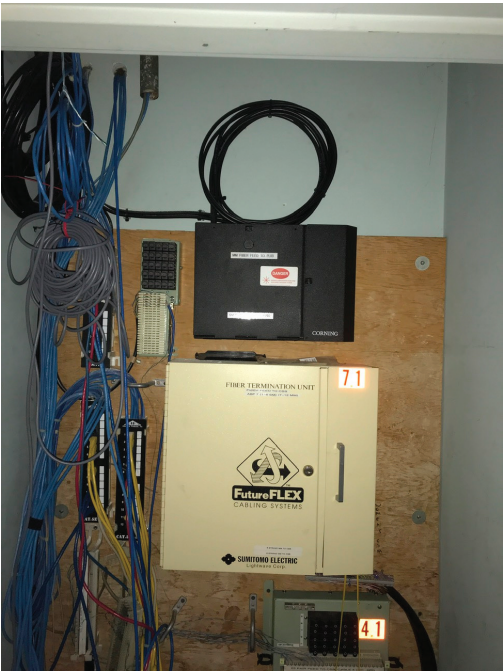
Planetarium Building (PL)

The Planetarium building is a two-story building, approximately 11,300 square feet. Built in 1976. Only one pair of fiber is working.

- Wire management for the inside of the closet to help protect the cabling.

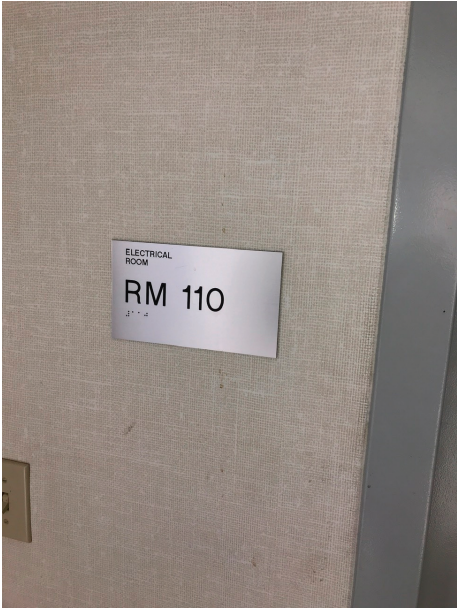
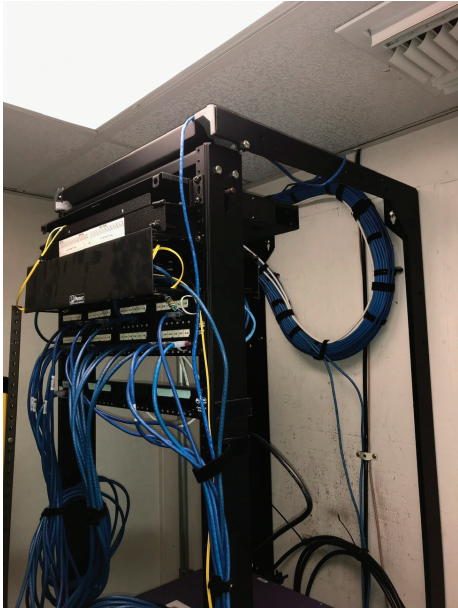
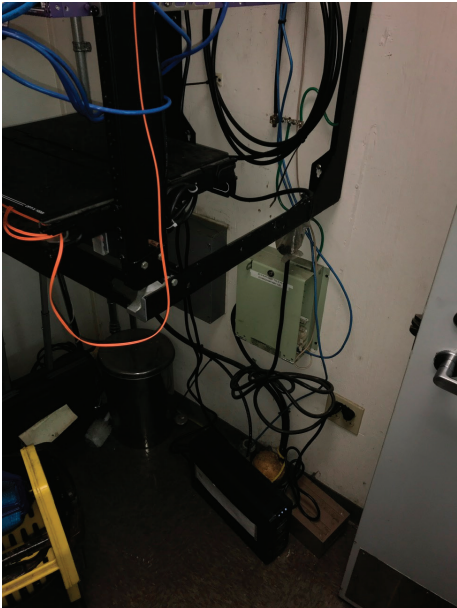
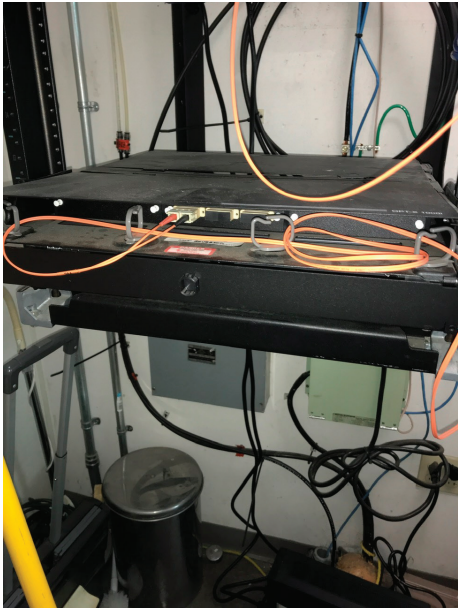
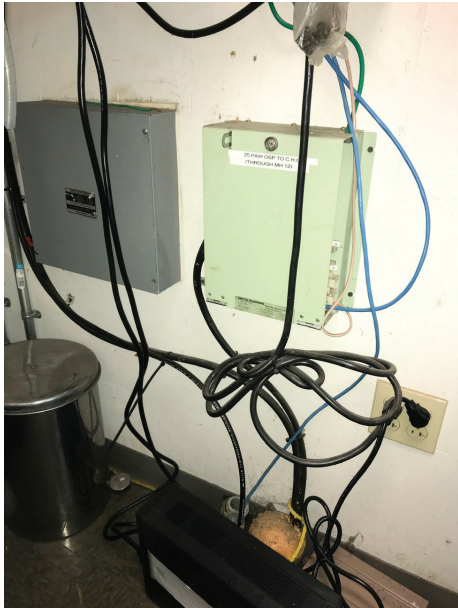
- There is some fire stop in the conduits.
- Jumper cables are loosely dressed into the wire management.

- Fire stop conduits.
- Add additional wire management and dress the jumper cables into the wire management.
- Protect the fiber jumper feeding into the racks and servers.

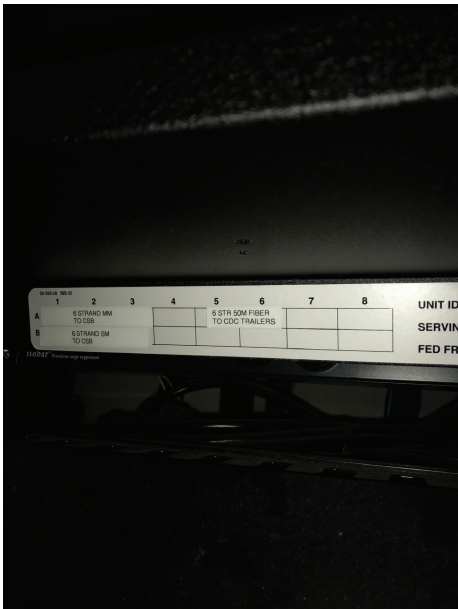
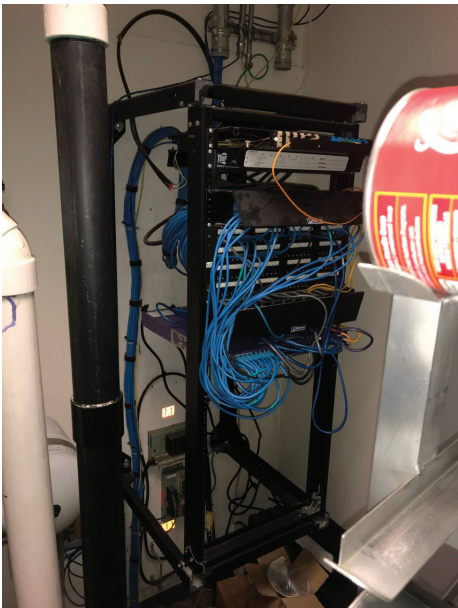
- There is some fire stop in the conduits.
- Clutter around the rack and cabling.
- Jumper cables are loosely dressed into the wire management.

- Fire stop conduits.
- Dress the jumper cables into the wire management.
- Protect the fiber jumper feeding into the racks and servers.

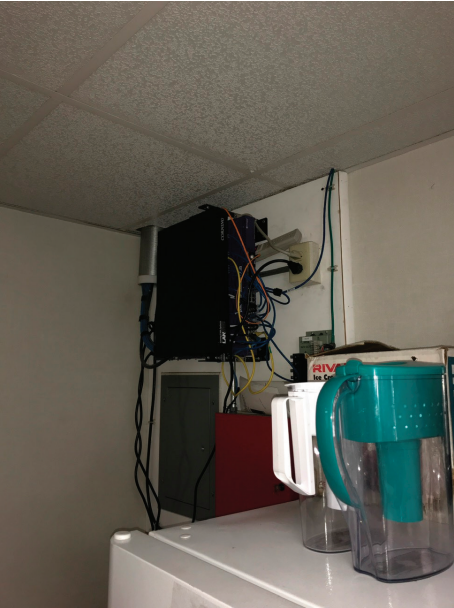
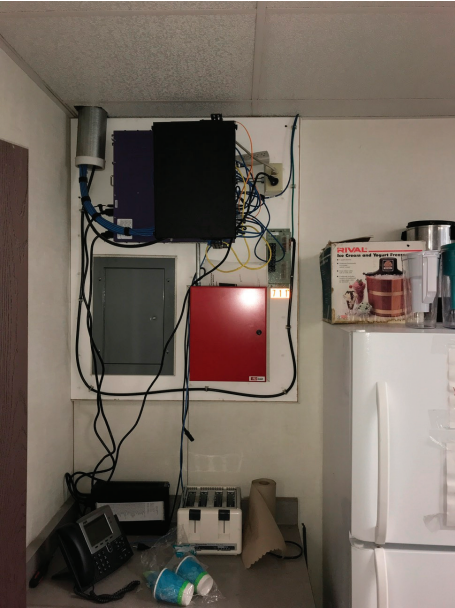
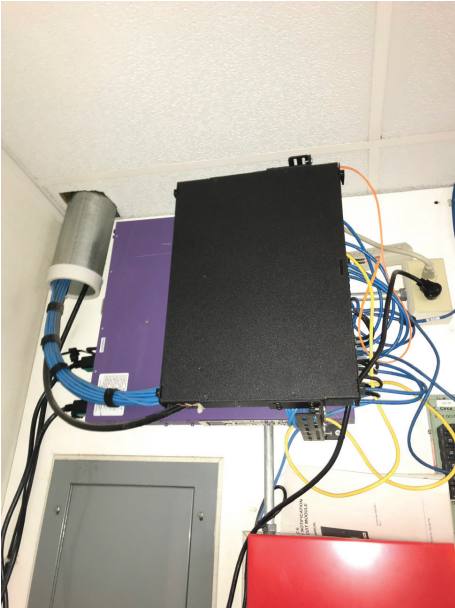
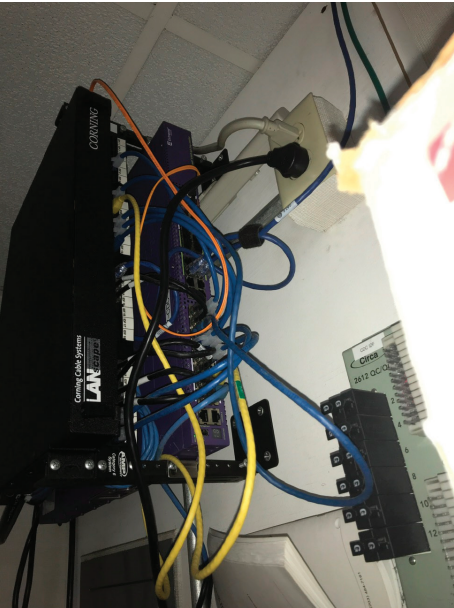
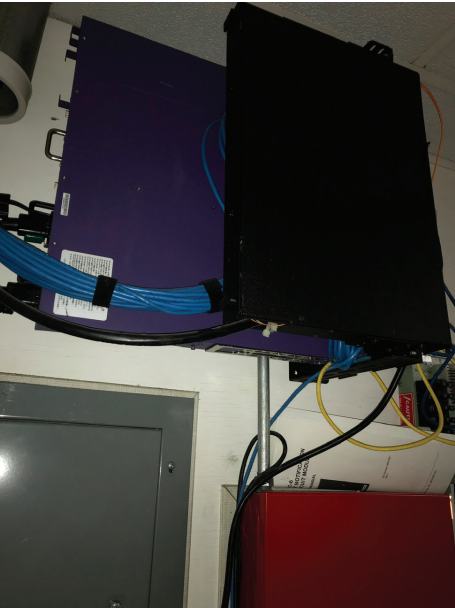
- The rack and equipment are above a work area (toaster below)
- Clutter around the rack and cabling.
- Jumper cables are loosely dressed into the wire management.
- Minimal protection from the surroundings.

- Replace the side mount with an enclosed cabinet.
- Dress the jumper cables.
- Protect the fiber jumper feeding into the racks and servers.
